Zeitschrift: IABSE reports = Rapports AIPC = IVBH Berichte
Band: 64 (1991)

Artikel: East River bridge rehabilitation in New York
Autor: Kotlyarsky, Edward / Trachtenberg, Eugene
DOI: <https://doi.org/10.5169/seals-49346>

East River Bridge Rehabilitation in New York

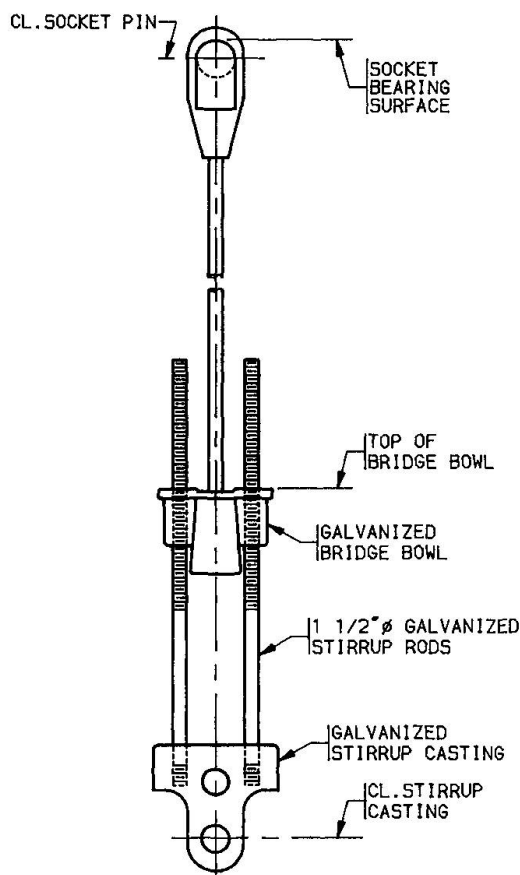
Fig. 1 New wire rope suspender

Existing suspenders were replaced with new 35 mm (1 3/8 in) diameter galvanized wire ropes attached to the cable with new cable bands. Suspenders attachment to the truss bottom chord consists of two stirrup rods, galvanized stirrup casting and bridge bowl (Fig. 1), provided for required adjustment of suspender length. The socket baskets were filled with zinc. Solid rods were used in areas requiring very short suspenders.

Upon completion of the suspender replacement, existing stays were replaced with 41.4 mm (1 5/8 in) galvanized structural wire ropes. The stay assembly and its attachment to the truss is similar to that of the suspender.

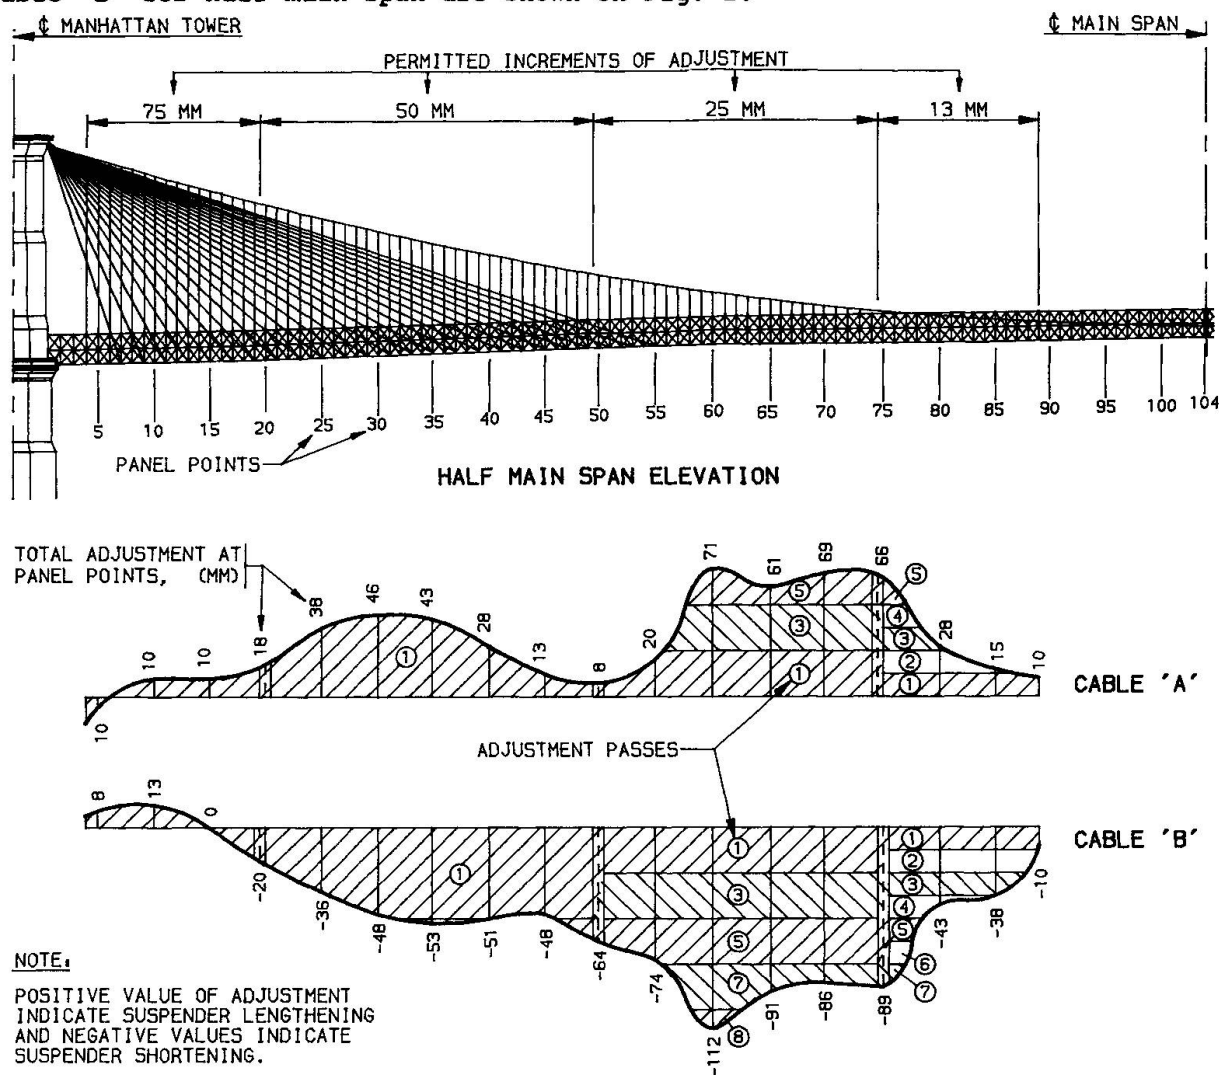
Fig. 2 Adjustment passes. Brooklyn half of Main Span

The values of adjustments and the number of passes for outer cable "A" and inner cable "B" for half main span are shown on Fig. 2.

The adjustments are mainly positive for cables A and D and negative for cables B and C. When done, these adjustments increase tension in the inner and reduce it in the outer cables thus achieving the desirable dead load distribution.

During each pass adjustments were made on all four suspenders at each panel point before proceeding to the next panel point. Subsequent passes were performed in predetermined sequence until all adjustments were completed.

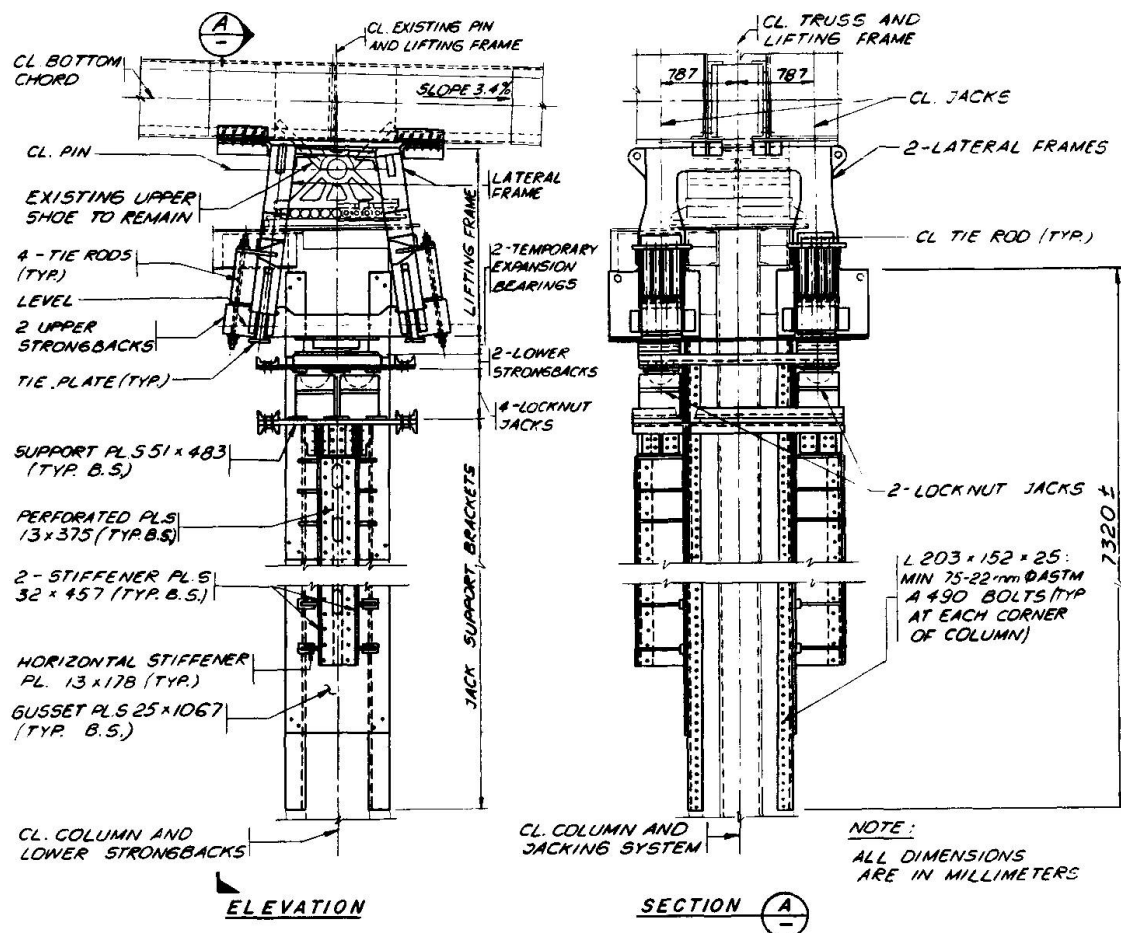
Fig. 4 Bearing replacement jacking system.

The entire system for the lifting and lowering of the existing trusses (Fig. 4) consisted of a high strength steel space frame, two temporary expansion bearings each seated on a strongback, four 4448 kN (500 ton) capacity locknut jacks and the lower support system. The temporary expansion bearings allowed the truss and jacking frame to translate and rock during the entire jacking operation. There were two different types of lower support system used: jack support brackets bolted to the existing columns at pp Nos. 20, 40, and 58; and jack support columns seated on the existing footings at pp Nos. 78, 82 and 86. Another procedure was used to replace expansion bearings at pp 0.

Lifting frame geometry was complicated by the need to fit in a very congested area and to provide clearances required to dismantle and remove the existing bearing elements and to erect new bearing components. Structural analysis of the space frame revealed that after lifting the existing truss, the maximum combined unit stress in the frame legs due to axial force and biaxial bending was 371 MPa (53.8 KSI). Because of the high design stresses in the frame elements they were fabricated of high strength quenched and tempered low alloy steel ASTM A-514 plates with minimum tensile yield point 689.5 MPa (100 ksi). Because this material is not available in thickness greater than 63.5 mm (2 1/2 in) each frame was built up of five plates laminated to provide the total leg thickness of 254 mm (10 in), and bolted together with 25.4 mm (1 in) diameter ASTM A-490 high strength bolts, tightened to a minimum tension of 285 kN (64 kips). The two upper strongbacks were built up of seven 50.8 mm (2 in) plates and two 25.4 mm (1 in) plates. The 50.8 mm (2 in) plate thickness provided openings for four 44.45 mm (1 3/4 in) diameter tie rods at both ends of each

upper strongback, where moment connections to the lateral frames were required. All tie rods were pretensioned to 44.5 kN (10 kips) each prior to the lifting operation. Each lower strongback was supported by two hydraulic jacks seated on two support brackets. Each bracket was connected to the existing column by seventy five 22.23 mm (7/8 in) diameter ASTM A-490 bolts through existing and new holes. The length of each of these connections was about 7.3 m (24 ft). Based on ASHTO requirements, the allowable shear stress on high-strength bolts in these connections was reduced by 20%.

The height of columns at three panel point locations was not sufficient to provide such long connections. This circumstance required the design of temporary four column steel towers installed on the existing 203.2 mm (8 in) thick cast steel base and braced around and to the existing column. Two lower strongbacks were longer than that used at high existing columns to accommodate location of jacks directly above the temporary columns.
