Artikel: East River bridge rehabilitation in New York
Autor: Kotlyarsky, Edward / Trachtenberg, Eugene
DOI: <https://doi.org/10.5169/seals-49346>

East River Bridge Rehabilitation in New York

SUMMARY

The rehabilitation of the Brooklyn and Queensboro Bridges, two of New York's most famous and historic structures, is presently under way. All construction operations including replacement of main carrying members were performed with minimal disruption of existing traffic, and the historic architectural details of the structures were fully preserved. In order to reach the final objective, the designs had to incorporate specific, detailed construction procedures and sequences.

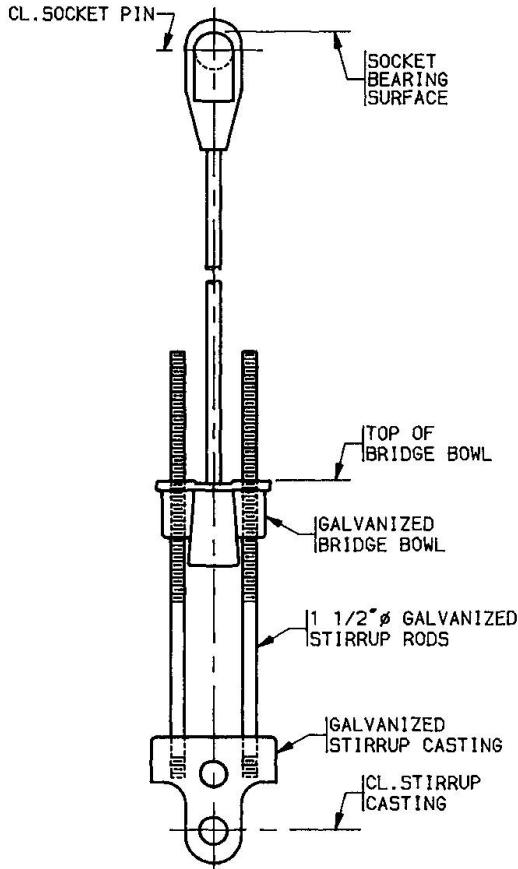
Fig. 1 New wire rope suspender

Existing suspenders were replaced with new 35 mm (1 3/8 in) diameter galvanized

wire ropes attached to the cable with new cable bands. Suspender attachment to the truss bottom chord consists of two stirrup rods, galvanized stirrup casting and bridge bowl (Fig. 1), provided for required adjustment of suspender length. The socket baskets were filled with zinc. Solid rods were used in areas requiring very short suspenders.

Upon completion of the suspender replacement, existing stays were replaced with 41.4 mm (1 5/8 in) galvanized structural wire ropes. The stay assembly and its attachment to the truss is similar to that of the suspender.

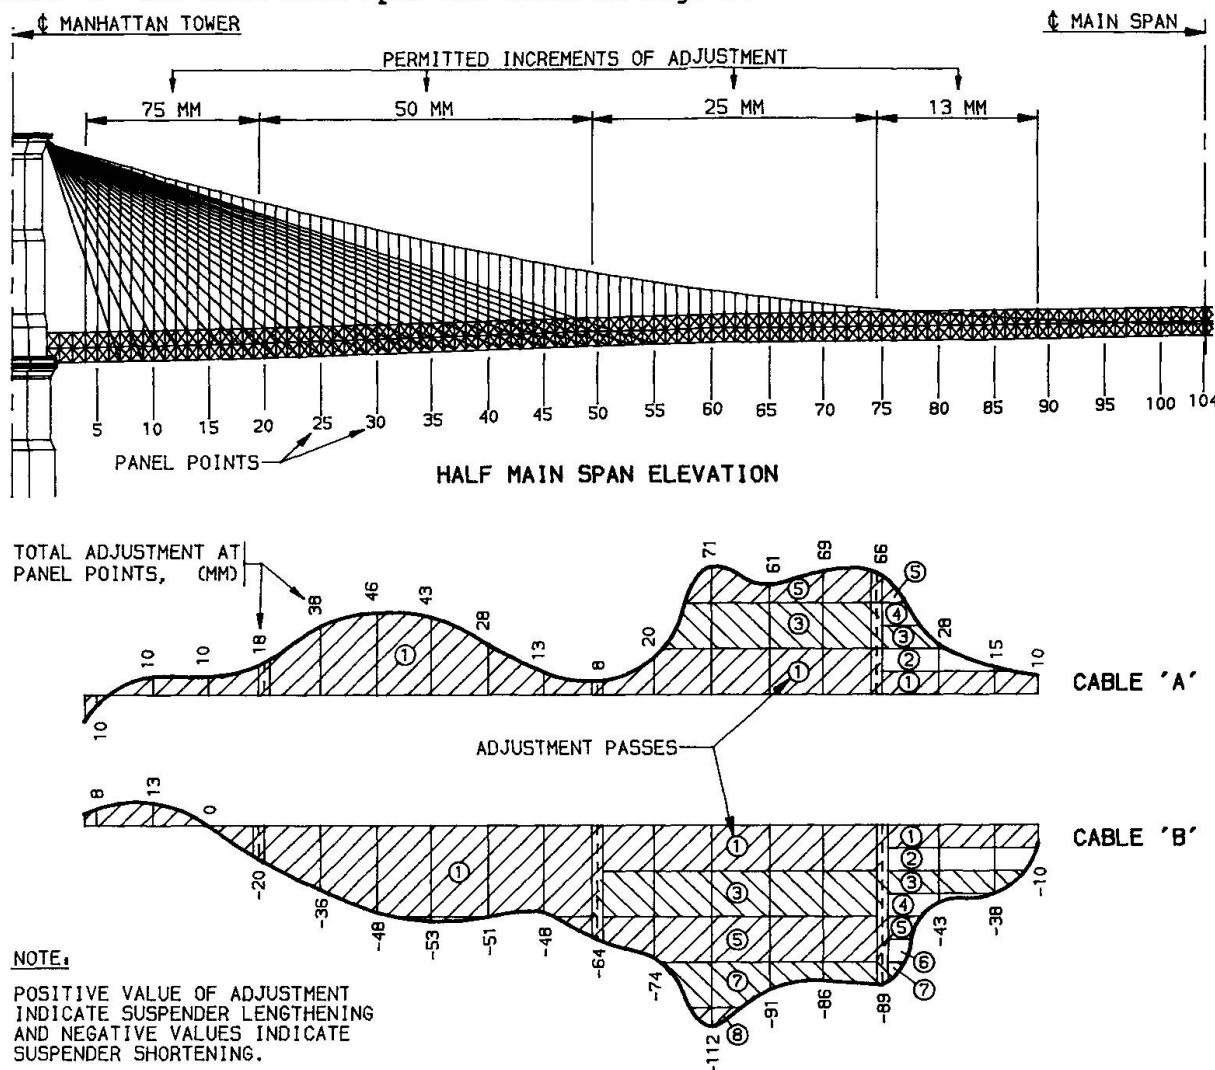
Fig. 2 Adjustment passes. Brooklyn half of Main Span

The values of adjustments and the number of passes for outer cable "A" and inner cable "B" for half main span are shown on Fig. 2.

The adjustments are mainly positive for cables A and D and negative for cables B and C. When done, these adjustments increase tension in the inner and reduce it in the outer cables thus achieving the desirable dead load distribution.

During each pass adjustments were made on all four suspenders at each panel point before proceeding to the next panel point. Subsequent passes were performed in predetermined sequence until all adjustments were completed.

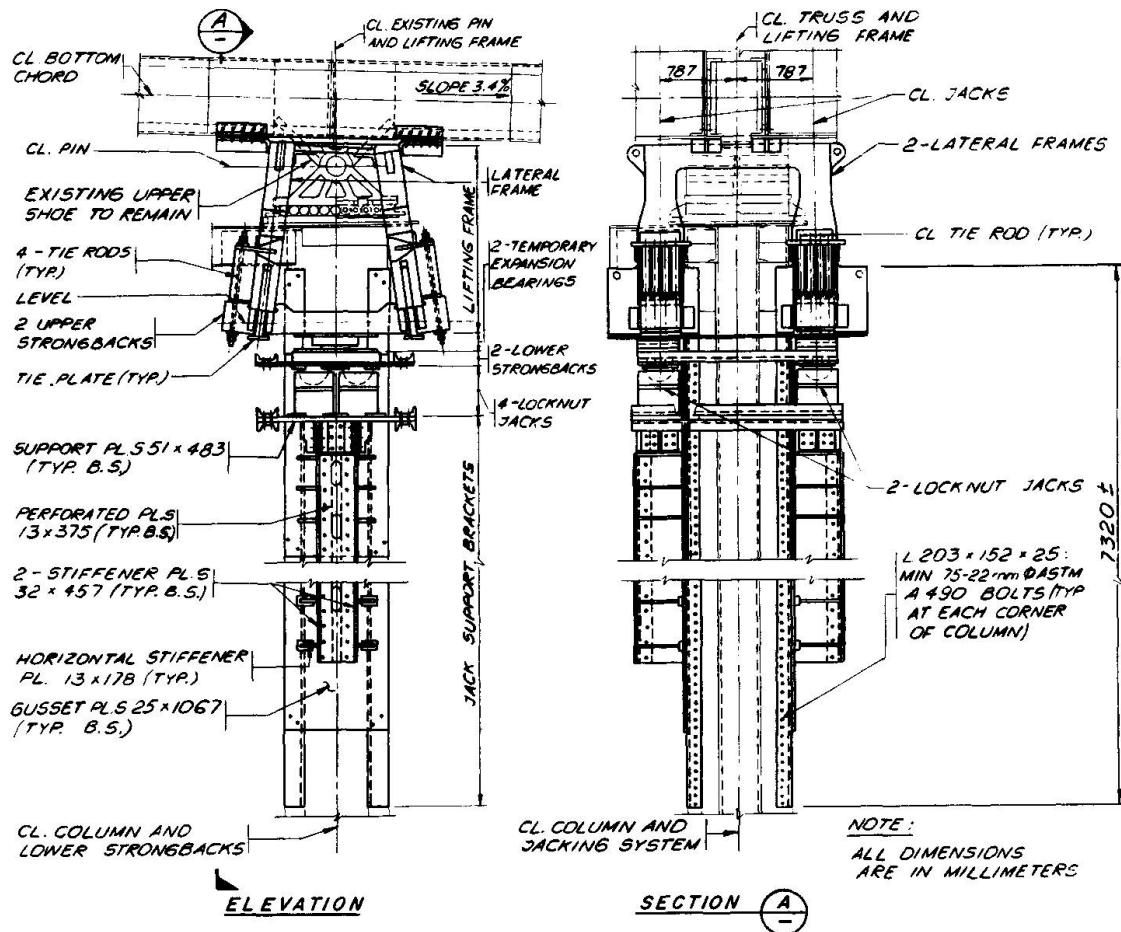
Fig. 4 Bearing replacement jacking system.

The entire system for the lifting and lowering of the existing trusses (Fig. 4) consisted of a high strength steel space frame, two temporary expansion bearings each seated on a strongback, four 4448 kN (500 ton) capacity locknut jacks and the lower support system. The temporary expansion bearings allowed the truss and jacking frame to translate and rock during the entire jacking operation. There were two different types of lower support system used: jack support brackets bolted to the existing columns at pp Nos. 20, 40, and 58; and jack support columns seated on the existing footings at pp Nos. 78, 82 and 86. Another procedure was used to replace expansion bearings at pp 0.

upper strongback, where moment connections to the lateral frames were required. All tie rods were pretensioned to 44.5 kN (10 kips) each prior to the lifting operation. Each lower strongback was supported by two hydraulic jacks seated on two support brackets. Each bracket was connected to the existing column by seventy five 22.23 mm (7/8 in) diameter ASTM A-490 bolts through existing and new holes. The length of each of these connections was about 7.3 m (24 ft). Based on ASHTO requirements, the allowable shear stress on high-strength bolts in these connections was reduced by 20%.

The height of columns at three panel point locations was not sufficient to provide such long connections. This circumstance required the design of temporary four column steel towers installed on the existing 203.2 mm (8 in) thick cast steel base and braced around and to the existing column. Two lower strongbacks were longer than that used at high existing columns to accommodate location of jacks directly above the temporary columns.

All four jacks were controlled by a synchronous lifting and lowering console that maintained simultaneous, equal vertical movement of jacks despite the different reactions on each pair of jacks along the bridge.
