Artikel: East River bridge rehabilitation in New York

Autor: Kotlyarsky, Edward / Trachtenberg, Eugene

East River Bridge Rehabilitation in New York Rénovation de ponts sur la East River à New York Erneuerung der East-River-Brücken in New York

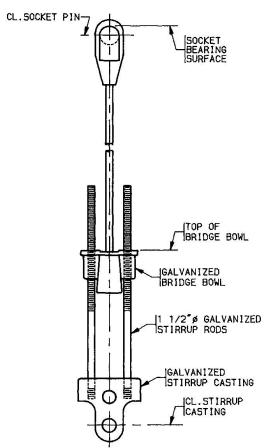
Fig. 1 New wire rope suspender

wire ropes attached to the cable with new cable bands. Suspender attachment to the truss bottom chord consists of two stirrup rods, galvanized stirrup casting and bridge bowl (Fig. 1), provided for required adjustment of suspender length. The socket baskets were filled with zinc. Solid rods were used in areas requiring very short suspenders.

Existing suspenders were replaced with new 35 mm (1 3/8 in) diameter galvanized

Upon completion of the suspender replacement, existing stays were replaced with 41.4 mm (1 5/8 in) galvanized structural wire ropes. The stay assembly and its attachment to the truss is similar to that of the suspender.

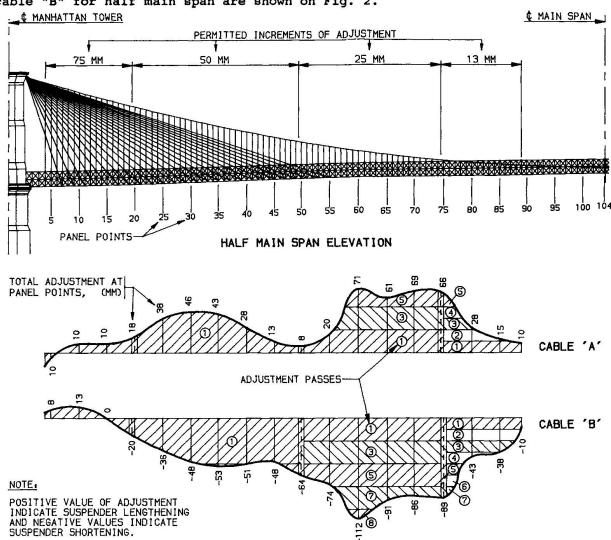
Fig. 2 Adjustment passes. Brooklyn half of Main Span

The values of adjustments and the number of passes for outer cable "A" and inner cable "B" for half main span are shown on Fig. 2.

The adjustments are mainly positive for cables A and D and negative for cables B and C. When done, these adjustments increase tension in the inner and reduce it in the outer cables thus achieving the desirable dead load distribution.

During each pass adjustments were made on all four suspenders at each panel point before proceeding to the next panel point. Subsequent passes were performed in predetermined sequence until all adjustments were completed.

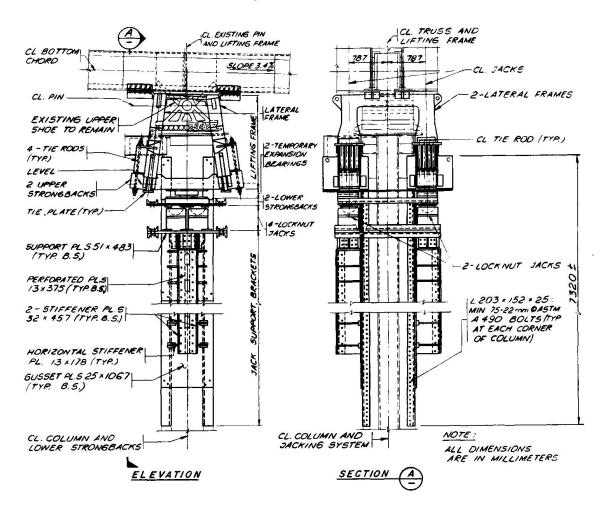
Fig. 4 Bearing replacement jacking system.

The entire system for the lifting and lowering of the existing trusses (Fig. 4) consisted of a high strength steel space frame, two temporary expansion bearings each seated on a strongback, four 4448 kN (500 ton) capacity locknut jacks and the lower support system. The temporary expansion bearings allowed the truss and jacking frame to translate and rock during the entire jacking operation. There were two different types of lower support system used: jack support brackets bolted to the existing columns at pp Nos. 20, 40, and 58; and jack support columns seated on the existing footings at pp Nos. 78, 82 and 86. Another procedure was used to replace expansion bearings at pp 0.

Lifting frame geometry was complicated by the need to fit in a very congested area and to provide clearances required to dismantle and remove the existing bearing elements and to erect new bearing components. Structural analysis of the space frame revealed that after lifting the existing truss, the maximum combined unit stress in the frame legs due to axial force and biaxial bending was 371 MPa (53.8 KSI). Because of the high design stresses in the frame elements they were fabricated of high strength quenched and tempered low alloy steel ASTM A-514 plates with minimum tensile yield point 689.5 MPa (100 ksi). Because this material is not available in thickness greater than 63.5 mm (2 1/2 in) each frame was built up of five plates laminated to provide the total leg thickness of 254 mm (10 in), and bolted together with 25.4 mm (1 in) diameter ASTM A-490 high strength bolts, tightened to a minimum tension of 285 kN (64 kips). The two upper strongbacks were built up of seven 50.8 mm (2 in) plates and two 25.4 mm (1 in) plates. The 50.8 mm (2 in) plate thickness provided openings for four 44.45 mm (1 3/4 in) diameter tie rods at both ends of each

upper strongback, where moment connections to the lateral frames were required. All tie rods were pretensioned to 44.5 kN (10 kips) each prior to the lifting operation. Each lower strongback was supported by two hydraulic jacks seated on two support brackets. Each bracket was connected to the existing column by seventy five 22.23 mm (7/8 in) diameter ASTM A-490 bolts through existing and new holes. The length of each of these connections was about 7.3 m (24 ft). Based on ASHTO requirements, the allowable shear stress on high-strength bolts in these connections was reduced by 20%.

The height of columns at three panel point locations was not sufficient to provide such long connections. This circumstance required the design of temporary four column steel towers installed on the existing 203.2 mm (8 in) thick cast steel base and braced around and to the existing column. Two lower strongbacks were longer than that used at high existing columns to accommodate location of jacks directly above the temporary columns.

All four jacks were controlled by a synchronous lifting and lowering console that maintained simultaneous, equal vertical movement of jacks despite the different reactions on each pair of jacks along the bridge.
