Zeitschrift: IABSE reports = Rapports AIPC = IVBH Berichte
Band: 66 (1992)

Artikel: Fatigue and failure of a flexed locked coil wire rope
Autor: Kopanakis, Georg
DOI: <https://doi.org/10.5169/seals-50694>

Fatigue and Failure of a Flexed Locked Coil Wire Rope

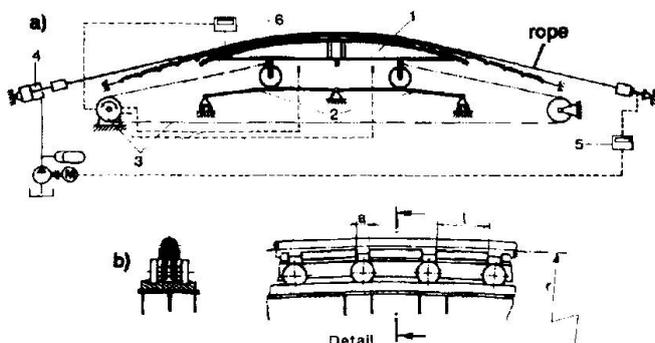
Fig. 1: Layout of the roller chain testing machine.

The testing machine consists of the following parts:

1. Saddle and roller chain (fabricated by the Swiss Ropeways Industry) fixed on a carriage
2. Track (of the carriage)
3. Drive system
4. Tensioning cylinder
5. Automatic control of the tensile force
6. Automatic control of the carriage velocity, influenced by rope temperature.

The first observation to be made is that the damage first starts and propagates in the second layer. The first wire breaks start in the "lower part" (i.e. at the rope side contacting the roller chain links) or/and in the "upper part" of the rope (i.e. the opposite rope side) (Fig. 1b).

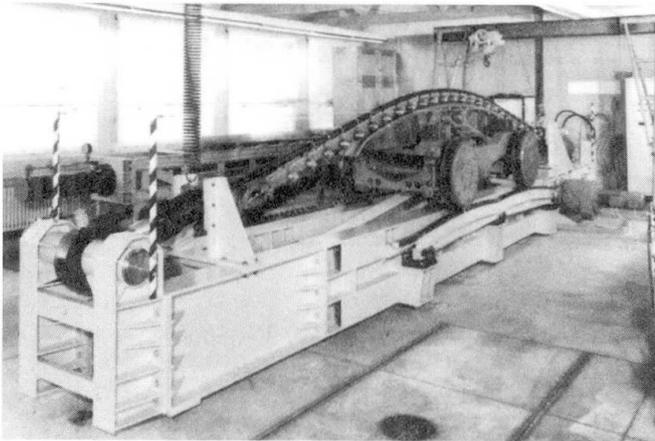
Fig. 2: View of the roller chain testing machine.

It has been designed to test ropes up to a diameter of 55 mm, reproducing the actual stress condition of a locked coil track rope flexed at a roller chain of a reversible tramway.

The rope specimen is bent over the roller chain and tensioned by the hydraulic cylinder. The shape of the carriage tracks has been calculated to invert the movement actually taking place in practice. Thus it is not the roller chain and the rope which roll over the saddle but the saddle which

slides under the fixed roller chain and rope.

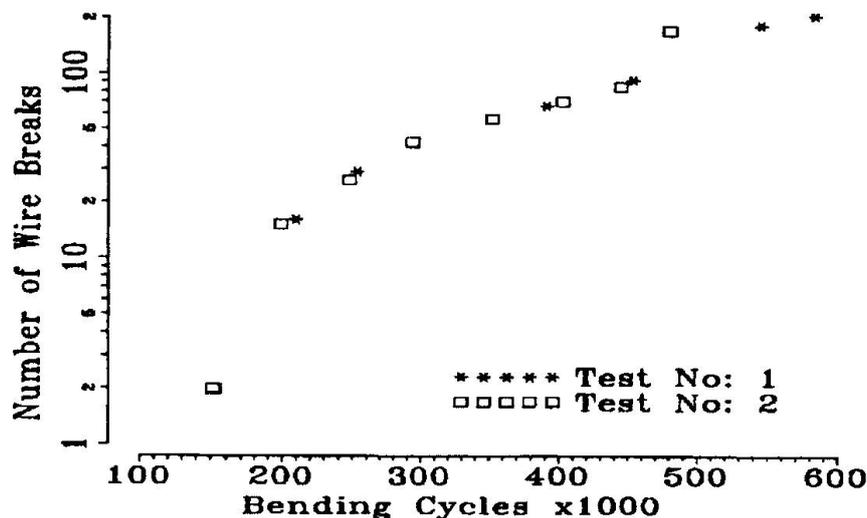
Fig. 6: The development of the number of wire breaks as a function of bending cycles, an example of the good reproducibility.

Although the reproducibility of wire rope fatigue tests is mostly not high even when using one and the same rope, the tests mentioned here show that in this particular case of locally high resultant stress a high degree of consistency is possible (Fig. 6).

The plots in figures 6, 10, 11, 12 and 13 show the development of the number of wire breaks as a function of bending cycles. The number of wire breaks is plotted with a logarithmic scale on the Y axis, and the number of cycles is plotted with linear scale on the X axis. The straight lines drawn are an exponential approximation.

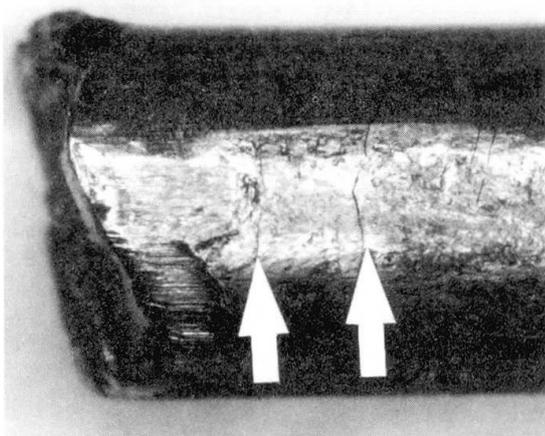
Fig. 8: A piece of an O-wire taken from the second layer with a fatigue break at the left. The arrows indicate the cracks nucleated next to the fatigue break.

Almost all the wires of the second layer were found to have multiple breaks (Fig. 7), as well as several cracks next to the existing breaks (Fig. 8). An extreme local lack of lubrication within the contact areas of two wires of different layers (Fig. 9), and traces of frictional wear within these areas characterized the damage.

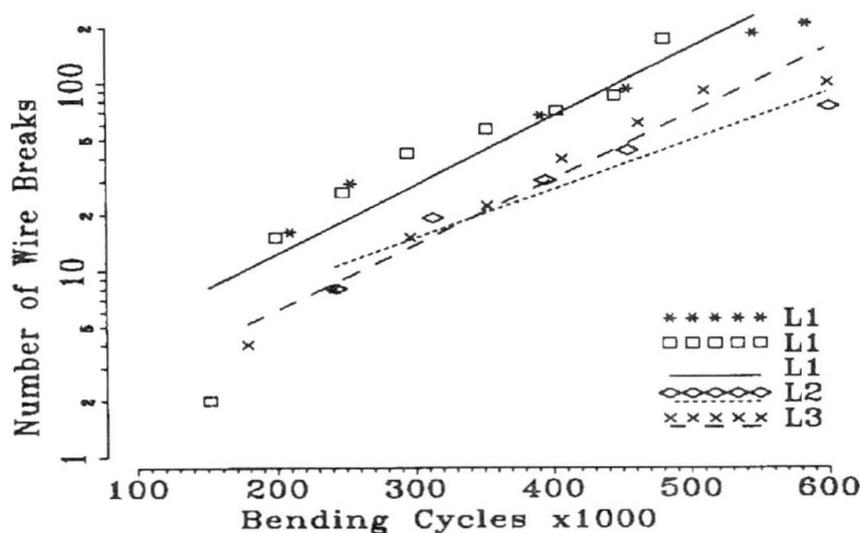
Fig. 10: The development of the number of wire breaks as a function of bending cycles; comparison between three initial lubricants.

Fig. 10 shows the comparison between three initial lubricants. The lubricants L2 and L3 have the same main component, being totally different to L1.

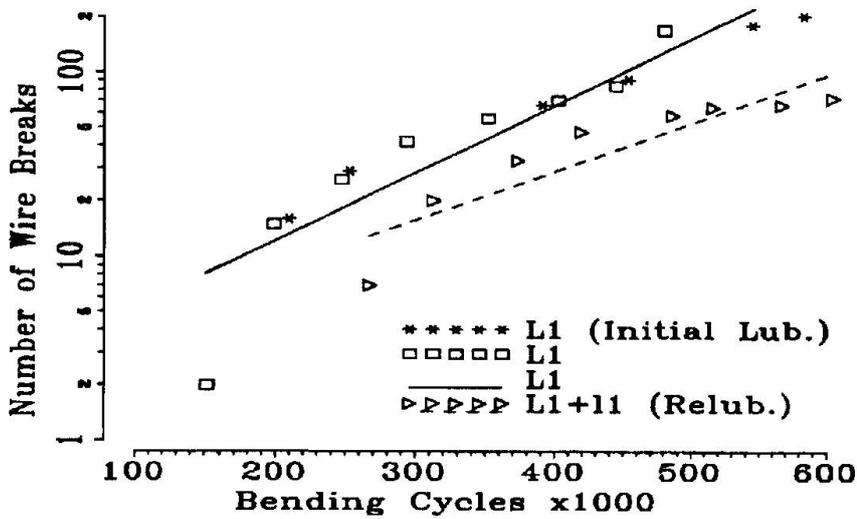
Fig. 11: The development of the number of wire breaks as a function of bending cycles; influence of service relubrication using a relubricant compatible with the initial lubricant.

An example is shown in Fig. 11. In this case a life increase of about 40 % has been achieved. Fig. 12 shows that if there is no compatibility between initial and service relubrication no significant improvement can be expected.

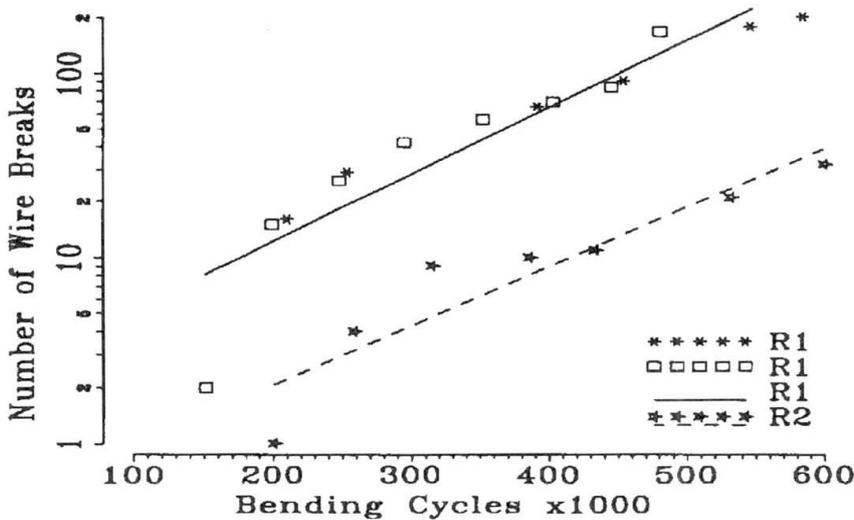
Fig. 13: The development of the number of wire breaks as a function of bending cycles; influence of the rope design and construction.

The life expectancy of the rope construction R2 (2 x locked coil) was, for this particular application and the ropes tested, almost 80% longer than that of R1 (1 1/2 x locked coil) (Fig.13).

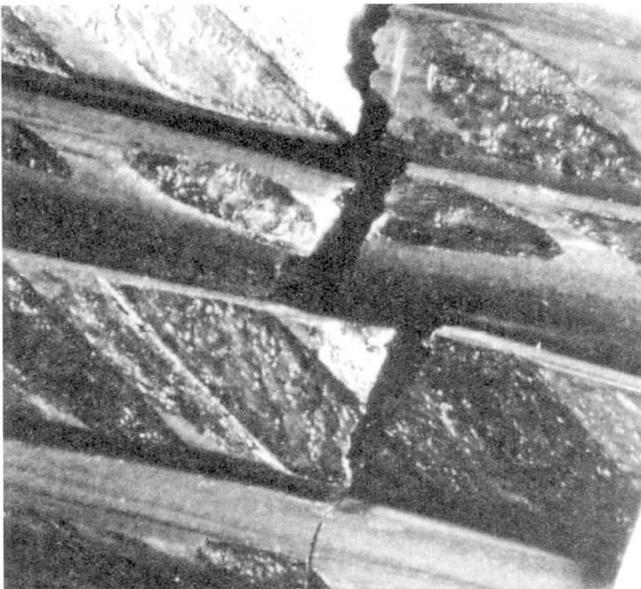
Fig. 14: Almost all the origins of the first cracks were situated within the intensive wear zones.

All the above findings correspond well to the results of the metallographic examinations carried out by the Swiss Federal Laboratories for Materials Testing and Research, according to which, with the exception of some single wires, all the origins of the first cracks were situated within the intensive wear zones (Fig.14), mainly caused by high local pressure. On the other hand the crack

propagation is caused by combined bending and torsion and secondarily by tension.

- The crack initiation in the second layer is a result either of friction wear combined with high pressure or of fretting.
