**Zeitschrift:** IABSE reports = Rapports AIPC = IVBH Berichte  
**Band:** 67 (1993)

**Artikel:** Stress histogramme and fatigue life evaluation of highway bridges  
**Autor:** Fujiwara, Minoru / Nishikawa, Kazuhiro / Murakoshi, Jun  
**DOI:** <https://doi.org/10.5169/seals-51388>

## Stress Histogramme and Fatigue Life Evaluation of Highway Bridges

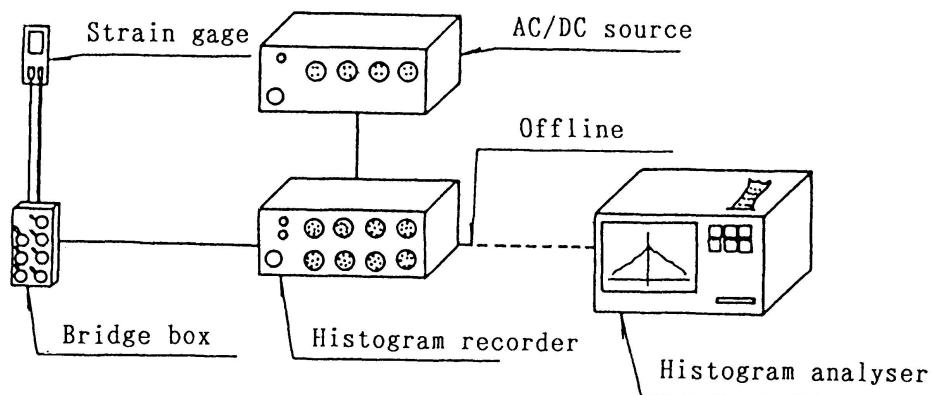
Fig. 1 System of measuring devices

The histogram recorder used is an device which consists of strain meter, amplifier, A / D converter, processor and memories to analyze stress ranges and their frequencies of histogram by digital process of analog data obtained from strain gages or other sensors. The histogram recorder we use has 8 channels to input and 8 data memories. Appearance of devices used for stress measurement is shown in Fig. 1 and Photo 1. The histogram recorder is small in size (200mm(W)×75mm(H)×120mm(D)) and light in weight (about 2kg). Histogram analyser in the figure is used only for initial setting and operation of histogram recorder, collecting of obtained data.

It contains CRT, printer, and micro floppy disk drive. Obtained data can be checked in field on time. System disks and data disks are used for analytical

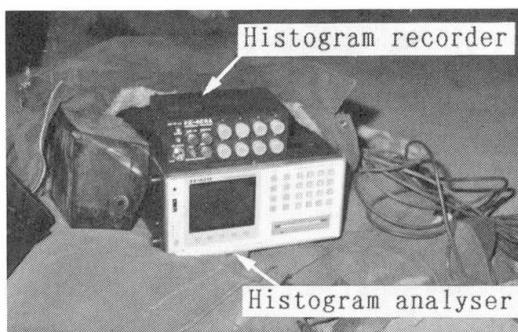
Photo 1 Appearance of measuring devices

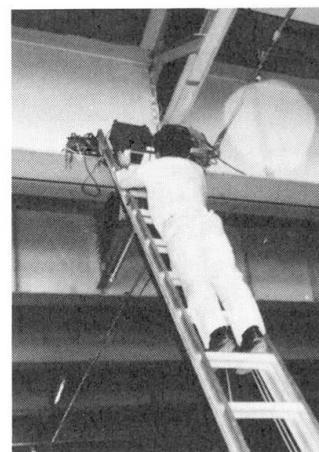
Photo 2 Initial setting of histogram recorder in field

program setting, recording and storing the obtained data. Photo 2 shows initial setting of histogram recorder installed on a bottom flange of a main girder end in an I-shaped plate girder bridge using histogram analyser. The histogram recorder is small enough to be installed on the bottom flange.

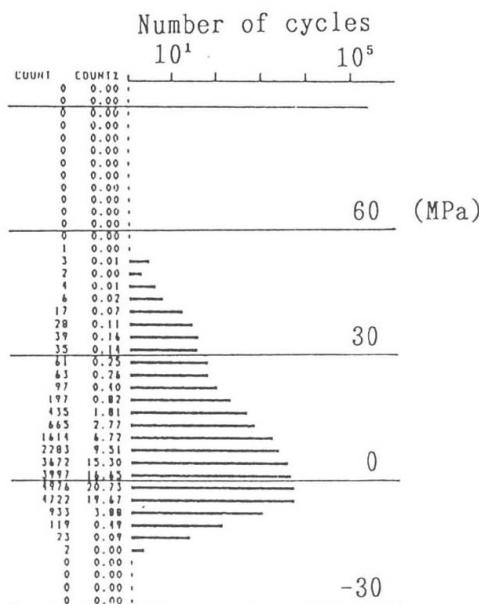
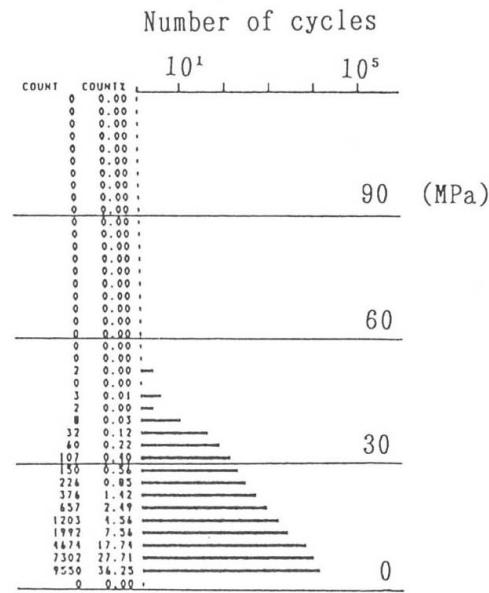
(a) Histogram by the Peak-valley method

(b) Histogram by Rain-flow Method

Fig. 2 Stress range histograms

Fig. 2 shows typical stress range histograms measured on a bottom flange of span center of a plate girder bridge during 24-hour period. (a) and (b) are obtained applying Peak-valley method and Rain-flow method to process measured stress respectively. In Peak-valley method, number of peak and valley appeared is recorded. The maximum stress obtained by Peak-valley method can be utilized to evaluate the load carrying capacity. Rain-flow method processing produces stress range histogram. Stress range histogram directly represents the accumulated fatigue damage of a bridge member during the measuring period. Remaining life for the fatigue damage can be estimated by applying the modified Miner's cumulative damage rule for such stress range histogram.

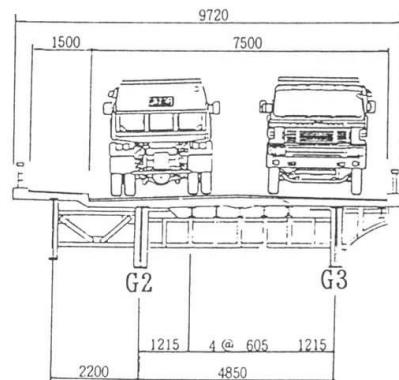
Fig. 3 Cross section of investigated bridge

Table 1 shows comparison between the measured maximum stresses during 24 hours and caluculated stresses at the span center of main girders of a plate girder bridge by present DLL. Fig. 3 shows the cross section of the bridge, which was designed by

12 ton truck. As one of limit states, we consider condition that residual deformation does not remain in bridge components, i.e., in case of main girder, it does not yield. For example, with respect to a main girder, assuming that the acting stress mostly consists of stress components due to dead and live load, the value of  $(\sigma_a - \sigma_d)$  is required to be larger than measured maximum stress due to actual live load as follows.

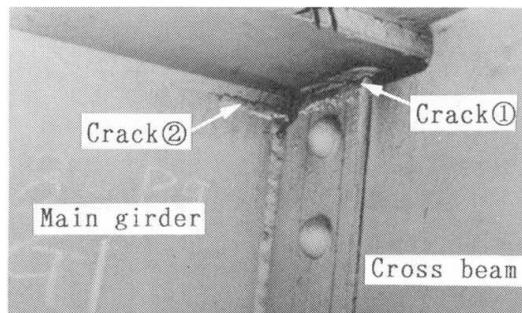
Photo 3 Fatigue cracks occurring at cross-beam connection

Photo 3 shows fatigue cracks which occurred at a connection between a main girder and a cross beam of an I-shaped plate girder bridge. Crack ① occurred top end of a vertical stiffener welded to top flange. Crack ② occurred on web at fillet-weld toe connecting web and top flange of main girder. Generally, crack ② occurred after crack penetration of top end welding of the vertical stiffener. These cracks, which are the most frequent of all cracks reported in Japan, do not

lead to a serious problem quickly. However, it can result in loss of durability of the bridge itself. The causes of damage are not clear enough so far. But at least, it can be said that these cracks were caused by secondary stresses due to relative deflection of main girders and deflection of RC floor slabs by wheel load of heavy traffic. The characteristics of damaged bridges and the effectiveness of repair and strengthening method have been investigated by directly monitoring stress histogram at the top ends of vertical stiffeners where cracks possibly occur.

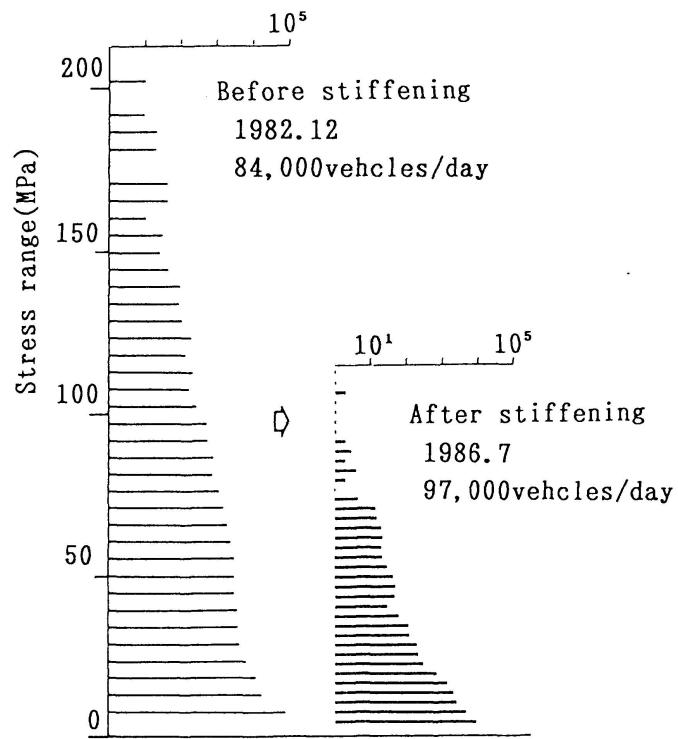
Fig. 4 Stress range histograms measured before and after the stiffening

Fig. 4 shows the results of stress range histogram measured

during 24 hours without traffic disturbance before and after stiffening of RC floor slab with additional stringers between main girders. The stiffening is one of the strengthening methods for RC floor slab. From this figure, the distribution of stress histogram can be seen shifted to much lower stress range after the stiffening. The fatigue life after the stiffening is estimated about 80 times as long as before. It is confirmed that the stiffening is effective for not only stiffening the RC floor slab but also reducing the local stresses at the cross-beam connection. This measurement could be carried out without disturbing traffic, therefore it is effective as one of the direct and easy approach for the investigation of fatigue damaged bridges.

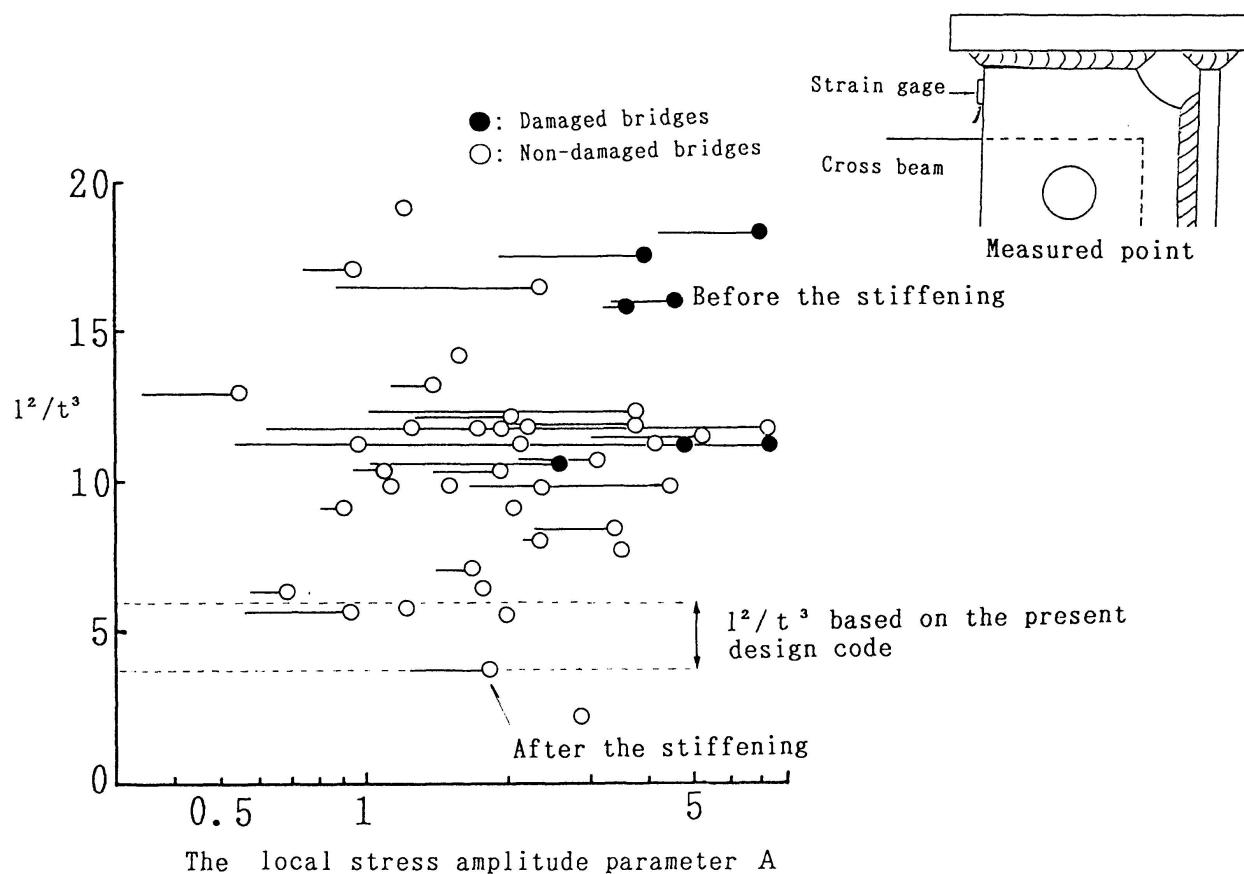
Fig. 5 Relationship between  $l^2/t^3$  and local stress amplitude parameter A for each bridge.

Fig. 5 shows relationship between  $l^2/t^3$  and the local stress amplitude parameter A for each bridge.  $l^2/t^3$  is the same order as a rotational angle of RC floor slab on main girder web where  $l$ =spacing of main girders,  $t$ =thickness of RC floor slab. The local stress amplitude parameter A in each bridge is shown by solid line for the scatter range of A at different cross-beam connections. Black dots means fatigue damaged bridges at cross-beam connection. Also indicated in this figure, is the comparison before and after the stiffening of RC floor slab with additional stringers mentioned in paragraph 3.2.1. By such direct approach, it is confirmed that occurrence of fatigue crack is influenced by the structural parameter  $l^2/t^3$  to a considerable degree.

The Japanese design code of RC floor slab had been revised several times for the purpose of increase of its stiffness from the durability point of view. As shown in the figure, The values of  $l^2/t^3$  for the RC floor slab designed by the present design code are approximately 3.8 to 5.8. These values are less than those of the fatigue damaged bridges. This indicates that the fatigue cracks are unlikely to occur at bridges designed by the present design code.
