Remaining Strength of Bridges in Rotterdam
Capacité restante des ponts à Rotterdam
Resttragfähigkeit von Brücken in Rotterdam

Kors NOORLANDER
Civil Engineer
Public Works Rotterdam
Rotterdam, The Netherlands

In the City of Rotterdam there are over 600 bridges. Decisions concerning maintenance are only possible on a responsible basis if the remaining strength of the structures is taken into account. This is illustrated by some case studies.

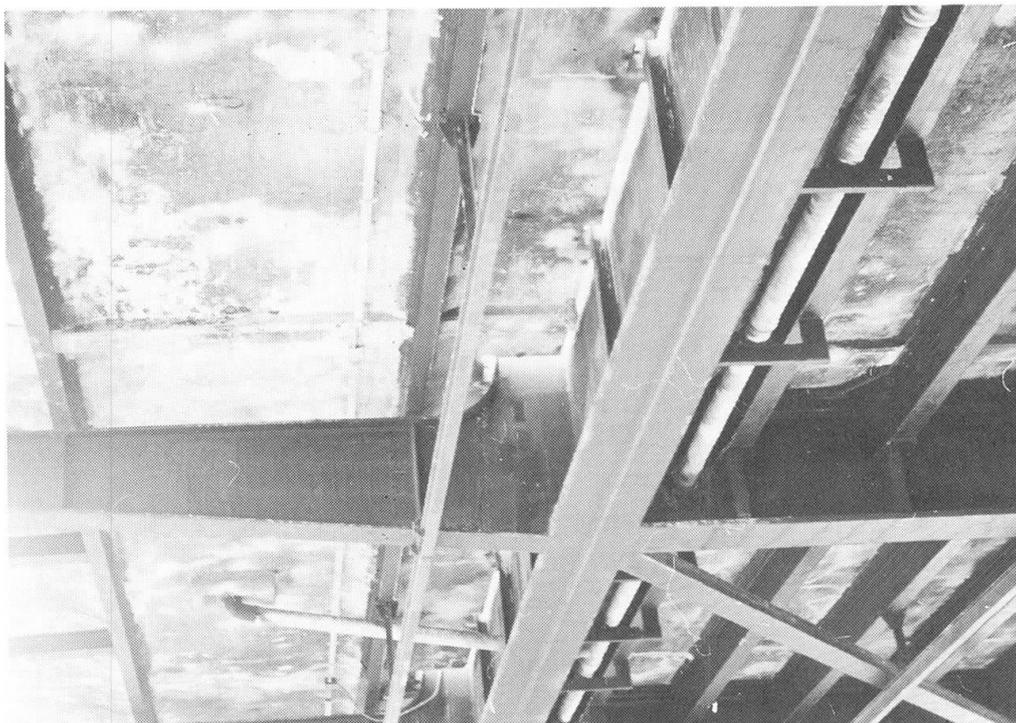
Photo 2 construction of cantilevers

The bridge has two spans and serves as an overpass of a railway. The structural system is a double stiffened arch connected by crossbeams with a reinforced concrete deck. Build in the late thirties, this was the first all welded larger bridge in the Netherlands. Details were strongly related to riveted construction. In this respect the strength of the cantilever was doubted.

Theoretical analysis revealed that the strength was less than the standards required. But the reliability of this analysis was questionable. So we decided to test the loading capacity by test loading. During the test deformations as well as strains were recorded. The testload was applied by means of a loaded truck. The results were that the safe load was over 50 % higher than the theoretical calculated load. Plastic deformations were not observed.

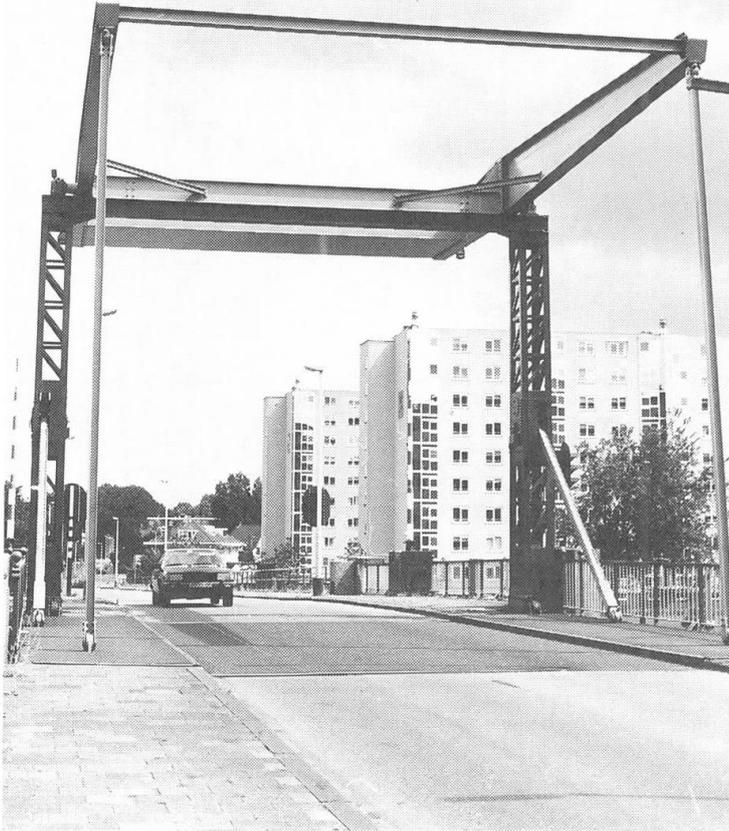
Photo 3 movable bridge

The bridge, of the type pictured in photo 3 and 4 is a specific example of this fact. In closed situation the beam coupling the axles of the balance is a double plate-girder. But after opening this beam is a Vierendeel-truss with high shear-force resulting a high variation of bending-stresses (140 N/mm^2) which was confirmed by means of strain measurements.

In this case the structure is a movable bridge. the problem was the stress-variation resulting from the opening and closing of the bridge. The structure is of a type which is completely balanced; balancing is accomplished by a counterweight supported on a beam above the bridge deck. Eccentricities, stress-concentrations, protruding axles, and so on play an important role in the distribution of the stresses. This is an ideal case for strain gages. The only equipment used were strain gages, measuring equipment, electrical wire, a mobile scaffolding and some small hand tools.

The strain measured indicated that the structure was nearly at the end of its life . Subsequent inspection did not reveal any cracks but some
