**Remaining Strength of Bridges in Rotterdam**  
**Capacité restante des ponts à Rotterdam**  
**Resttragfähigkeit von Brücken in Rotterdam**

**Kors NOORLANDER**  
Civil Engineer  
Public Works Rotterdam  
Rotterdam, The Netherlands

**SUMMARY**

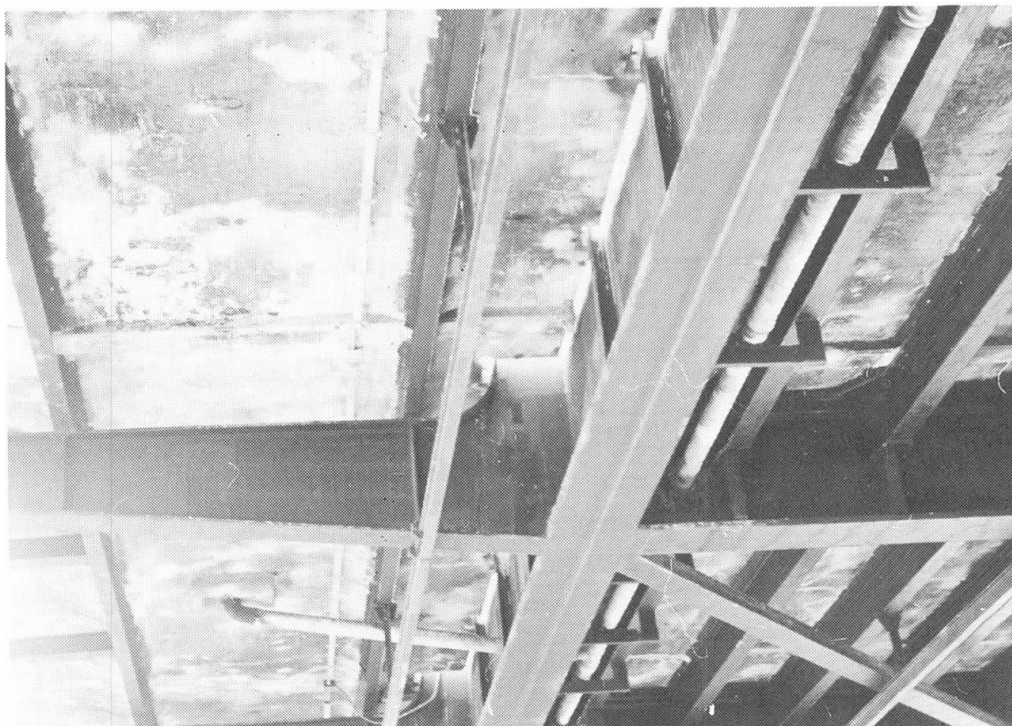
Photo 2 construction of cantilevers

The bridge has two spans and serves as an overpass of a railway. The structural system is a double stiffened arch connected by crossbeams with a reinforced concrete deck. Build in the late thirties, this was the first all welded larger bridge in the Netherlands. Details were strongly related to riveted construction. In this respect the strength of the cantilever was doubted.

Theoretical analysis revealed that the strength was less than the standards required. But the reliability of this analysis was questionable. So we decided to test the loading capacity by test loading. During the test deformations as well as strains were recorded. The testload was applied by means of a loaded truck. The results were that the safe load was over 50 % higher than the theoretical calculated load. Plastic deformations were not observed.

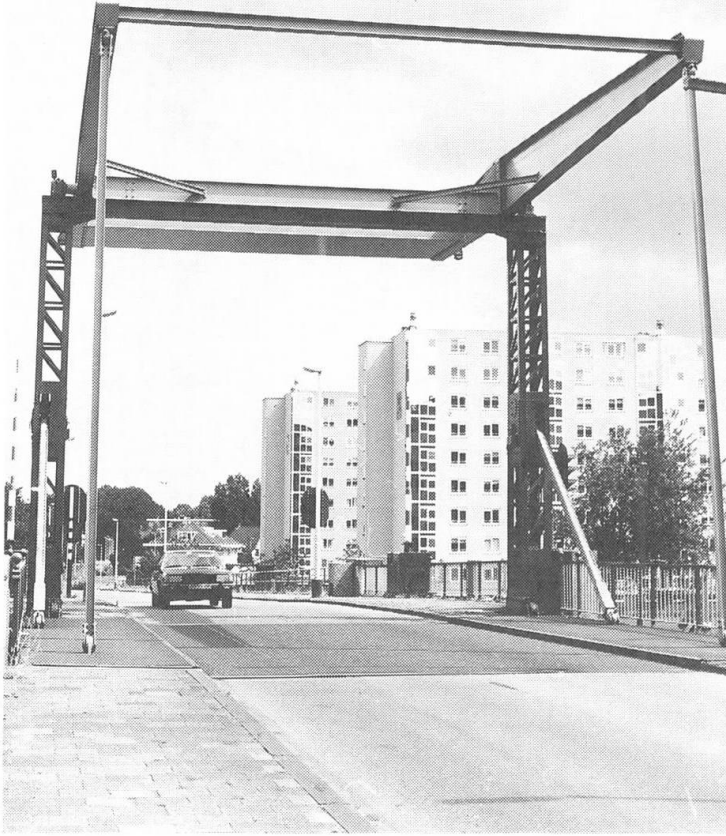
Photo 3 movable bridge

The bridge, of the type pictured in photo 3 and 4 is a specific example of this fact. In closed situation the beam coupling the axles of the balance is a double plate-girder. But after opening this beam is a Vierendeel-truss with high shear-force resulting a high variation of bending-stresses ( $140 \text{ N/mm}^2$ ) which was confirmed by means of strain measurements.

In this case the structure is a movable bridge. the problem was the stress-variation resulting from the opening and closing of the bridge. The structure is of a type which is completely balanced; balancing is accomplished by a counterweight supported on a beam above the bridge deck. Eccentricities, stress-concentrations, protruding axles, and so on play an important role in the distribution of the stresses. This is an ideal case for strain gages. The only equipment used were strain gages, measuring equipment, electrical wire, a mobile scaffolding and some small hand tools.

The strain measured indicated that the structure was nearly at the end of its life . Subsequent inspection did not reveal any cracks but some
