**Artikel:** Vibration and serviceability in post terminal buildings  
**Autor:** Dahlsjö, Harald / Ohlsson, Sven  
**DOI:** <https://doi.org/10.5169/seals-52584>

## **Vibration and Serviceability in Post Terminal Buildings**

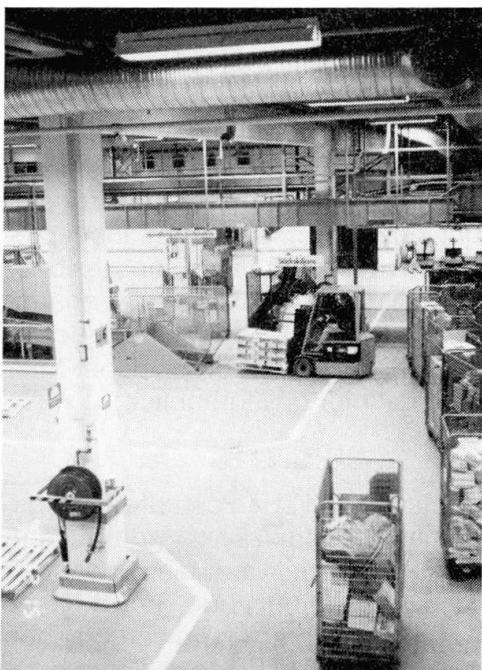
Fig. 1 Ground floor view

The ground floor includes a loading dock for lorries and two machine sorting lines for arriving mail. They are used for a first preliminary sorting with respect to letter size and item type. Furthermore the ground floor includes three machine sorting lines for mail leaving the terminal. The sorted mail is put into mailbags or post containers. One of these lines includes a robot station where sorted post parcels (boxes) are automatically put into containers. The first floor accommodates five machine sorting lines and one which is manually operated.

Post containers are continuously (day and night) transported across the ground floor to different stations by 8 forklift trucks. Each forklift will typically carry out 150 - 200 transportation tasks daily. A forklift weighs 27 kN and a post container adds a weight of 3 to 8 kN. The post is transported between the ground floor and the first floor by use of overhead conveyors. Except for forklift drivers, 15 persons are working on each floor at a time.

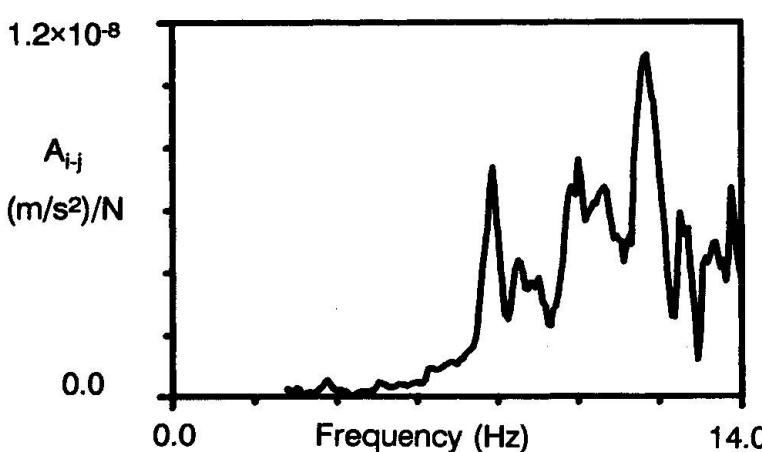
Fig. 2 Magnitude of accelerance function  $A_{i,j}$  for two locations  $i,j$  at ground floor of the Årsta post terminal

A value for the fundamental frequency  $f_1=7.8$  Hz was found for the floor area with 12 m span intended for forklift activity [4, 1989]. The second test series showed the same value for the fundamental frequency [4, 1991]. By 'the same' is meant identical within the two-digit accuracy. Higher modes were closely spaced,  $f_2=8.5$  and  $f_3=9.0$  Hz. The values for the experimentally measured natural frequencies are in fairly good agreement with theoretically calculated values based on the assumption about fully effective floor element cross sections (no cracks). Damping ratios  $c/c_{cr}$  for corresponding modes were evaluated to 1.3%, 1.2% and 1.7% respectively [4, 1991]. These values are rather typical (including the scatter) for this type of construction.

Two conclusions may be that the floor area in question is basically uncracked even after it had experienced some static and dynamic service loads and that no substantial effective increase in concrete stiffness has occurred due to ageing. The risk of future cracking and corresponding reduction in resonance frequencies may of course not be neglected. The experimental values found for damping ratios support the previous suggestion of  $c/c_{cr} = 1\%$  for design purposes.

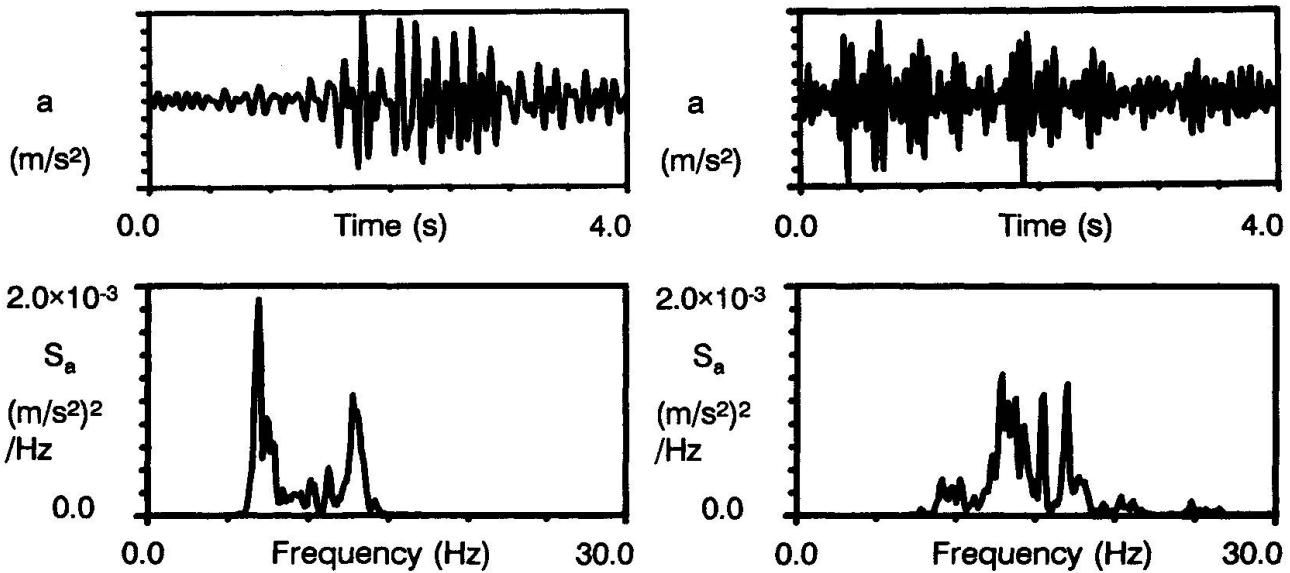
**Fig. 3** Acceleration time record ( $\pm 0.5 \text{ m/s}^2$ ) and corresponding acceleration spectral density  $S_a$  for ground floor due to regular driving of a forklift of type AT.

**Fig. 4** Acceleration time record ( $\pm 0.5 \text{ m/s}^2$ ) and corresponding acceleration spectral density  $S_a$  for ground floor due to regular driving of a forklift of type Rocla.

The vibration tests which utilized forklift traffic as a simulated service load were carried through for a number of prescribed driving paths and manoeuvres. They also included two different forklift types. Examples of acceleration measurements at the ground floor in the

vicinity of the driving area for the forklift are presented in Figs. 3 and 4 (after [4] 1991). It is worth noting that the softer wheels of the forklift of type AT result in a low-frequency dominated acceleration spectrum, basically limited to the frequency band 5 - 15 Hz, while the corresponding frequency range for the forklift type Rocla is approximately 8 - 30 Hz. From Fig 3. it is clear that the spectral function shows a pronounced peak around 6.5 Hz. Closer studies have shown that this is not an effect of a floor resonance, but rather originates from the dynamic characteristics of the vehicle. This peak appears in vibration spectra for different floor areas and it changes only when the load carried by the forklift is altered.
