Vibration and Serviceability in Post Terminal Buildings

Harald DAHLSJÖ

Sven OHLSSON

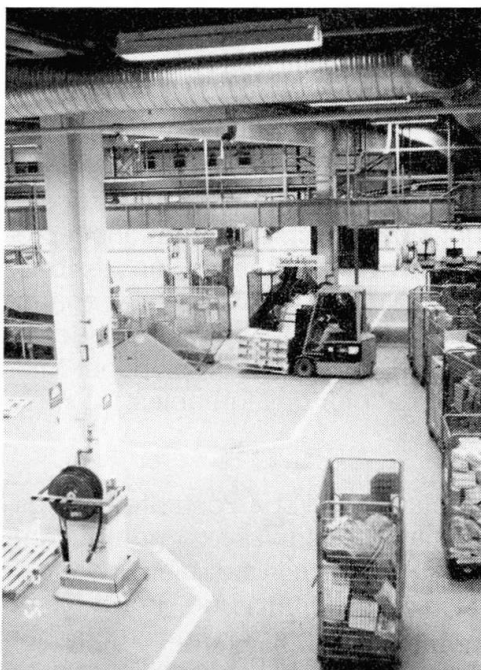
Fig. 1 Ground floor view

The ground floor includes a loading dock for lorries and two machine sorting lines for arriving mail. They are used for a first preliminary sorting with respect to letter size and item type. Furthermore the ground floor includes three machine sorting lines for mail leaving the terminal. The sorted mail is put into mailbags or post containers. One of these lines includes a robot station where sorted post parcels (boxes) are automatically put into containers. The first floor accommodates five machine sorting lines and one which is manually operated.

Post containers are continuously (day and night) transported across the ground floor to different stations by 8 forklift trucks. Each forklift will typically carry out 150 - 200 transportation tasks daily. A forklift weighs 27 kN and a post container adds a weight of 3 to 8 kN. The post is transported between the ground floor and the first floor by use of overhead conveyors. Except for forklift drivers, 15 persons are working on each floor at a time.

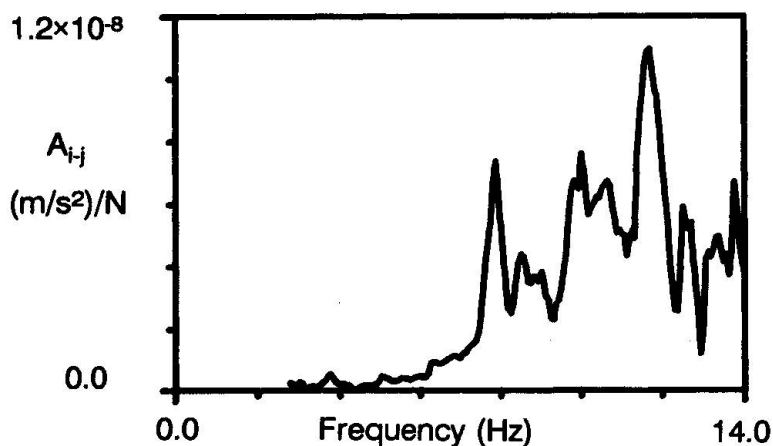
Fig. 2 Magnitude of accelerance function $A_{i,j}$ for two locations i,j at ground floor of the Årsta post terminal

A value for the fundamental frequency $f_1=7.8$ Hz was found for the floor area with 12 m span intended for forklift activity [4, 1989]. The second test series showed the same value for the fundamental frequency [4, 1991]. By 'the same' is meant identical within the two-digit accuracy. Higher modes were closely spaced, $f_2=8.5$ and $f_3=9.0$ Hz. The values for the experimentally measured natural frequencies are in fairly good agreement with theoretically calculated values based on the assumption about fully effective floor element cross sections (no cracks). Damping ratios c/c_{cr} for corresponding modes were evaluated to 1.3%, 1.2% and 1.7% respectively [4, 1991]. These values are rather typical (including the scatter) for this type of construction.

Two conclusions may be that the floor area in question is basically uncracked even after it had experienced some static and dynamic service loads and that no substantial effective increase in concrete stiffness has occurred due to ageing. The risk of future cracking and corresponding reduction in resonance frequencies may of course not be neglected. The experimental values found for damping ratios support the previous suggestion of $c/c_{cr}=1\%$ for design purposes.

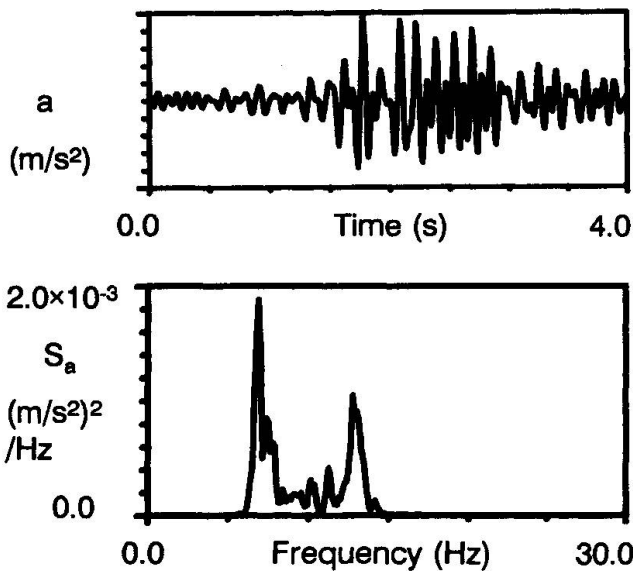
Fig. 3 Acceleration time record ($\pm 0.5 \text{ m/s}^2$) and corresponding acceleration spectral density S_a for ground floor due to regular driving of a forklift of type AT.

The vibration tests which utilized forklift traffic as a simulated service load were carried through for a number of prescribed driving paths and manoeuvres. They also included two different forklift types. Examples of acceleration measurements at the ground floor in the

vicinity of the driving area for the forklift are presented in Figs. 3 and 4 (after [4] 1991). It is worth noting that the softer wheels of the forklift of type AT result in a low-frequency dominated acceleration spectrum, basically limited to the frequency band 5 - 15 Hz, while the corresponding frequency range for the forklift type Rocla is approximately 8 - 30 Hz. From Fig 3, it is clear that the spectral function shows a pronounced peak around 6.5 Hz. Closer studies have shown that this is not an effect of a floor resonance, but rather originates from the dynamic characteristics of the vehicle. This peak appears in vibration spectra for different floor areas and it changes only when the load carried by the forklift is altered.

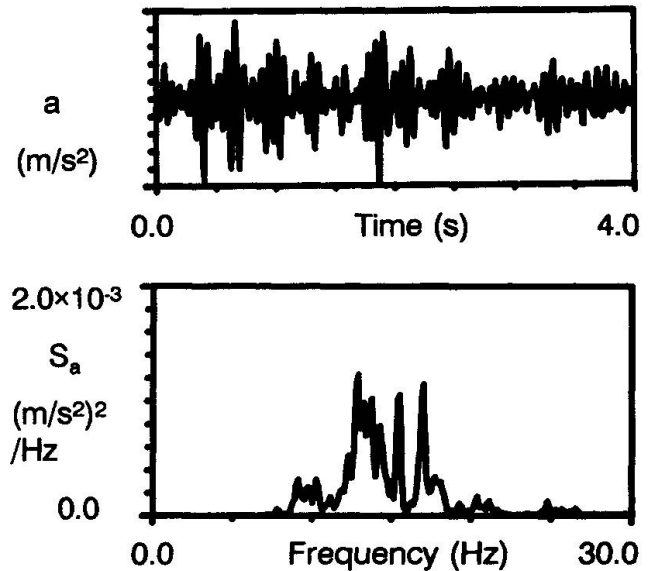
Fig. 4 Acceleration time record ($\pm 0.5 \text{ m/s}^2$) and corresponding acceleration spectral density S_a for ground floor due to regular driving of a forklift of type Rocla.
