Zeitschrift: IABSE reports = Rapports AIPC = IVBH Berichte
Band: 70 (1993)

Session 2

Inspection and Monitoring

Indirect Methods of Investigation for Evaluating Historic Masonry

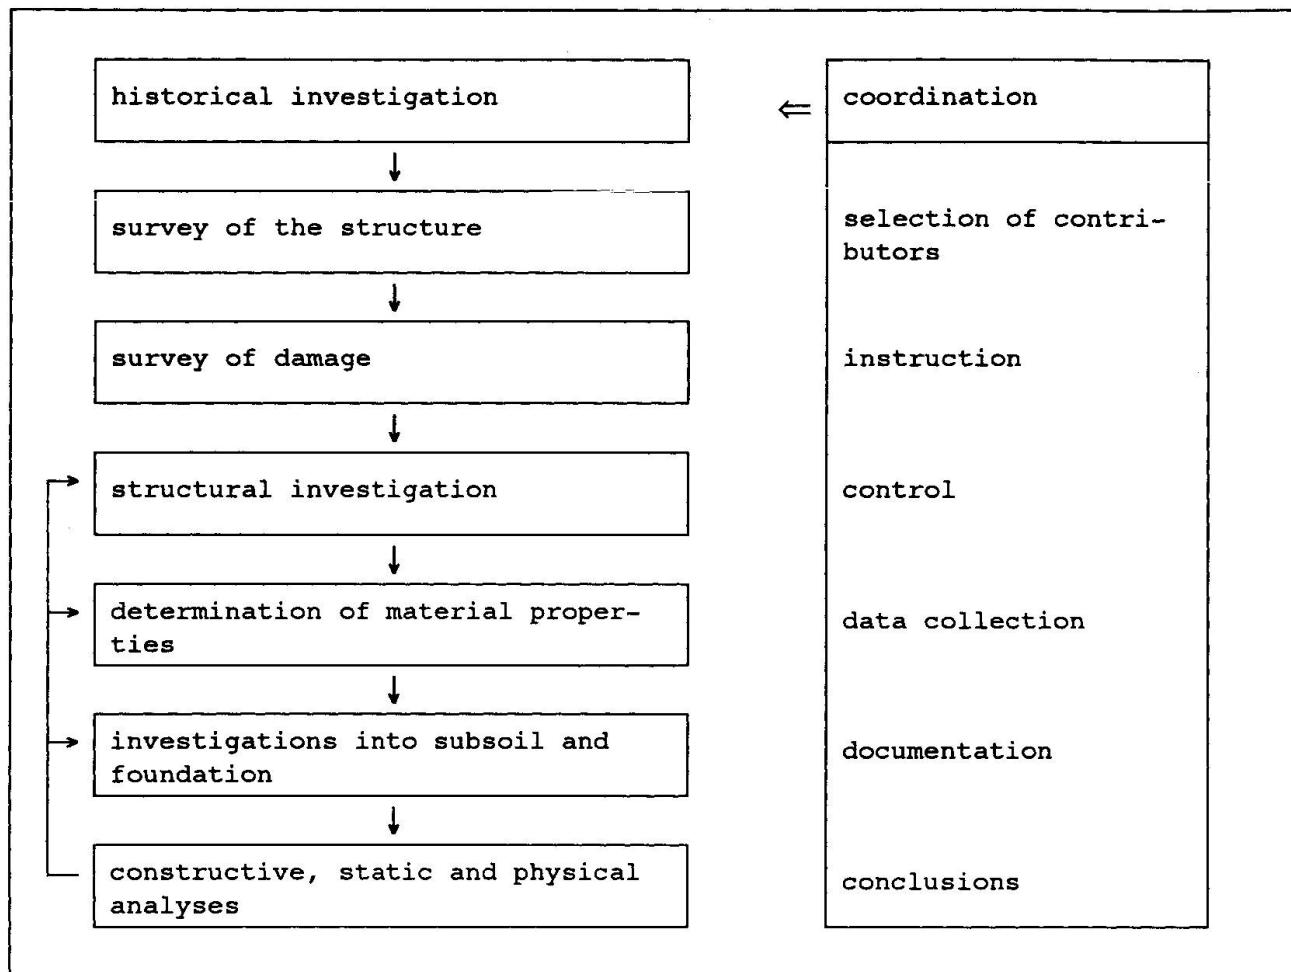
Fig. 1: Survey and evaluation of historic buildings

When dealing with complex buildings, the appraisal and the assessment of their structural condition should be done step-by-step in a well coordinated way (fig. 1). The indirect investigation methods must be integrated into the overall concept, since the necessary documentation should be available for their use. Also, the investigation aims must be determined beforehand.

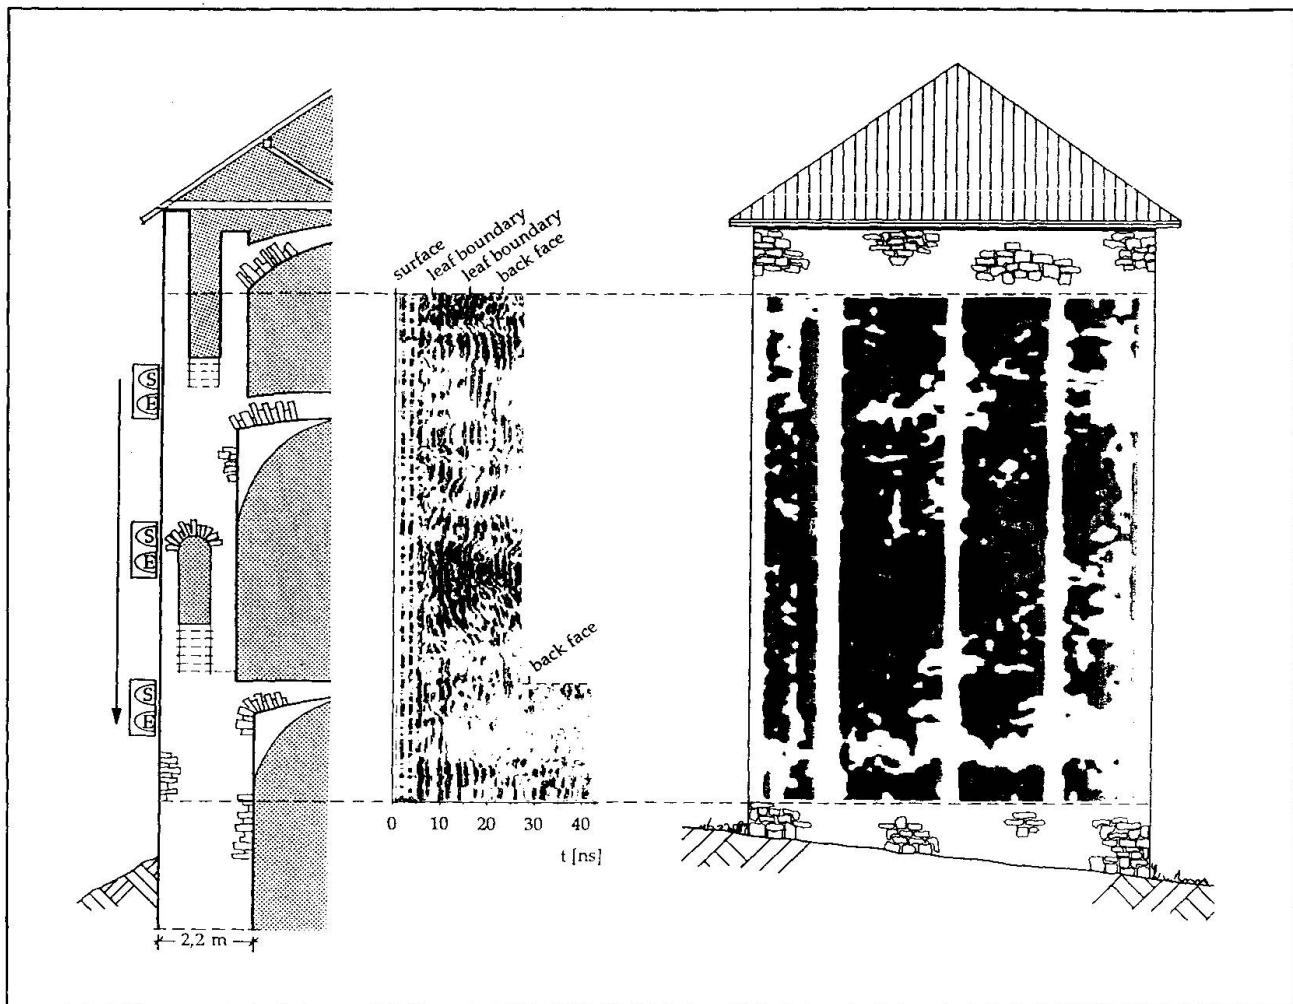
Fig. 2: Radar investigation on the wall of a medieval tower; left: cross section and radargram, right: view of the wall with radar data

The moisture content of masonry materials is determined on the basis of their relative permittivity which in turn is calculated from the velocity of the electromagnetic waves when penetrating the part. In general, these calculations necessitate a transmission arrangement consisting of transmitter and receiver, which means that both surfaces of the structural part must be accessible. Because of the high measurement volume, smooth lateral moisture profiles do result that present the lateral moisture distribution in a realistic way.

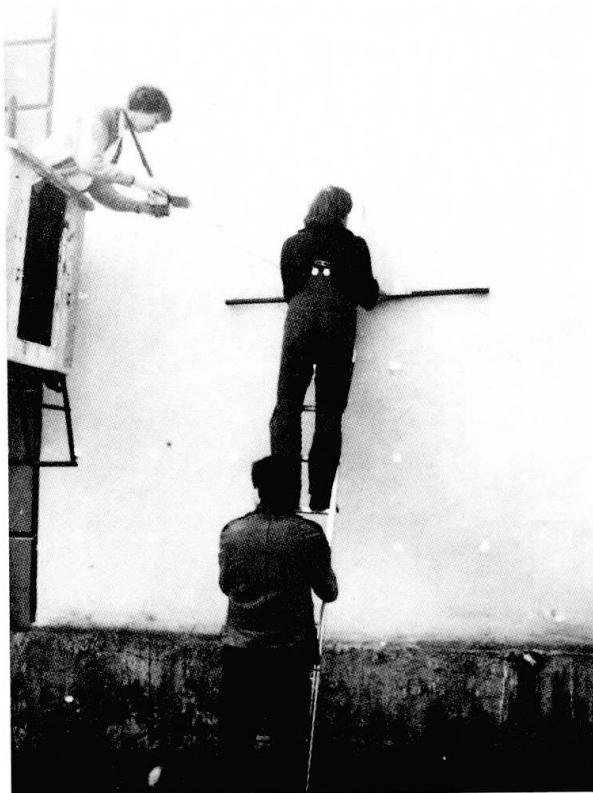
Fig. 3: Investigation with the geoelectric method

Therefore, it is not acceptable to state quantitative moisture contents directly, even if this is done in the case of moisture meters (see 4.8). However, it is possible to detect moist zones by mapping the specific electric resistivities, e. g. by using the Wenner arrangement as shown in figures 3 and 4.

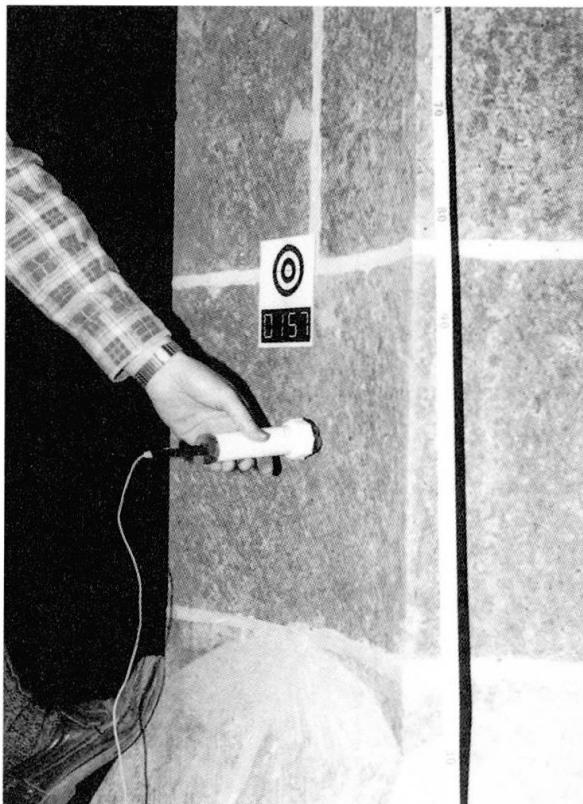
Fig. 5: Investigation with the self-potential method

A special variant of the geoelectric technique, the self-potential method, is based on the principle that iron corrosion generates an electric field that is picked up by two probes [9]. This method is very suitable for the detection of active corrosion processes. However, precondition is that the location of enclosed metals is known and that one of the probes is placed directly at it.

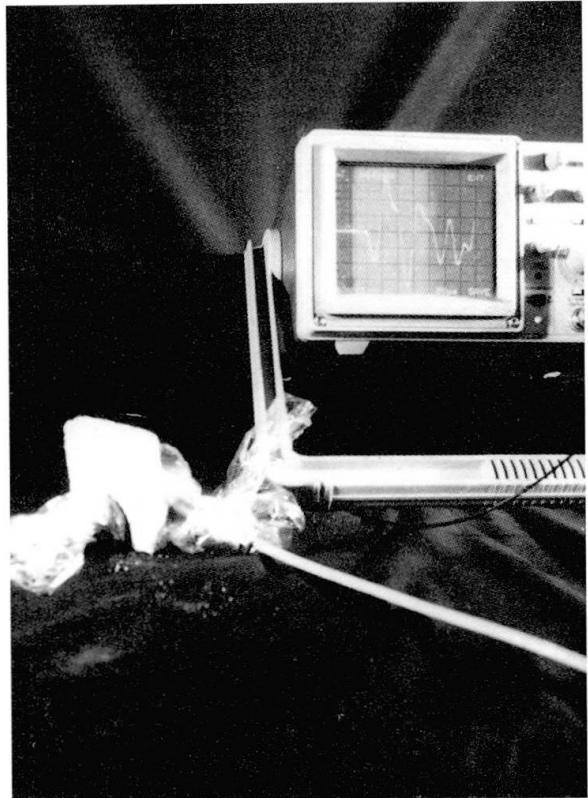
Fig. 8: Ultrasonic measurement to determine the mechanic properties of mortar

Further research work is necessary to increase the knowledge as to whether measuring the velocity of ultrasonic waves allows statements about the strength of stones or masonry (fig. 8). While the relation between the velocity of elastic waves and material properties has been proven physically for homogenous materials, the transformation into a measurement method that can be used under real conditions has not yet taken place [12, 13, 14, 15, 16].

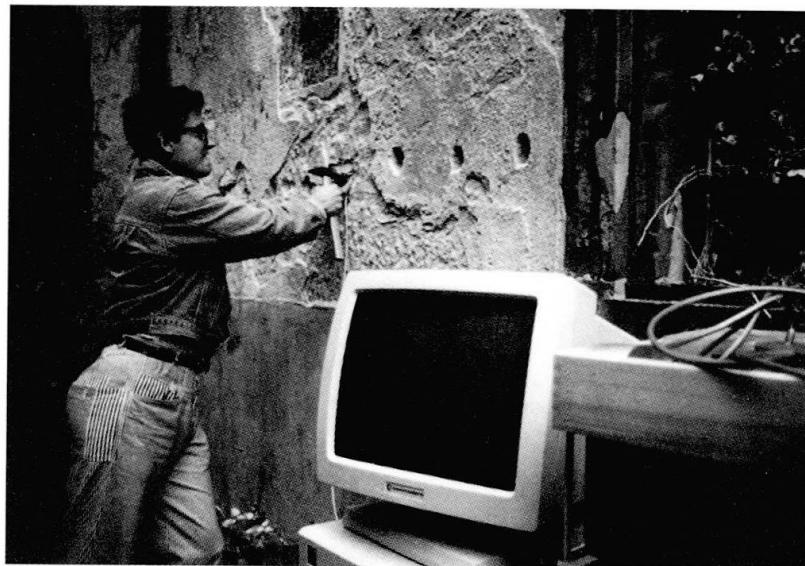
Fig. 9: Investigation of a wall with the seismic method

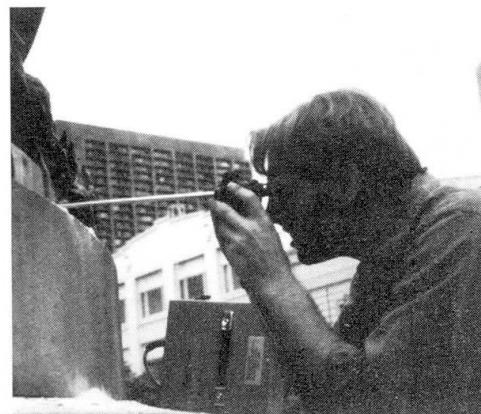
Fig. 2 - Fiberoptic Borescope

Inspection openings are destructive, but they are also the surest, and often the only way, to verify the condition of the internal parts of a structure. Sometimes the inside of a structure can be observed in a less destructive manner by using a fiberoptic borescope. The instrument's light transmitting wand is inserted into a 12 mm diameter drilled hole. The interior can then be viewed through the eyepiece on the end of the wand. The observations can be documented by a camera that attaches to the eyepiece (Fig. 2).

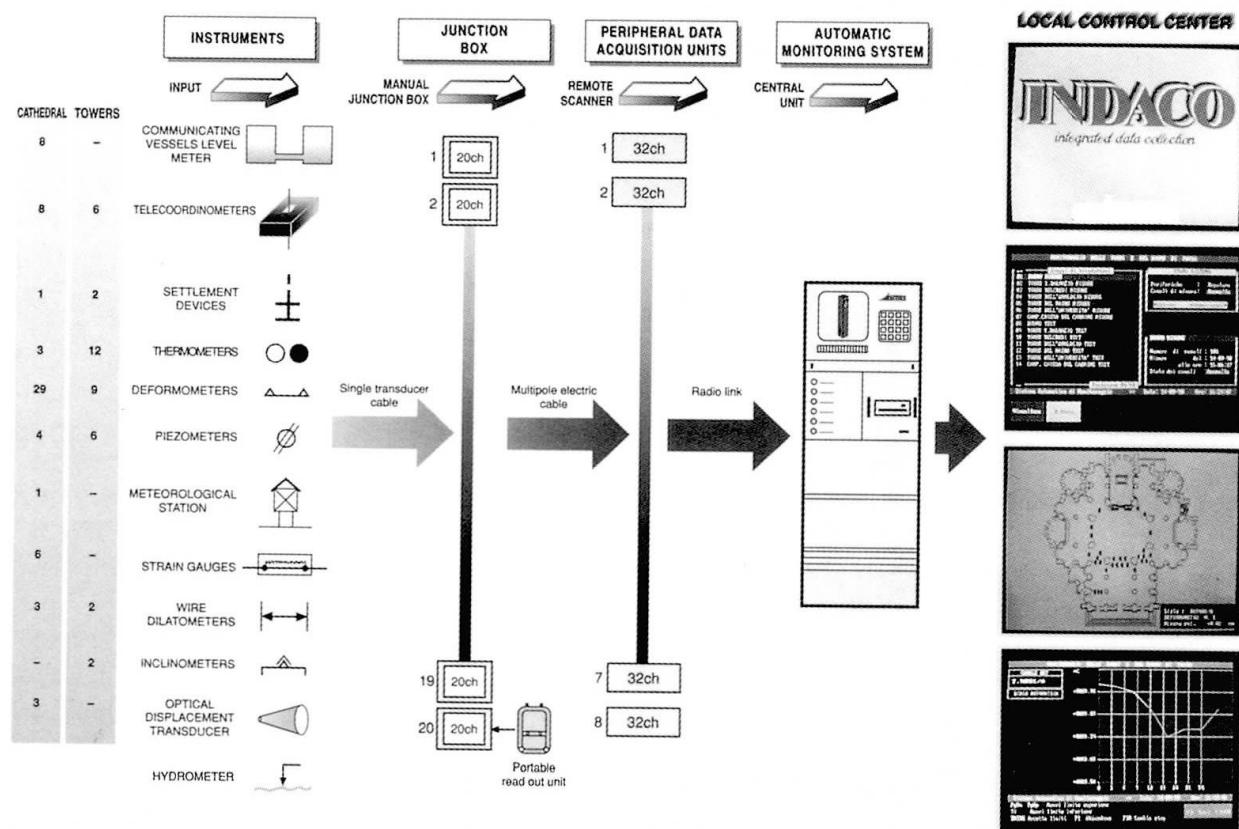
Figure 1: Pavia Towers and Cathedral. Data acquisition system: block diagram

In order to control the Cathedral and the six Towers, a sophisticated automatic monitoring system based on eight Peripheral Measurement Units and one Data Acquisition Centre have been installed in 1990. The peripheral measurement units, installed inside the monuments to be monitored, are linked via radio with the centre, located at the University of Pavia. Fig.1 shows the block diagram of the system and the list of the instruments installed in each monument [2].

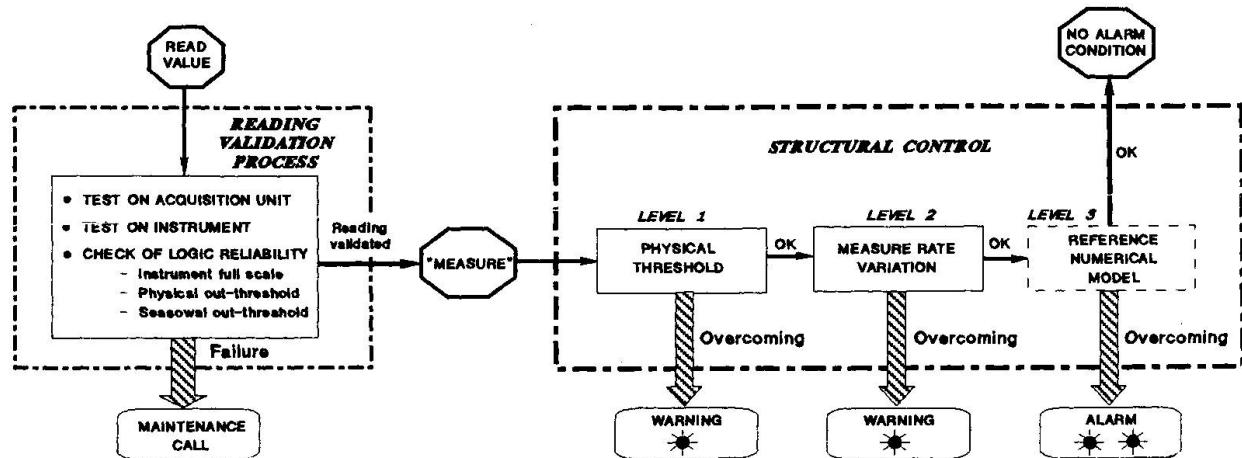
Figure 2: On line control architecture

Different criteria have been determined to identify different situations. Each read value is subjected to a validation and control procedure carried out on the automatic monitoring system. The architecture of the control is showed in Fig. 2.

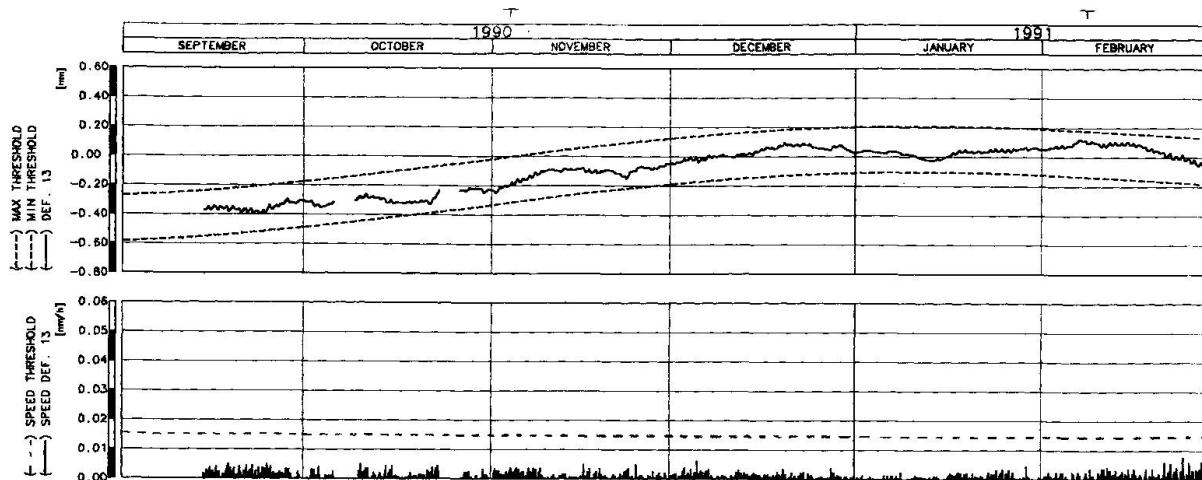
Figure 3: An example of periodic threshold of the measures.

Figure 3a shows the opening-closure history of a crack (solid line), read in the dome of the Cathedral, together with the established threshold bounding values (dotted lines). Figure 3b gives the same information on the opening-closure variation rate: the dotted line is the maximum threshold value.

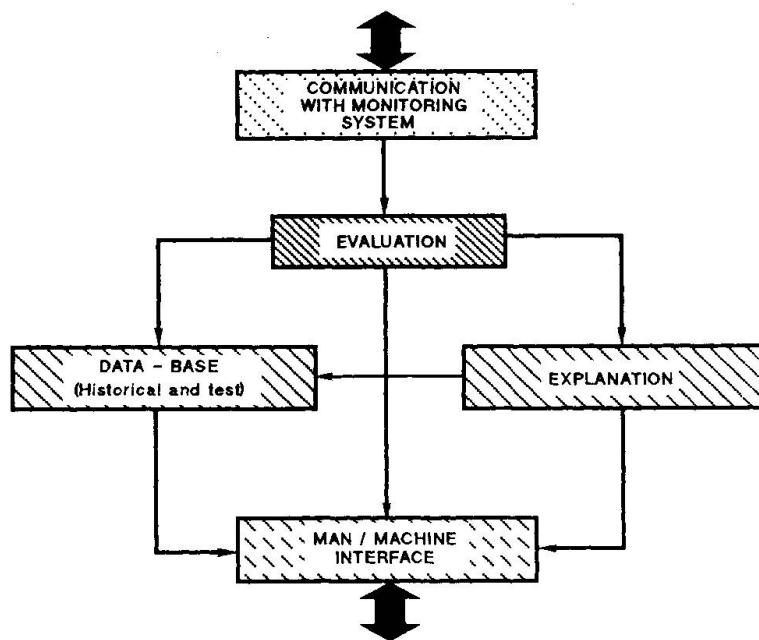
Figure 5: MISTRAL Architecture

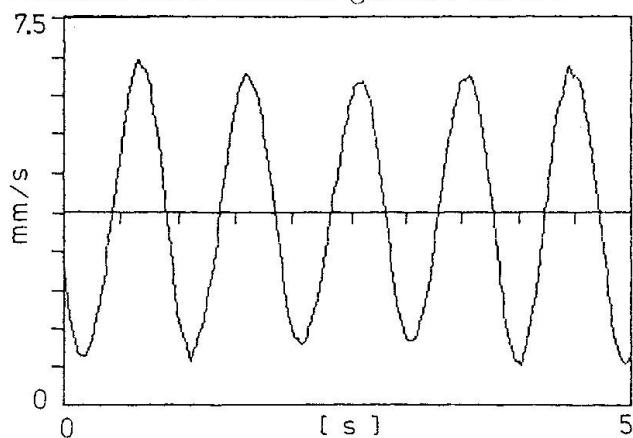
Bild 6: Zeitverlauf der Bogenschwingung (volles Geläut)

Die wesentliche Erregerfrequenz der großen Glocke liegt bei $f = 1,05 \text{ Hz}$. Betrugen die Schwingungsamplituden vor dem Umbau maximal $s_x = \pm 1,8 \text{ mm}$, so gingen sie auf $s_x = \pm 0,8 \text{ mm}$ nach dem Abtragen der Querwand herunter. Um zu vermeiden, daß nach der Sanierung wieder Resonanzschwingungen auftreten, soll zwischen dem Turm und dem neu aufgemauerten Wandteil ein Luftschlitz gelassen werden.

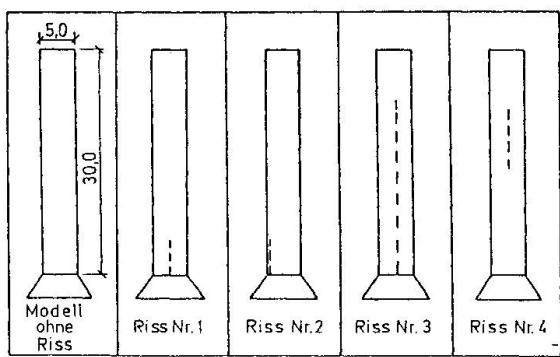
Bild 7: Darstellung der Risse

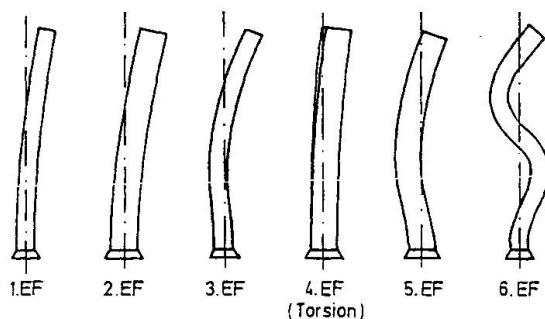
Bild 8: Darstellung der Eigenschwingungsformen (ungerissener Zustand)

Da vom Kirchturm verlässliche Baupläne vorlagen, (Masseverteilung und Trägheitsmomente) wurde ein mathematisches Modell aufgestellt. (FE-Modell *NASTRAN*) Das Ausgangsmodell hatte einen E-Modul von $E = 3,3 \cdot 10^3 \text{ MN/m}^2$ für das Mauerwerk. Die berechneten Eigenfrequenzen lagen etwa 20% unterhalb der gemessenen Frequenzen. Wird ein E-Modul von $E = 4,5 \cdot 10^3 \text{ MN/m}^2$ im Modell verwandt, so ergeben sich die Eigenfrequenzen, die auch bei der Messung ermittelt worden waren.

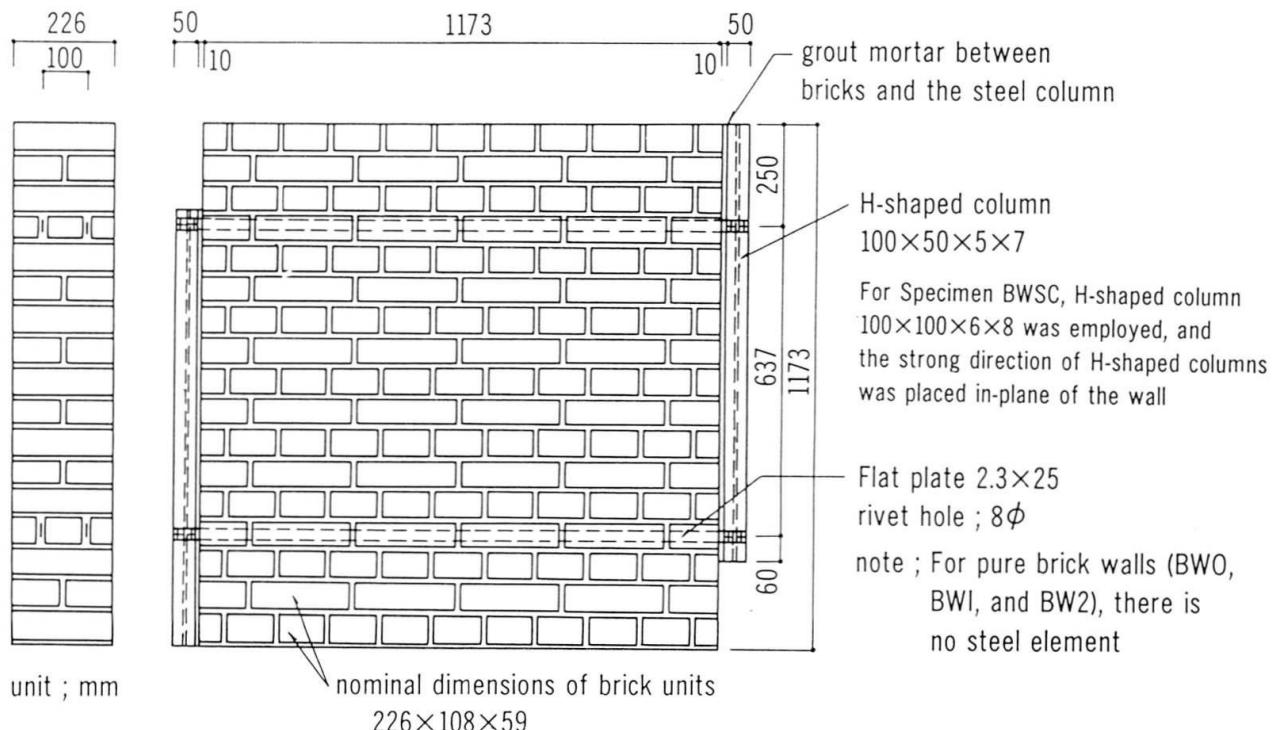
Fig. 2 Dimensions and detail of brick masonry wall specimens

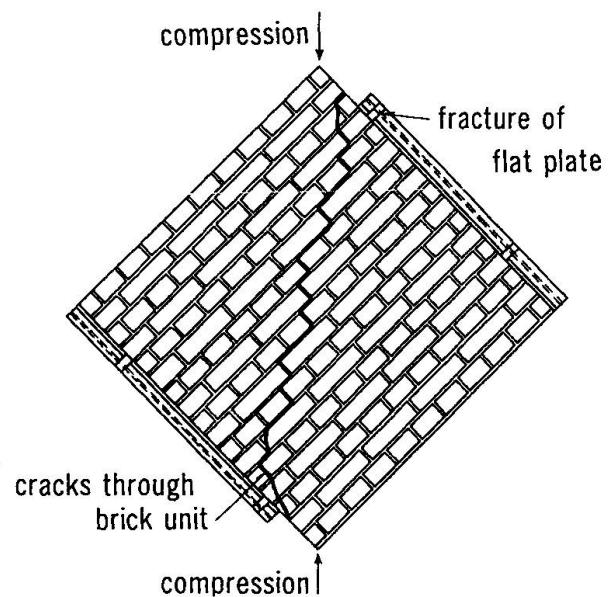
Fig.4 Crack pattern of a wall specimen

Shear force - shear strain relationships of the specimens are shown in Fig. 3. Representative crack pattern after the testing is shown in Fig. 4. The new pure brick masonry walls (Specimens BW1 and BW2) showed very brittle failure. When a diagonal crack appeared in the wall, load was completely lost simultaneously. Most of cracks were observed along joints of the brick masonry. The old pure brick masonry wall (Specimen BW0) showed more ductile manner because the measurement point of

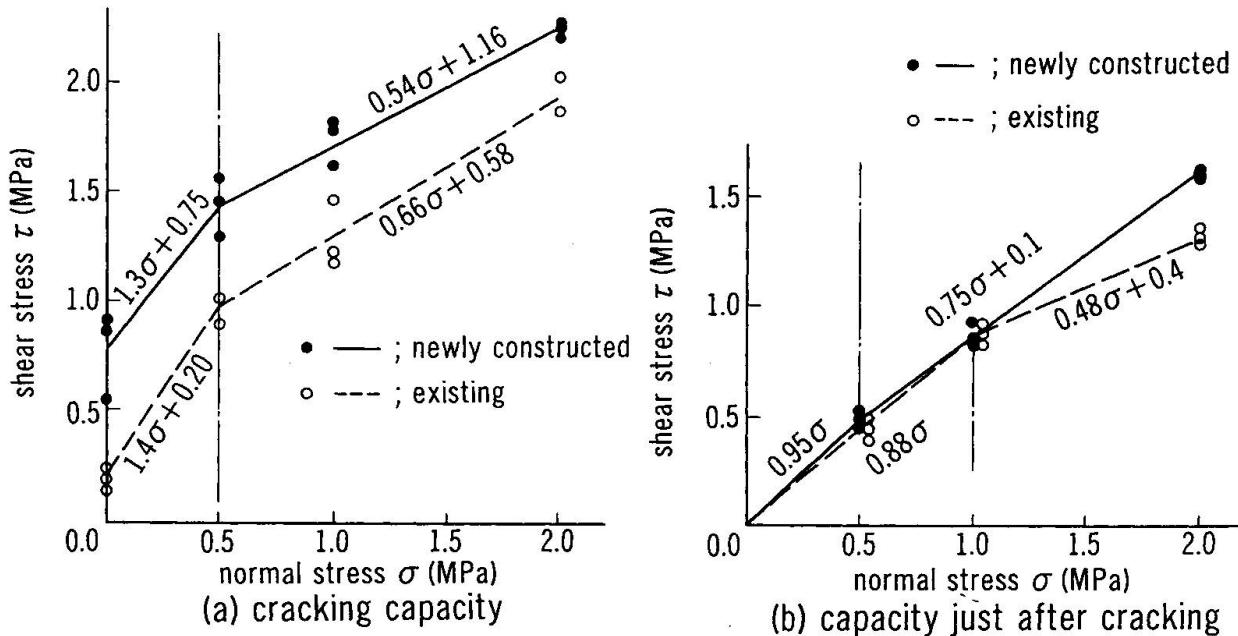
Fig.8 Sliding shear capacities

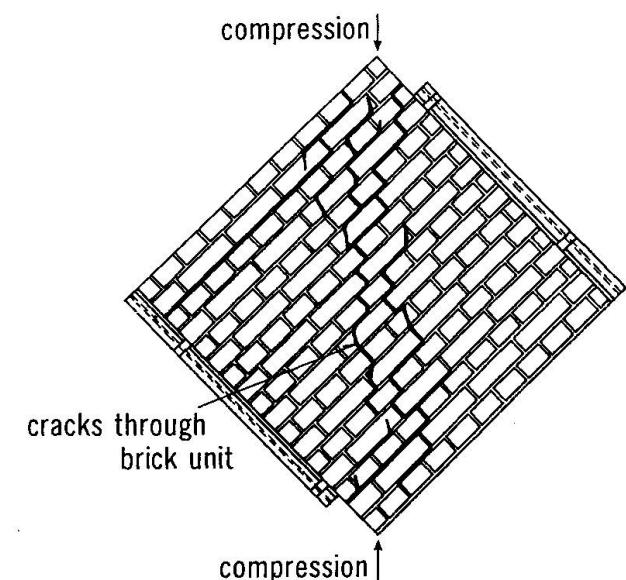
Fig. 11 Crack pattern of a retrofitted wall specimen

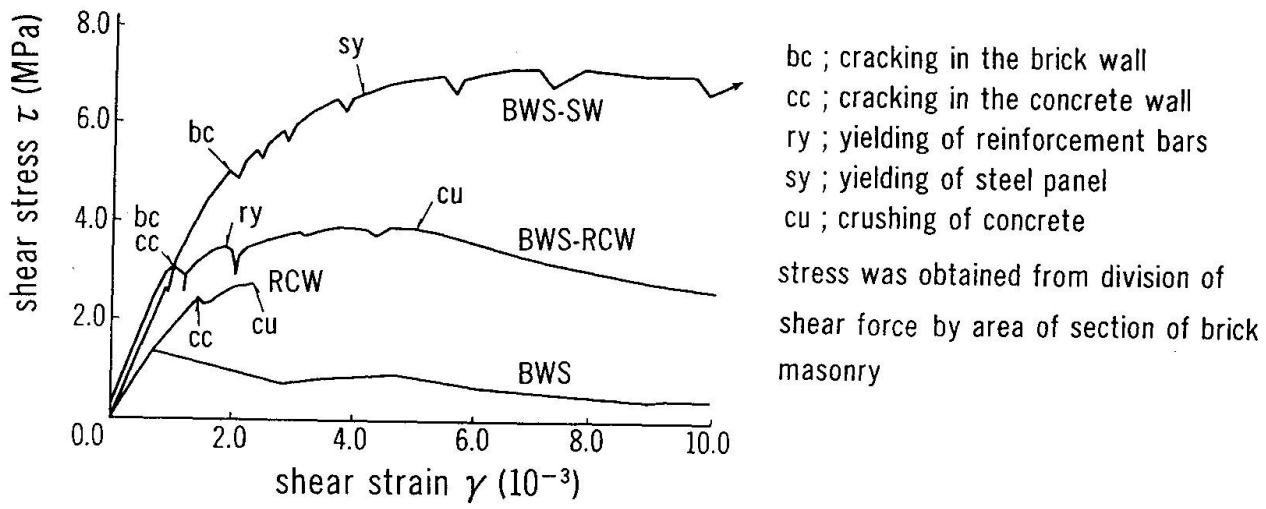
Fig. 12 Shear stress and shear strain relationship

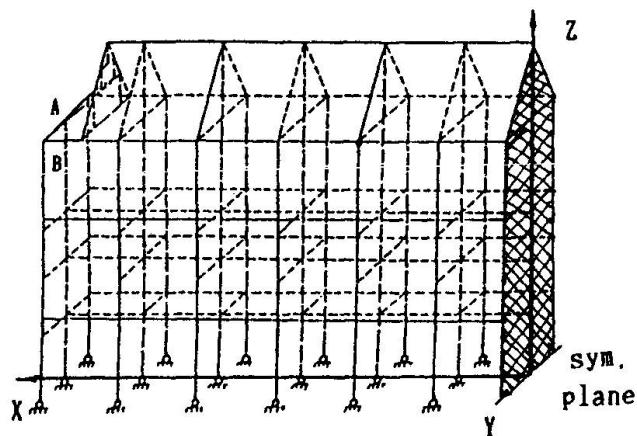
Fig.8 The FEM Model of the Front Tower

as Fig.8. The number of beam elements, flexible elements and nodes is 208, 162 and 280, respectively. The value of the flexible elements will be determined afterward. Because the columns of the structure have no other connections with the base stones but are only set upon it, hinges were used as the boundary condition. The nodes located in the symmetrical plane are constrained, as shown in Fig.9.

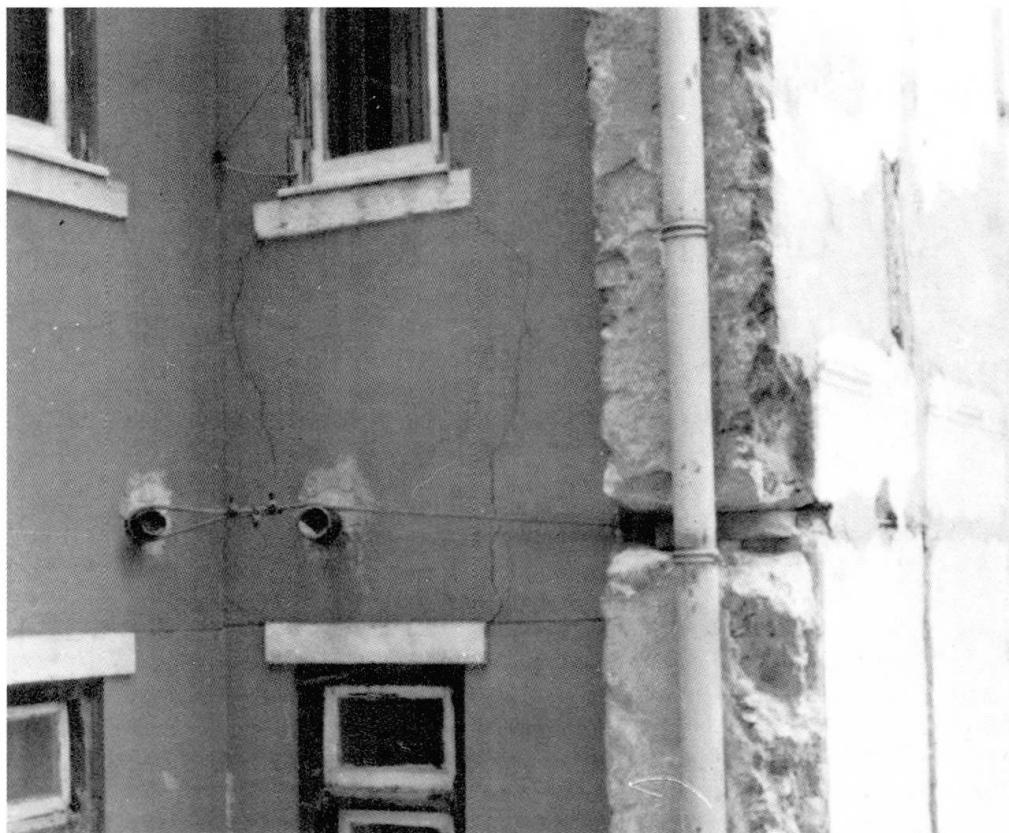
Fig. 2: Damaged masonry wall due to demolition of an adjoining building

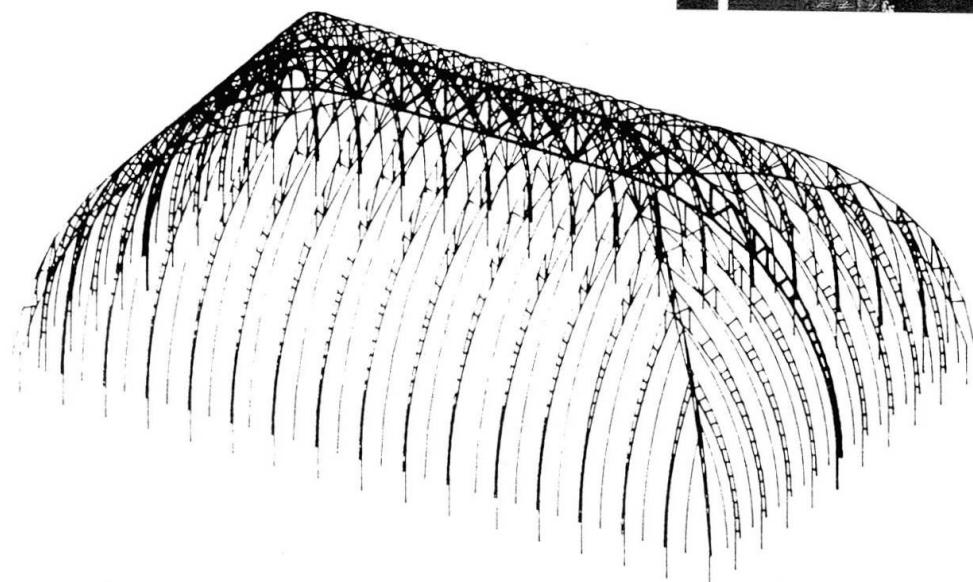
Fig.7 The mesh of the 3-D numerical analysis

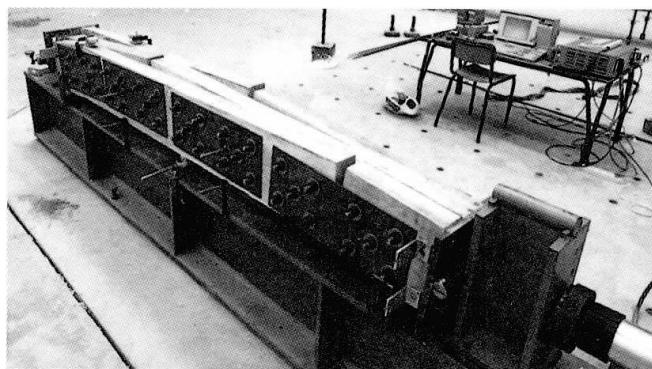
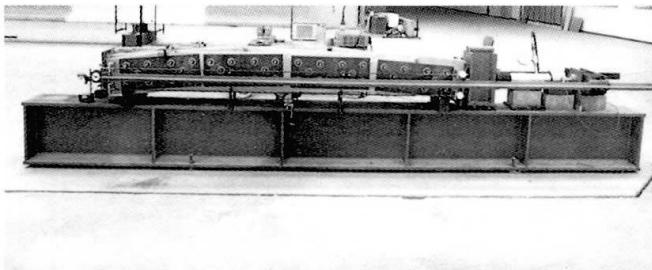
Fig.8 The model and the loading device of the test

The Figure shows also the loading device able to simulate the load conditions of the element in the real structure, known by the results of the 3-D elastic analysis previous mentioned. In figure 9 some particulars of the instrumentation are shown.

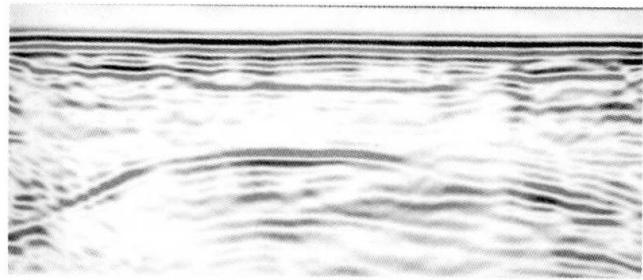
Fig. 4 Radar Output, Computer Enhanced Image of Data From Fig. 3

The radar equipment is expensive to purchase, requires a highly skilled operator and must be compiled with a sophisticated computer software program. Of course this is all quite expensive. In addition, there are several potential technical pitfalls such as accurate calibration of the pulse propagation velocity in a given material and errors due to the manual towing of the transducer across the surface.

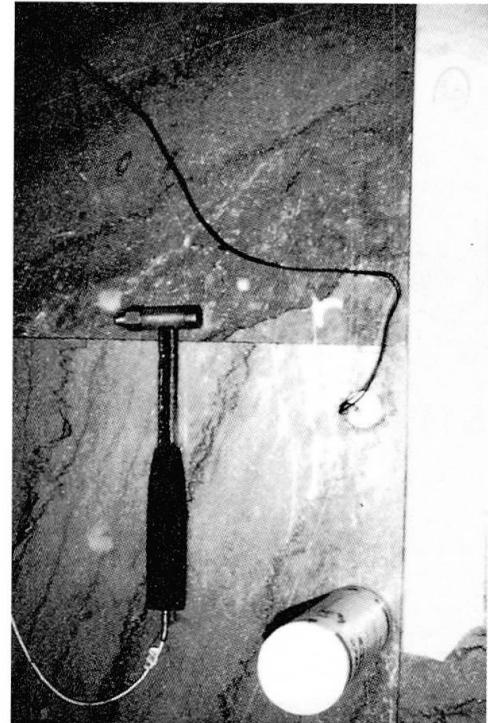
Fig. 5 Impact Echo Equipment

The equipment produced good data for reading thicknesses and integrity on granite and sandstone columns, veneer walls, and brick walls less than 600 mm thick. A steel column behind granite facing was located using this technique but the orientation of the flanges was not discernible. Brick walls over 600 mm thick could not be fully measured. Multiple layers (terrazzo floor over setting bed over brick) did not produce good results; brick arches and beams were not detected as they were using radar. The equipment is best used to detect cracking parallel to the surface (in this case, stone). Optimum

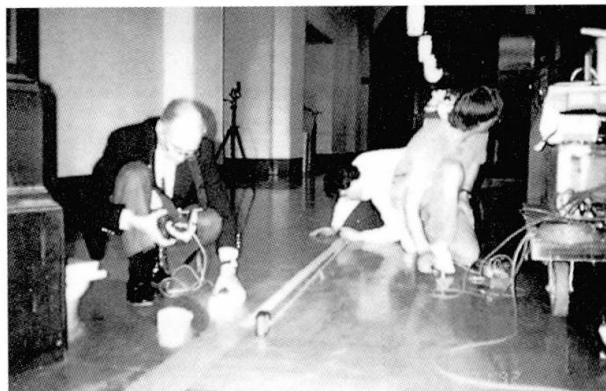
Fig. 10 Magnetic Detection & SASW Equipment

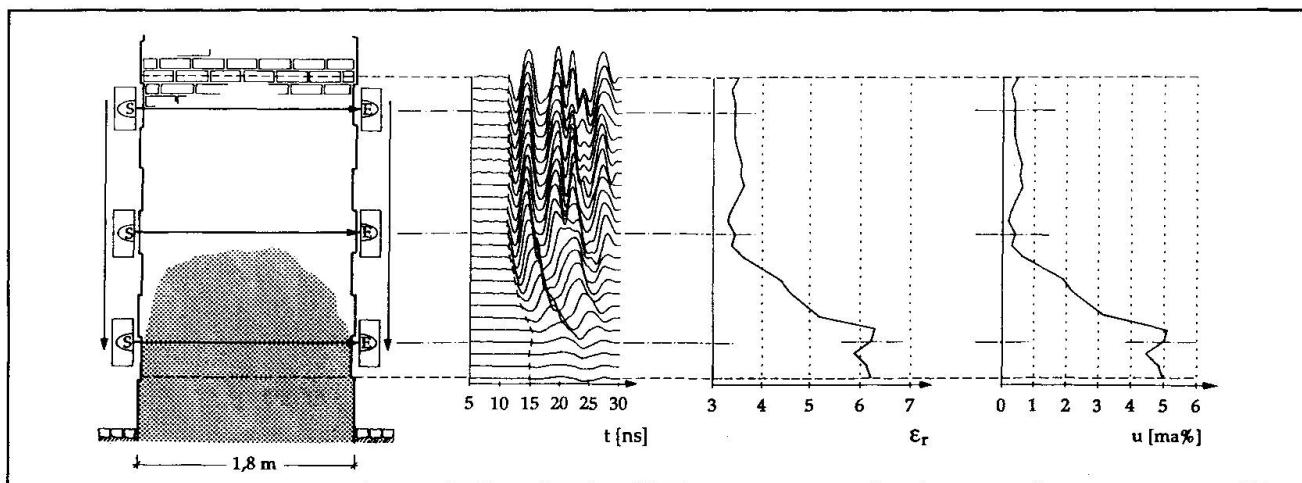
Fig. 4: The transmission arrangement on a column with rising moisture; schematic cross section, received signals, relative permittivity and moisture profile (S..transmitter, E..receiver, ↓..direction of profiling)

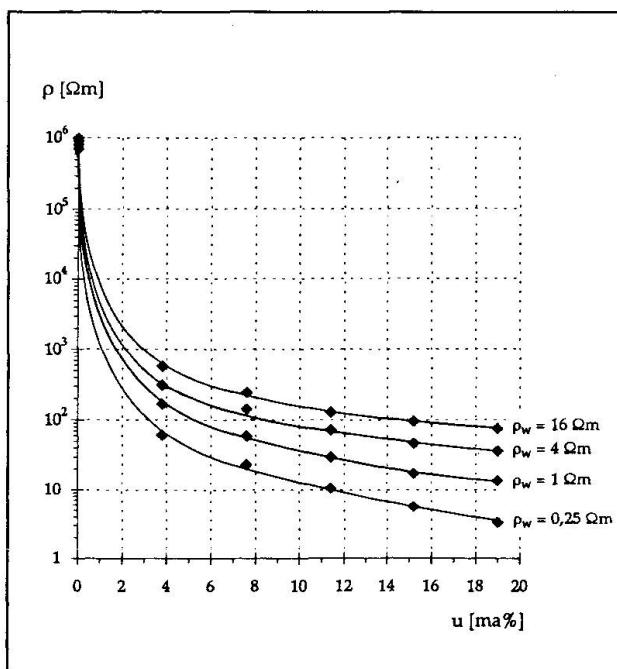
Fig. 5: Dependence of the electric resistivity ρ of brick on the gravimetric moisture content u ; parameter ρ_w is the resistivity of the porous aqueous solution

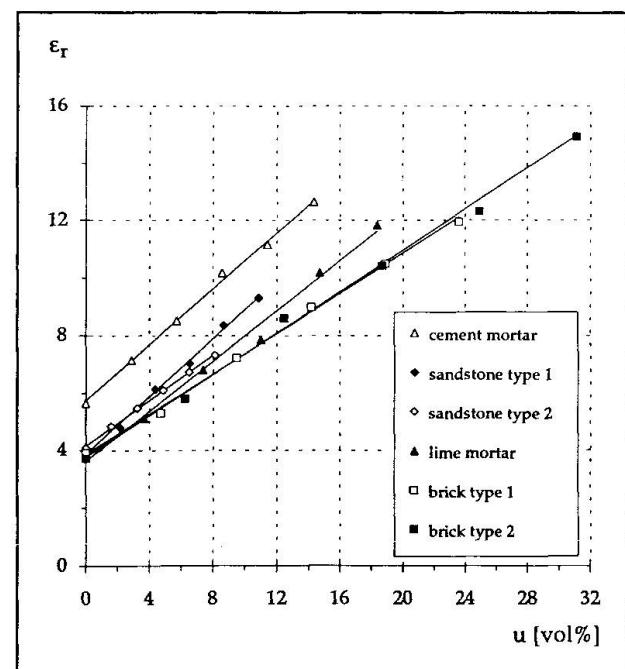
Fig. 6: Dependence of the relative permittivity ϵ_r of different materials on the volumetric moisture content u

The relative permittivities were measured using the radar technique in the transmission mode. The dependence of the permittivity on the moisture content, as depicted in fig. 6, may be approximated by a linear relation. Dissolved salts cause a slight increase up to 10 % of the relative permittivity. The influence of temperature and pressure was found to be insignificant for the application of radar on historic masonry.

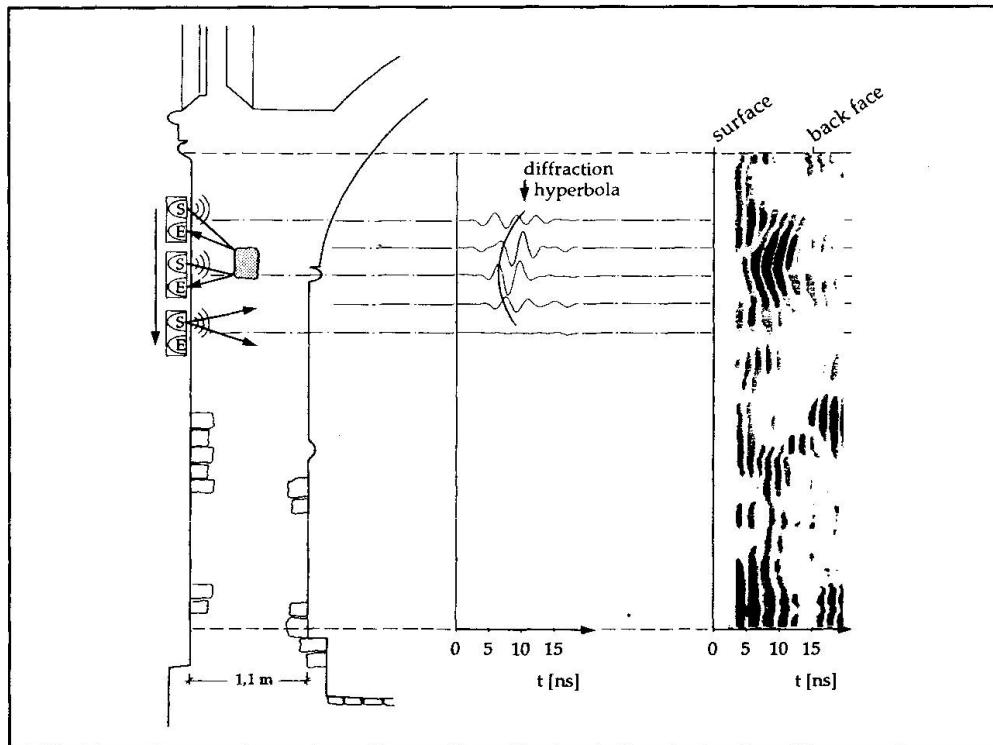
Fig. 9: The detection of anomalies with the reflection arrangement; wall cross section of the Matthiaskapelle in Kobern/Mosel, receiver signal and radargram

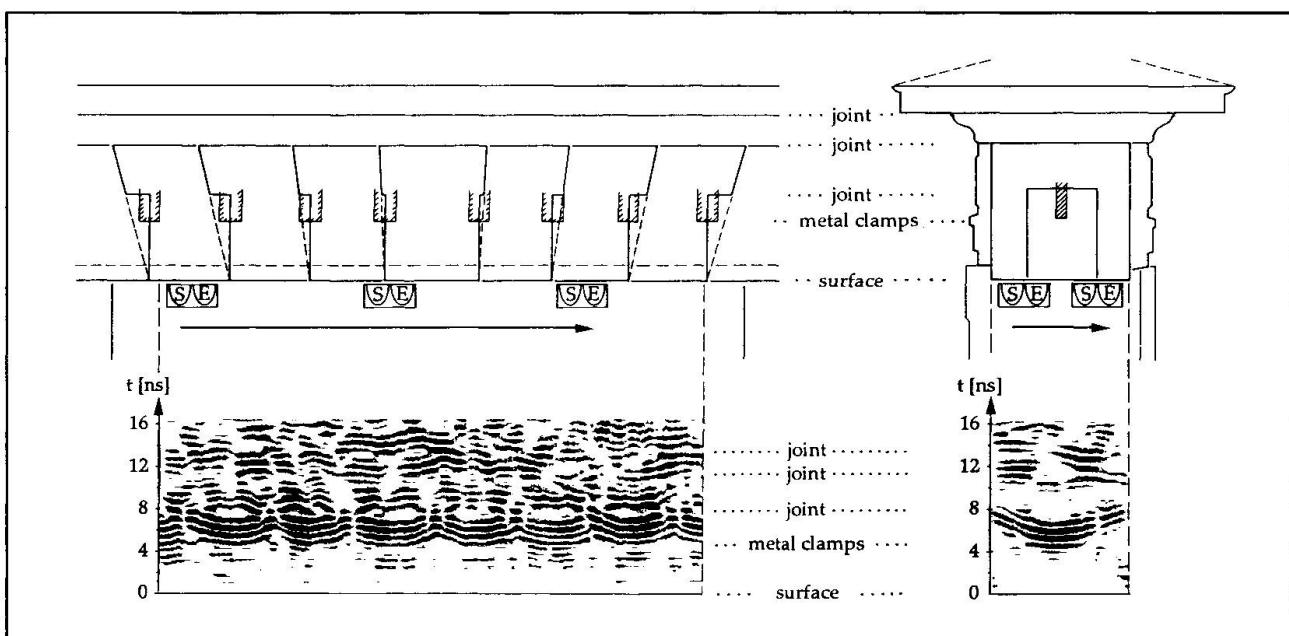
Fig. 10: Longitudinal and transversal cross section of the beam of the Jägertor in Potsdam and corresponding radargrams

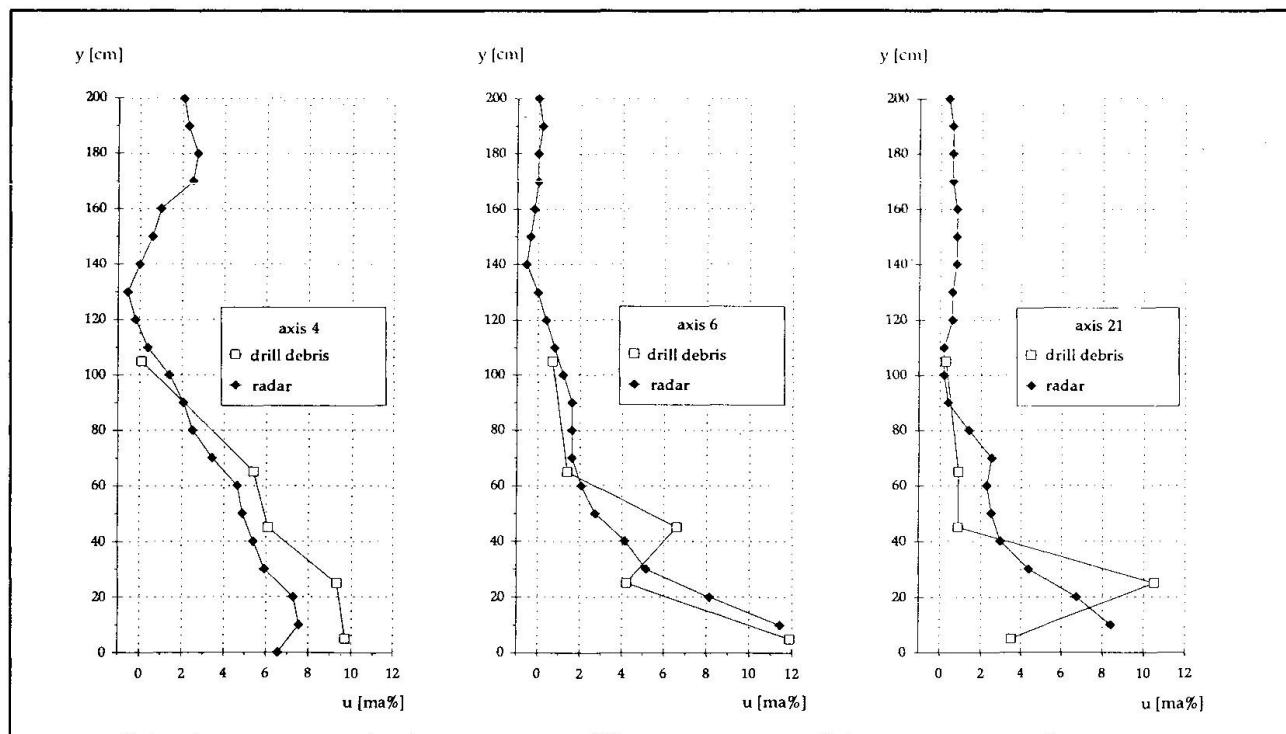
Fig. 11: Moisture content u of a brick wall at 3 cross sections, determined with radar or the gravimetric method on drill debris

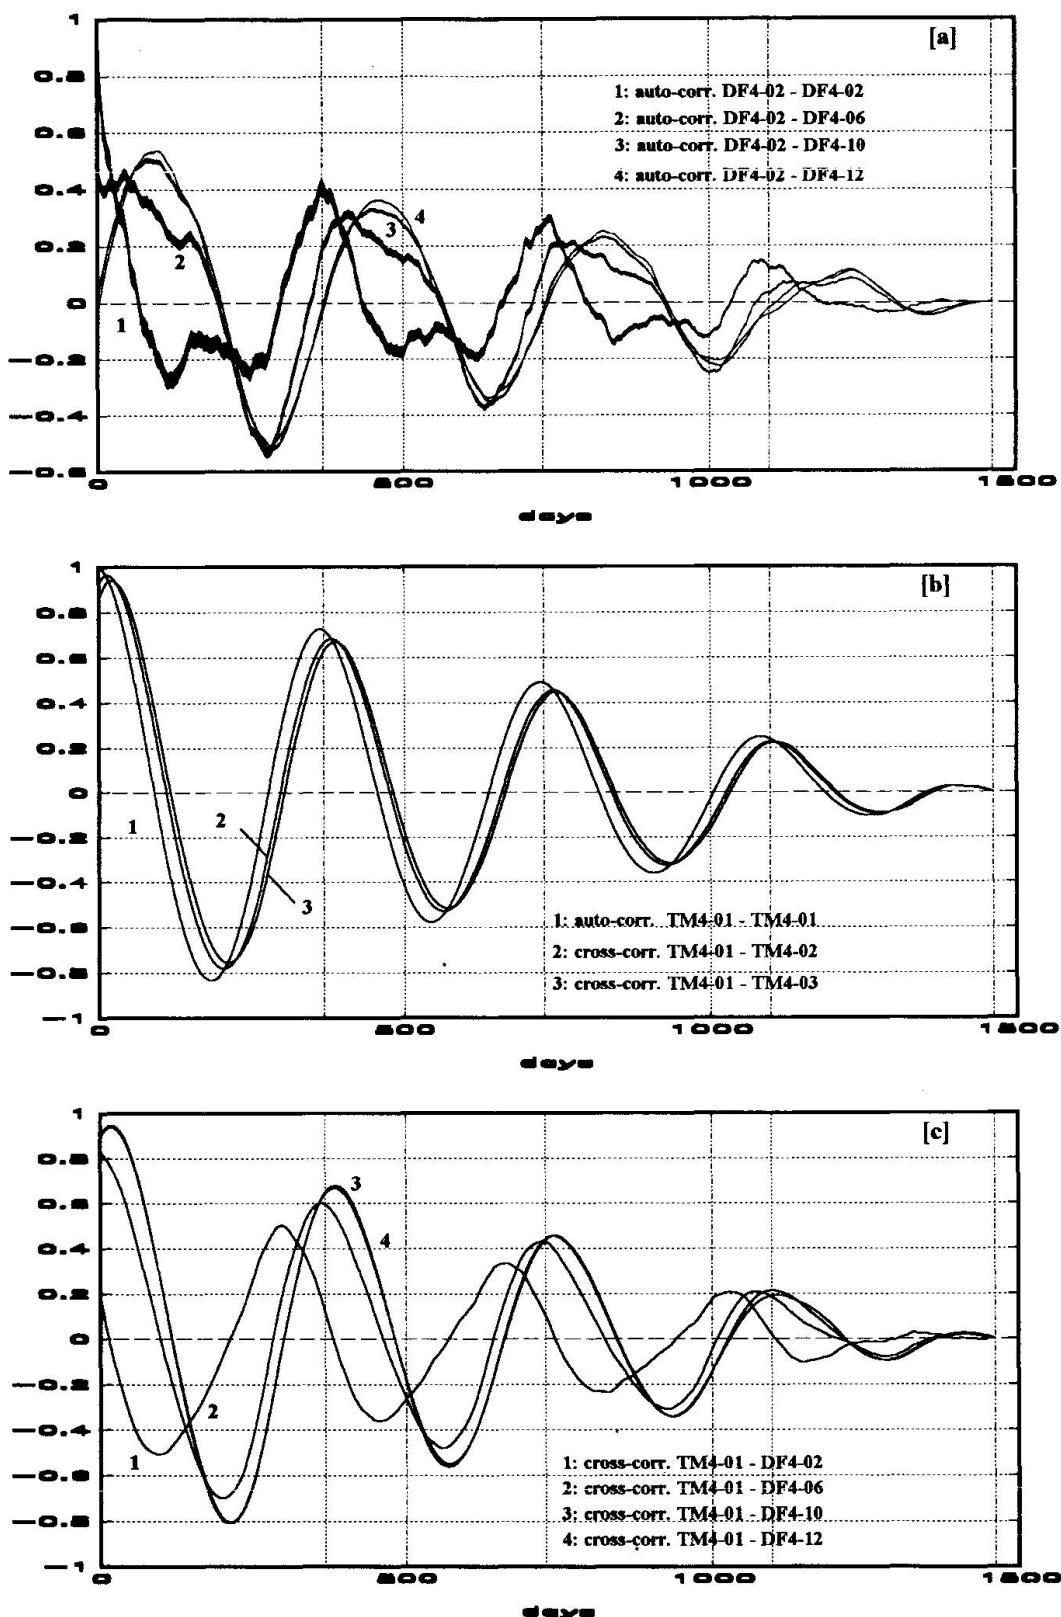
Figure 1: Correlation analyses on data recorded in web no. 4:

[c]: correlation between data recorded by termometers and deformeters
