Zeitschrift: IABSE reports = Rapports AIPC = IVBH Berichte
Band: 70 (1993)

Session 2

Inspection and Monitoring

Indirect Methods of Investigation for Evaluating Historic Masonry

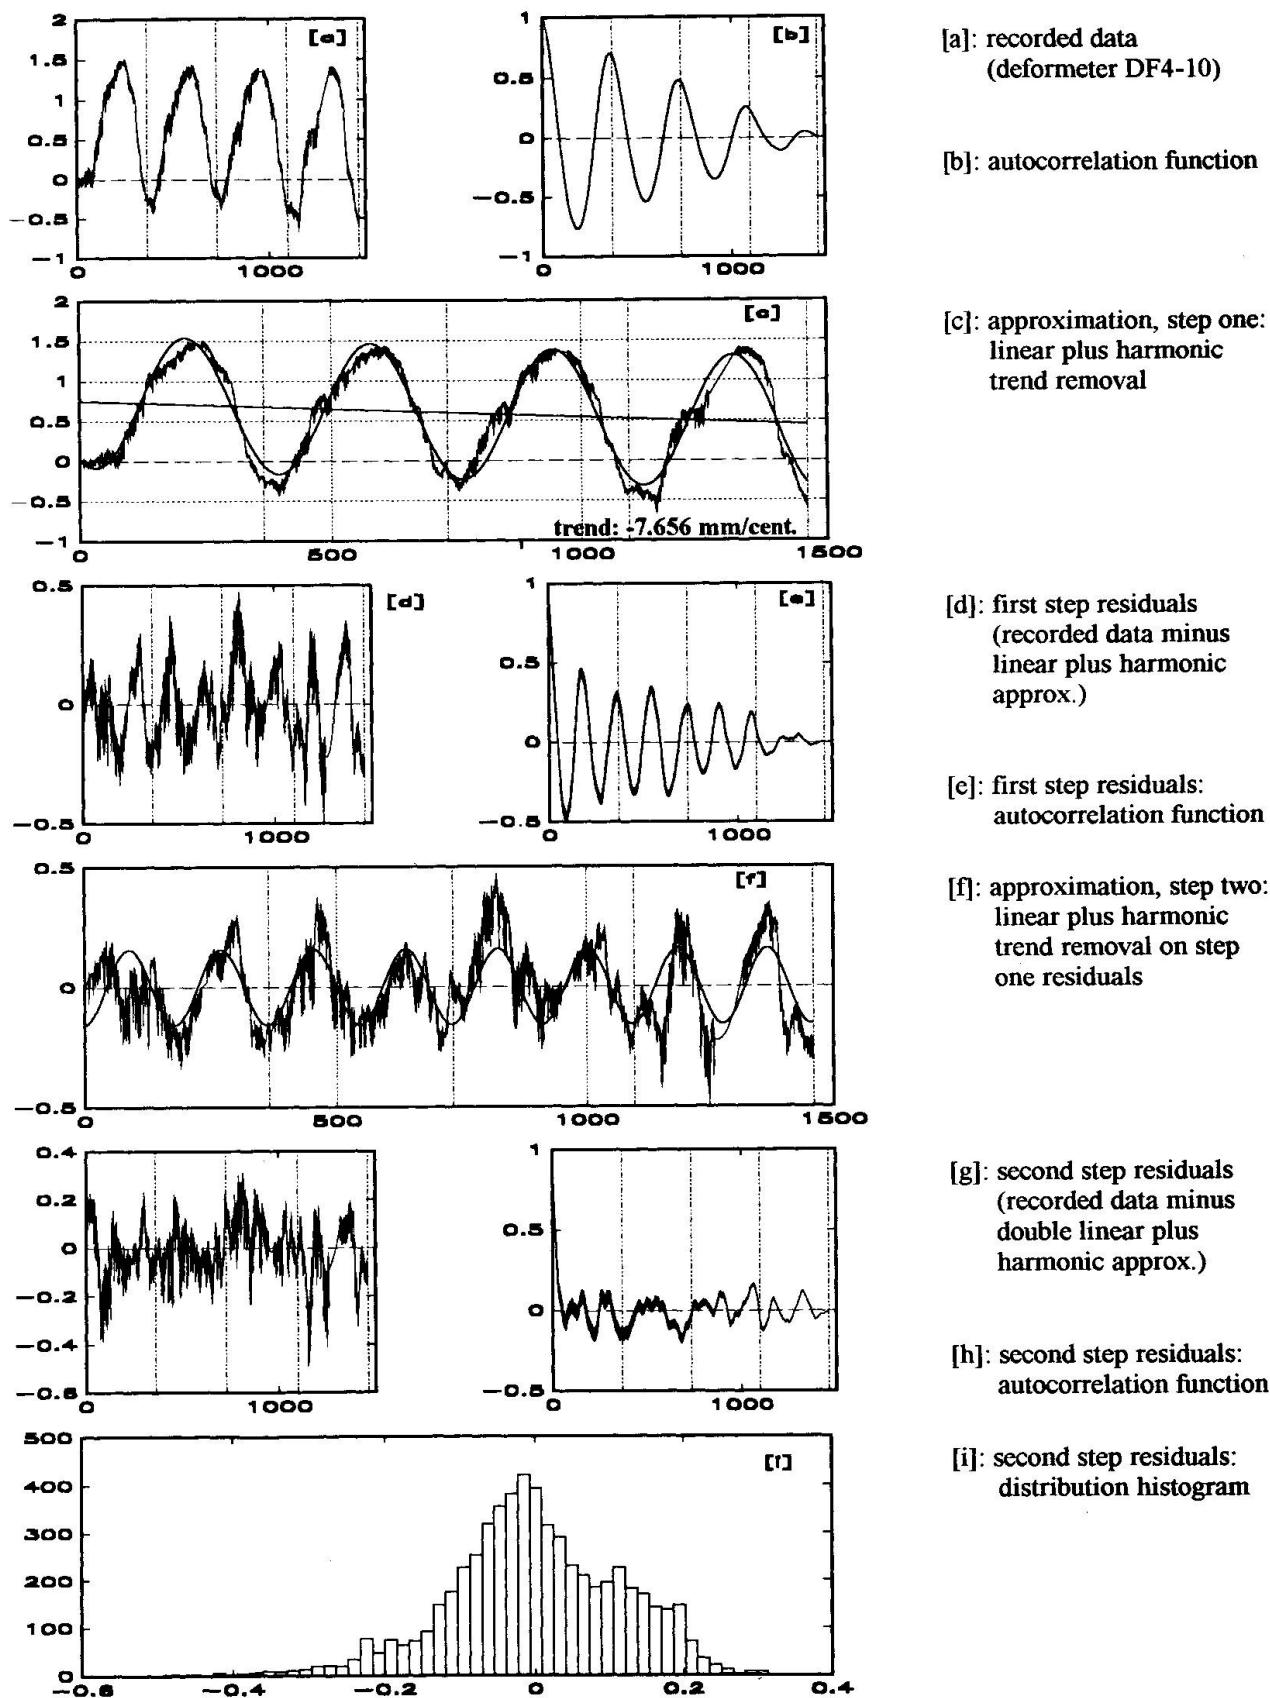
Figure 2: Trend removal procedure; application on data recorded by deformeter no. DF4-10 (web no. 4, internal dome, lower part [negative values=cracks opening])

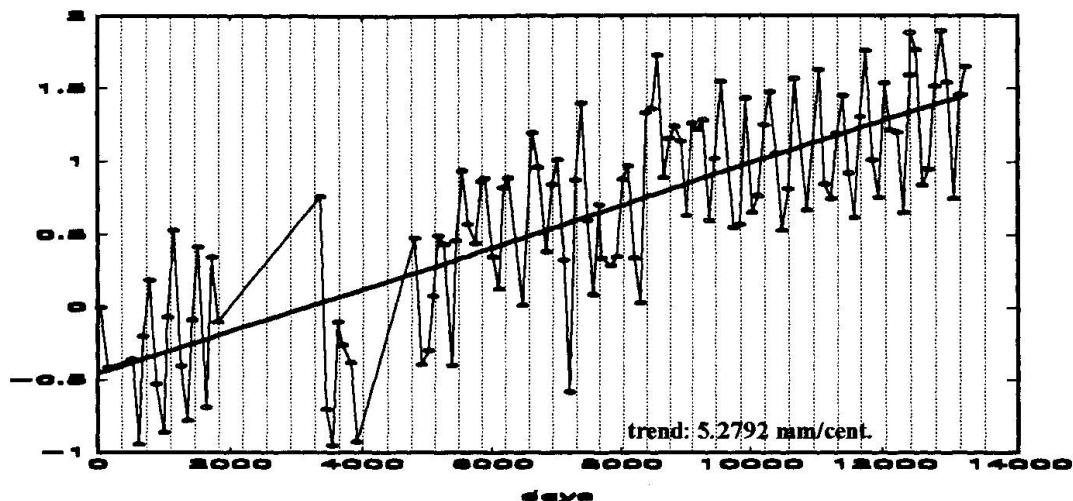
Figure 3: O.D. data (years 1956-1992), base no. 5: linear regression
(values in mm [positive values=cracks opening])

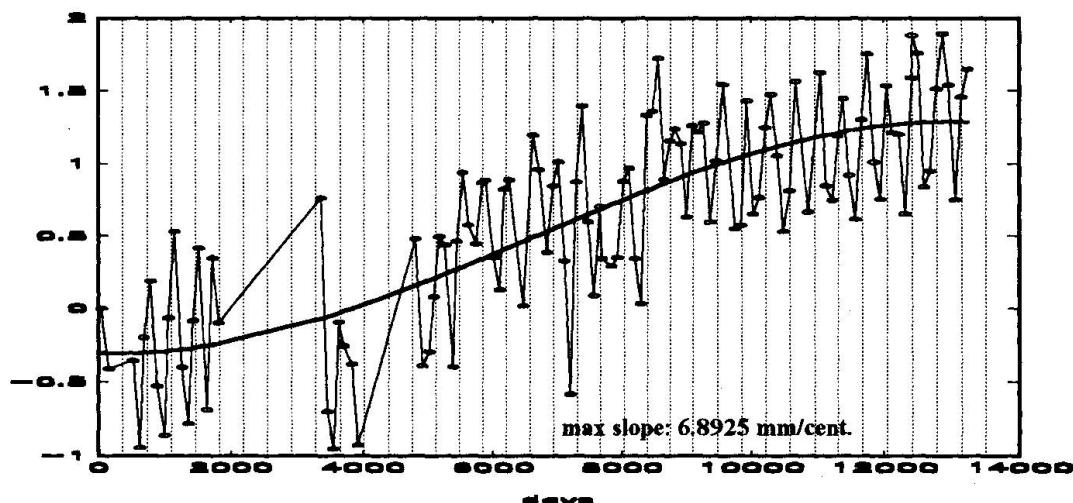
Figure 4: O.D. data (years 1956-1992), base no. 5: cubic regression
(values in mm [positive values=cracks opening])

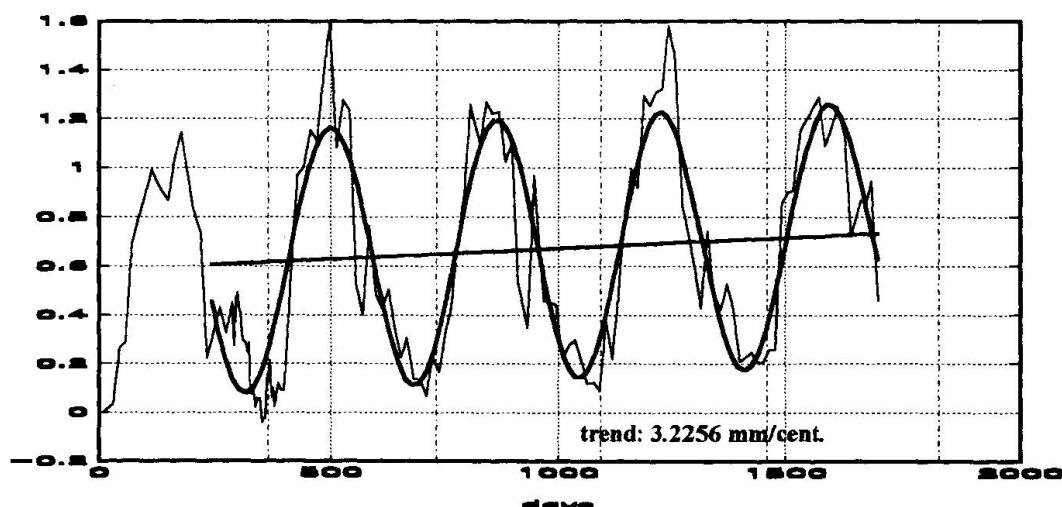
Figure 5: trend analysis of S.B.A.A. data (years 1956-1992), deformeter no. 6, web no. 4: linear plus harmonic approximation (values in mm [positive values=cracks opening])

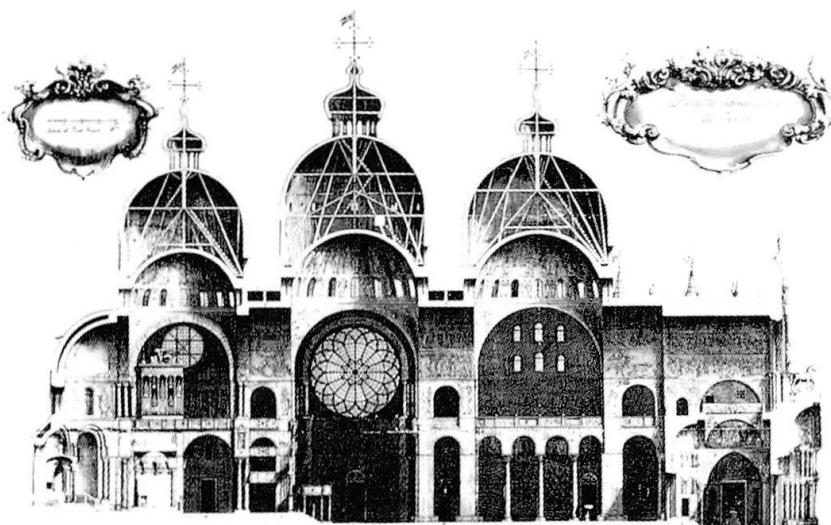
Fig. 1 - Longitudinal section (A. Visentini, XVIII century)

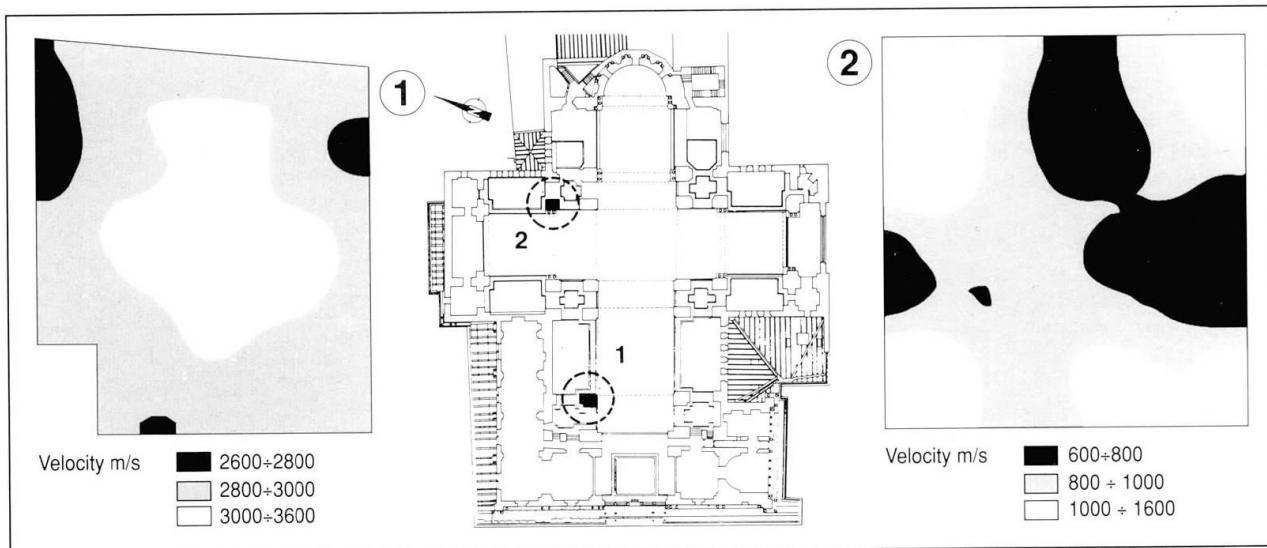
Fig. 5 - Results of tomographic survey in two pillars with different mechanical characteristics

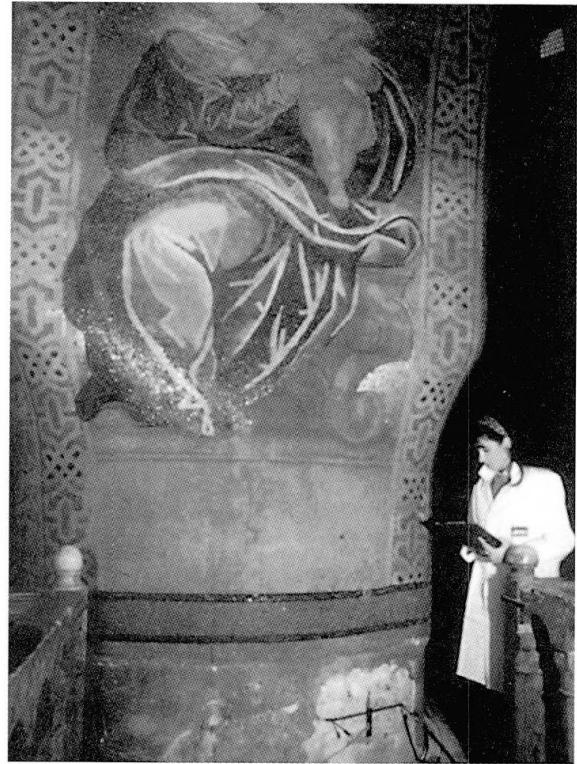
Fig. 7 - Measurement of the state of stress in a pillar by means of the flat-jack technique

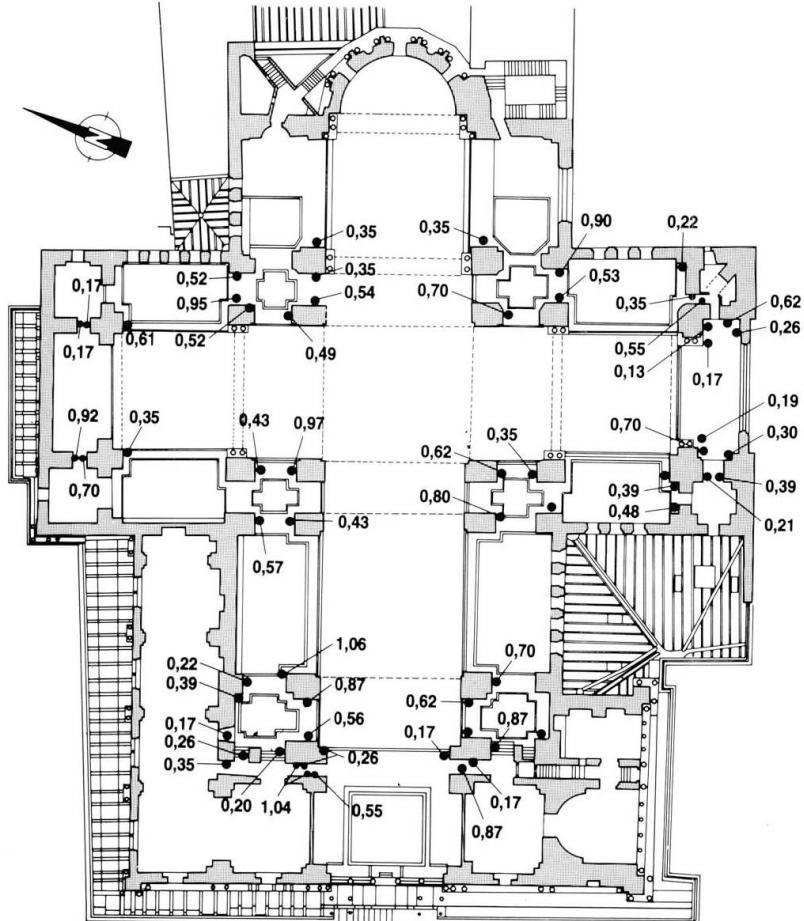
Fig. 8 - General lay-out of the flat-jack testing point with the indication of the measured states of stress

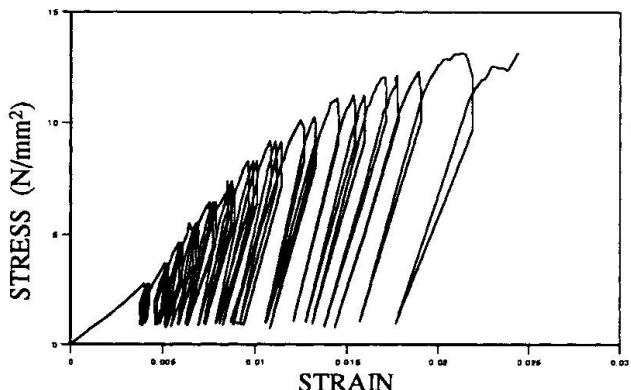
Fig. 2 - Stress-strain curve of strain gauge 7 - specimen 2.

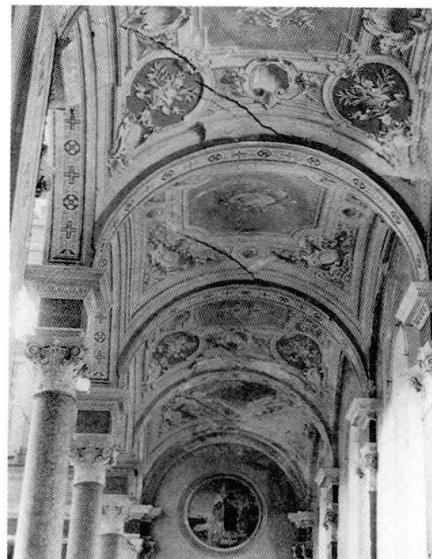
Fig. 3 - Fissures in the thin vaults of the side aisles.

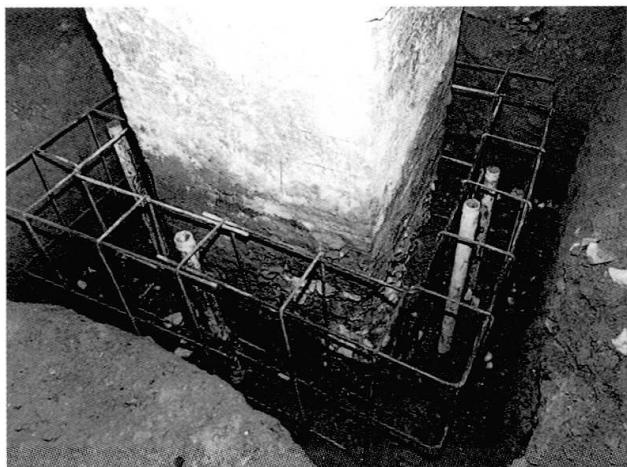
Fig. 6 - Collegamento tra basamento del pilastro e testa dei micropali.

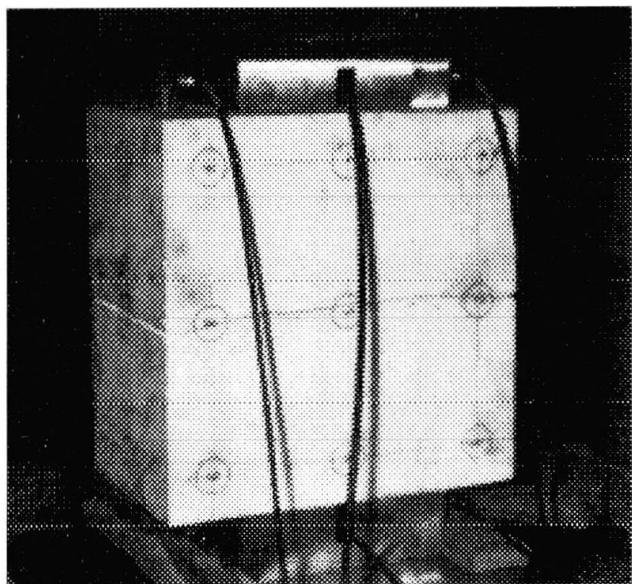
Fig. 2 Marble block with glued probes

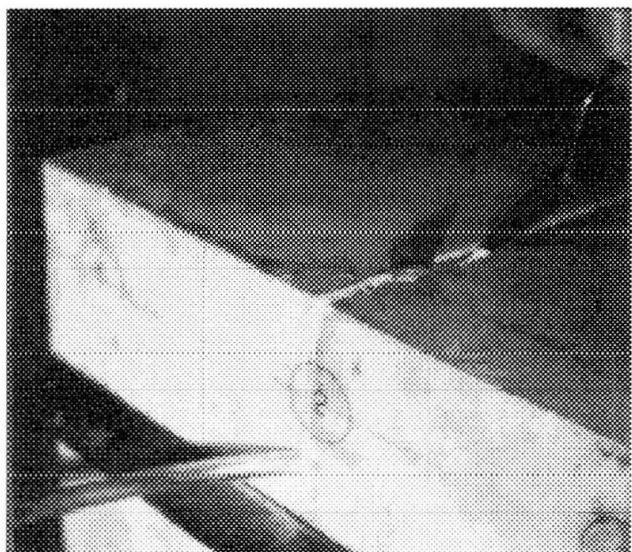
Fig. 4 Preparing the block for repair

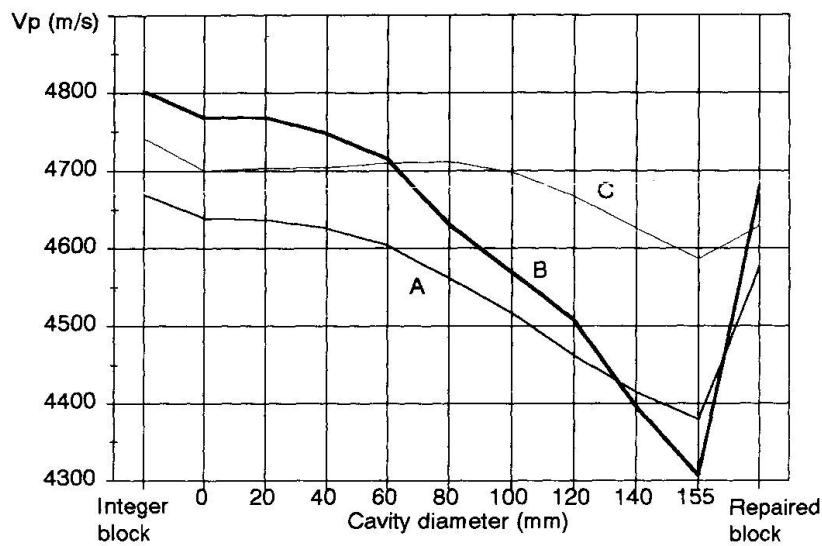
Fig. 6 Pulse velocity along different paths

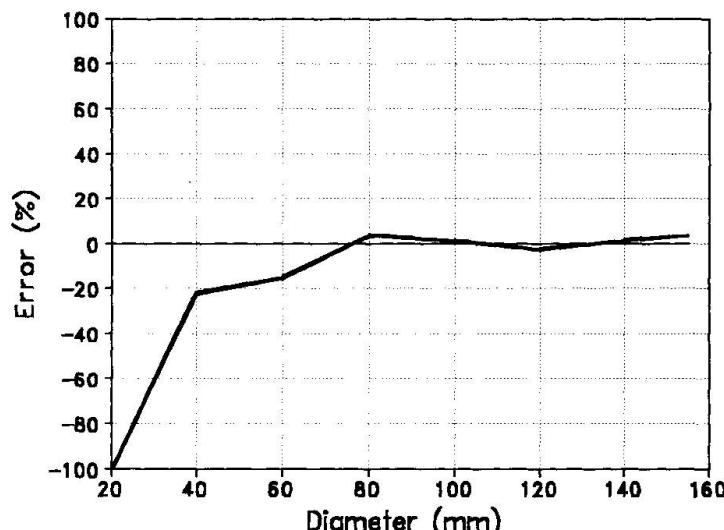
Fig. 8 Error in the evaluation of the diameter
