Zeitschrift: IABSE reports = Rapports AIPC = IVBH Berichte
Band: 70 (1993)
Rubrik: Session 2: Inspection and monitoring

Session 2

Inspection and Monitoring
Inspection et surveillance
Inspektion und Überwachung

Indirect Methods of Investigation for Evaluating Historic Masonry

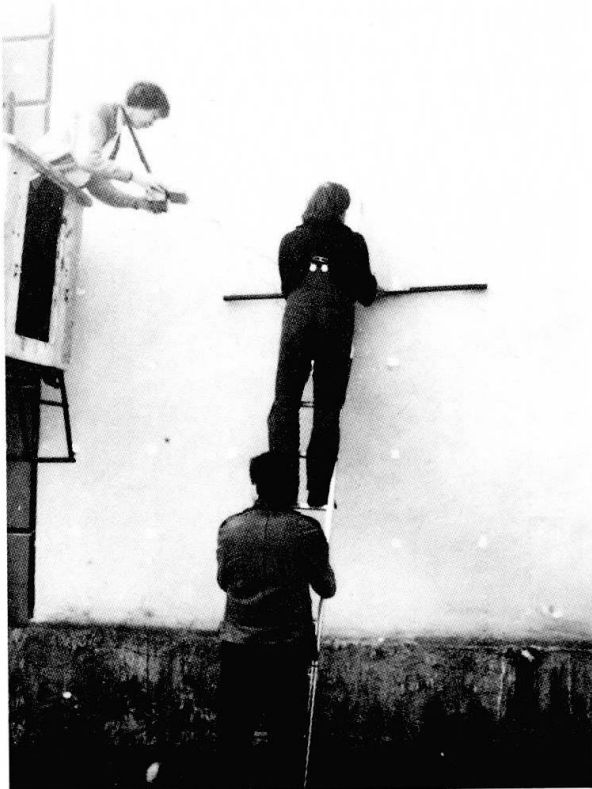
Fig. 3: Investigation with the geoelectric method

Therefore, it is not acceptable to state quantitative moisture contents directly, even if this is done in the case of moisture meters (see 4.8). However, it is possible to detect moist zones by mapping the specific electric resistivities, e. g. by using the Wenner arrangement as shown in figures 3 and 4.

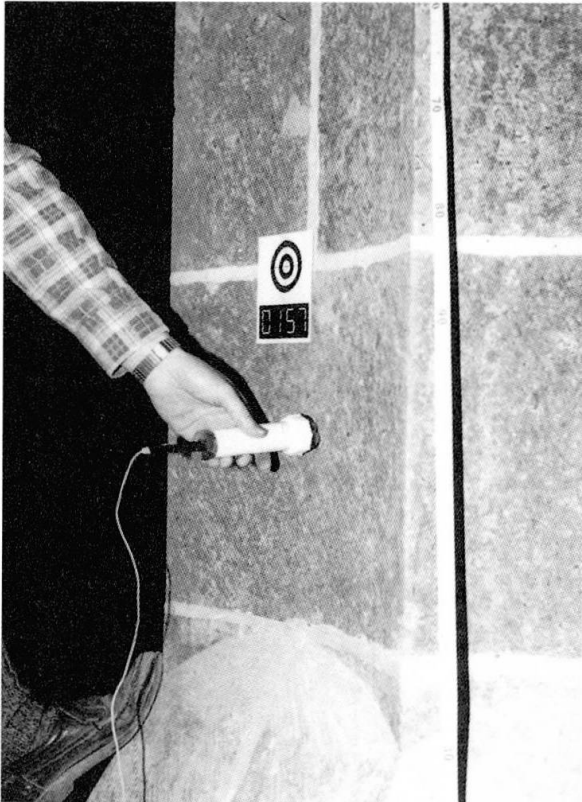
Fig. 5: Investigation with the self-potential method

A special variant of the geoelectric technique, the self-potential method, is based on the principle that iron corrosion generates an electric field that is picked up by two probes [9]. This method is very suitable for the detection of active corrosion processes. However, precondition is that the location of enclosed metals is known and that one of the probes is placed directly at it.

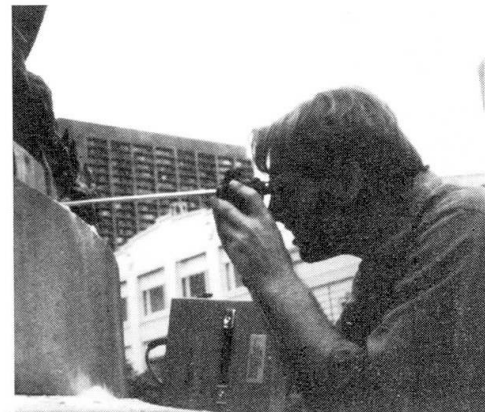
Fig. 2 - Fiberoptic Borescope

Inspection openings are destructive, but they are also the surest, and often the only way, to verify the condition of the internal parts of a structure. Sometimes the inside of a structure can be observed in a less destructive manner by using a fiberoptic borescope. The instrument's light transmitting wand is inserted into a 12 mm diameter drilled hole. The interior can then be viewed through the eyepiece on the end of the wand. The observations can be documented by a camera that attaches to the eyepiece (Fig. 2).

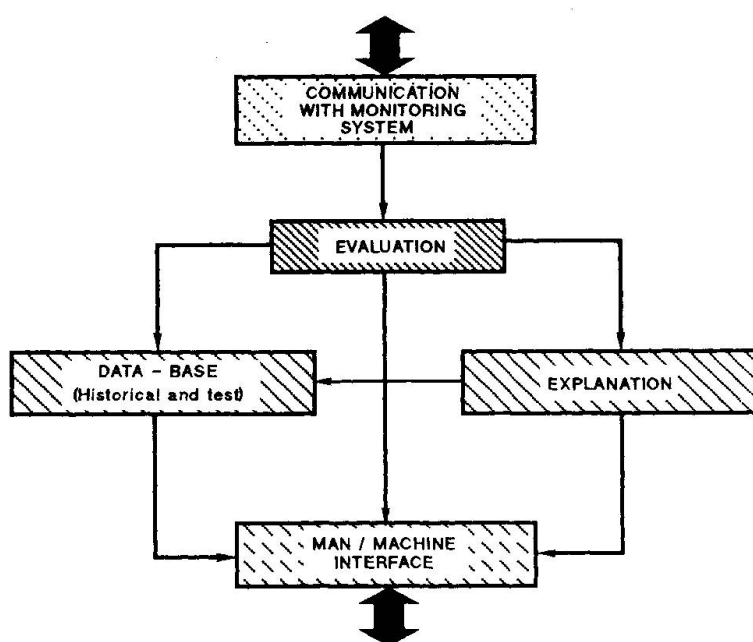
Figure 5: MISTRAL Architecture

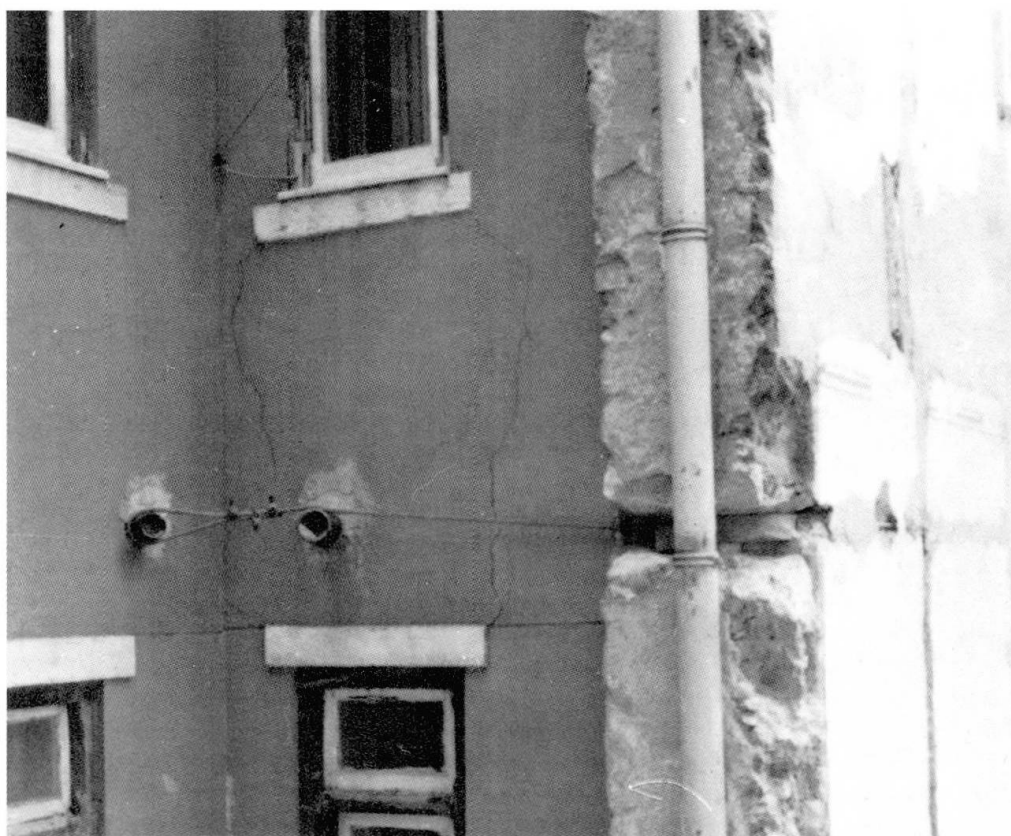
Fig. 2: Damaged masonry wall due to demolition of an adjoining building

- excavation works, both at the surface and underground, in the proximity of, or under existing buildings, resulting in localized differential settlements of the wall foundations;
- demolition of one of two buildings having a common separation wall, resulting in the destruction of the original connection between intersecting walls, both at the façade and at the back (Fig. 2);
- alterations to the existing structural system involving the total or partial demolition of load bearing walls (negative shoring-structure interaction);
- overloading through a change in building usage (eg. office archives in previous dwellings).

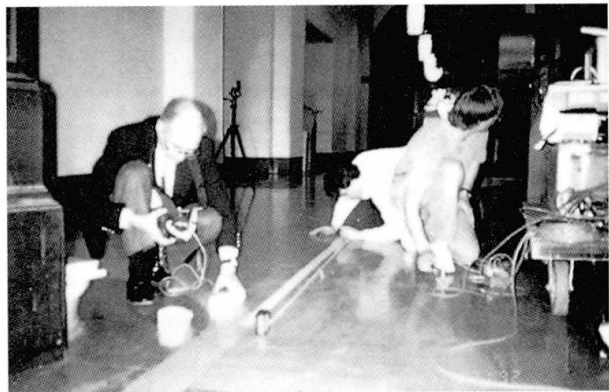
Fig. 10 Magnetic Detection & SASW Equipment

Costs are quite low for the equipment. The less expensive Fisher instrument worked just as well as the higher cost Profometer instrument for these purposes. Electromagnetic detection is recommended for use with all other methods to ascertain whether hidden objects are metallic. Specially trained operators are not required.

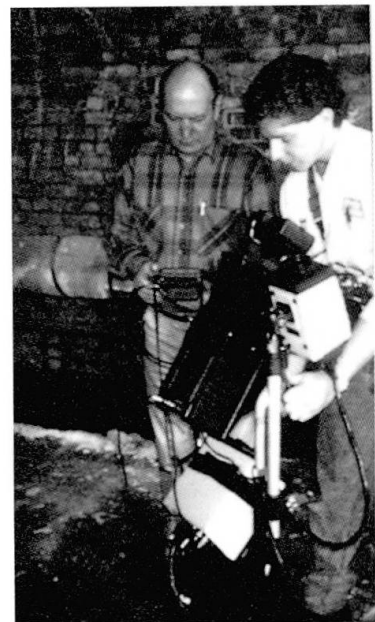
Fig 11. Infrared Equipment in Use

The basic principle is that an object having a temperature above absolute zero will radiate electromagnetic waves. Wavelengths fall within certain bands depending on temperature. At room temperature, typical wavelengths are 4 to 40 micrometers which is outside the visible spectrum. At very high temperatures the wavelengths are less than 1 micrometer and fall within the visible spectrum. Hence when metal is heated and begins to glow red, the electromagnetic waves emanating from the object fall within the visible range.

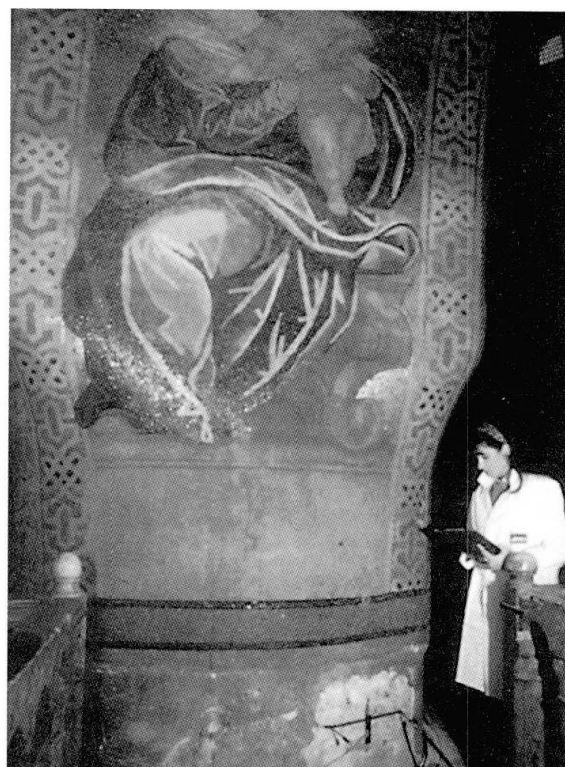
Fig. 7 - Measurement of the state of stress in a pillar by means of the flat-jack technique

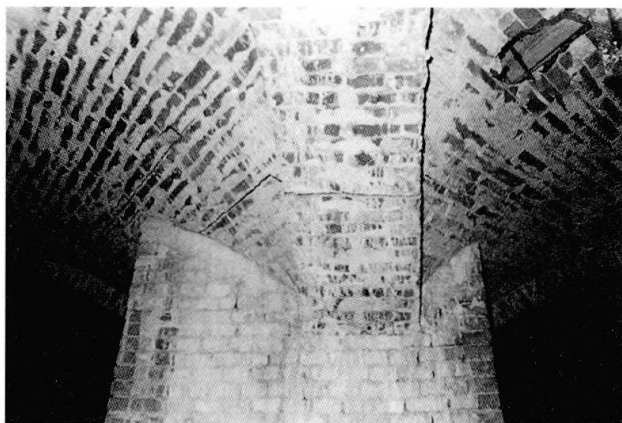
Fig. 4 - Fissures in the the 12 cm thick vaults on the underground level.
