**Zeitschrift:** IABSE reports = Rapports AIPC = IVBH Berichte  
**Band:** 70 (1993)  
**Rubrik:** Keynote lecture

## Indirect Methods of Investigation for Evaluating Historic Masonry

### Fritz WENZEL

### Martin KAHLE

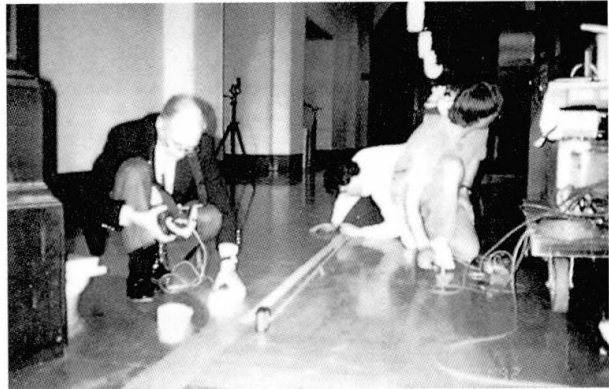
Fig. 10 Magnetic Detection & SASW Equipment

Costs are quite low for the equipment. The less expensive Fisher instrument worked just as well as the higher cost Profometer instrument for these purposes. Electromagnetic detection is recommended for use with all other methods to ascertain whether hidden objects are metallic. Specially trained operators are not required.

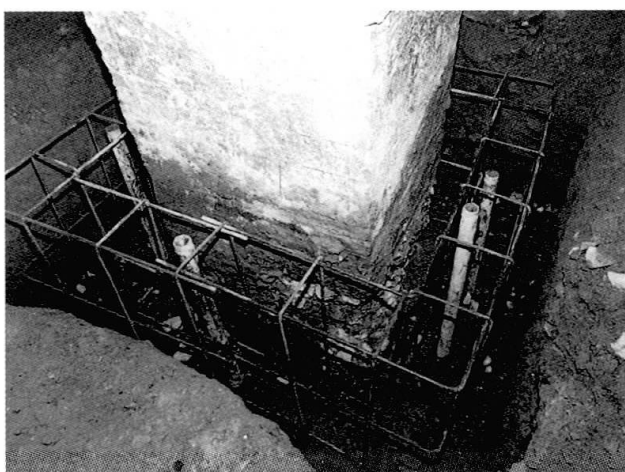
Fig. 6 - Collegamento tra basamento del pilastro e testa dei micropali.
