**Zeitschrift:** IABSE reports = Rapports AIPC = IVBH Berichte  
**Band:** 70 (1993)

## Indirect Methods of Investigation for Evaluating Historic Masonry

### Fritz WENZEL

### Martin KAHLE

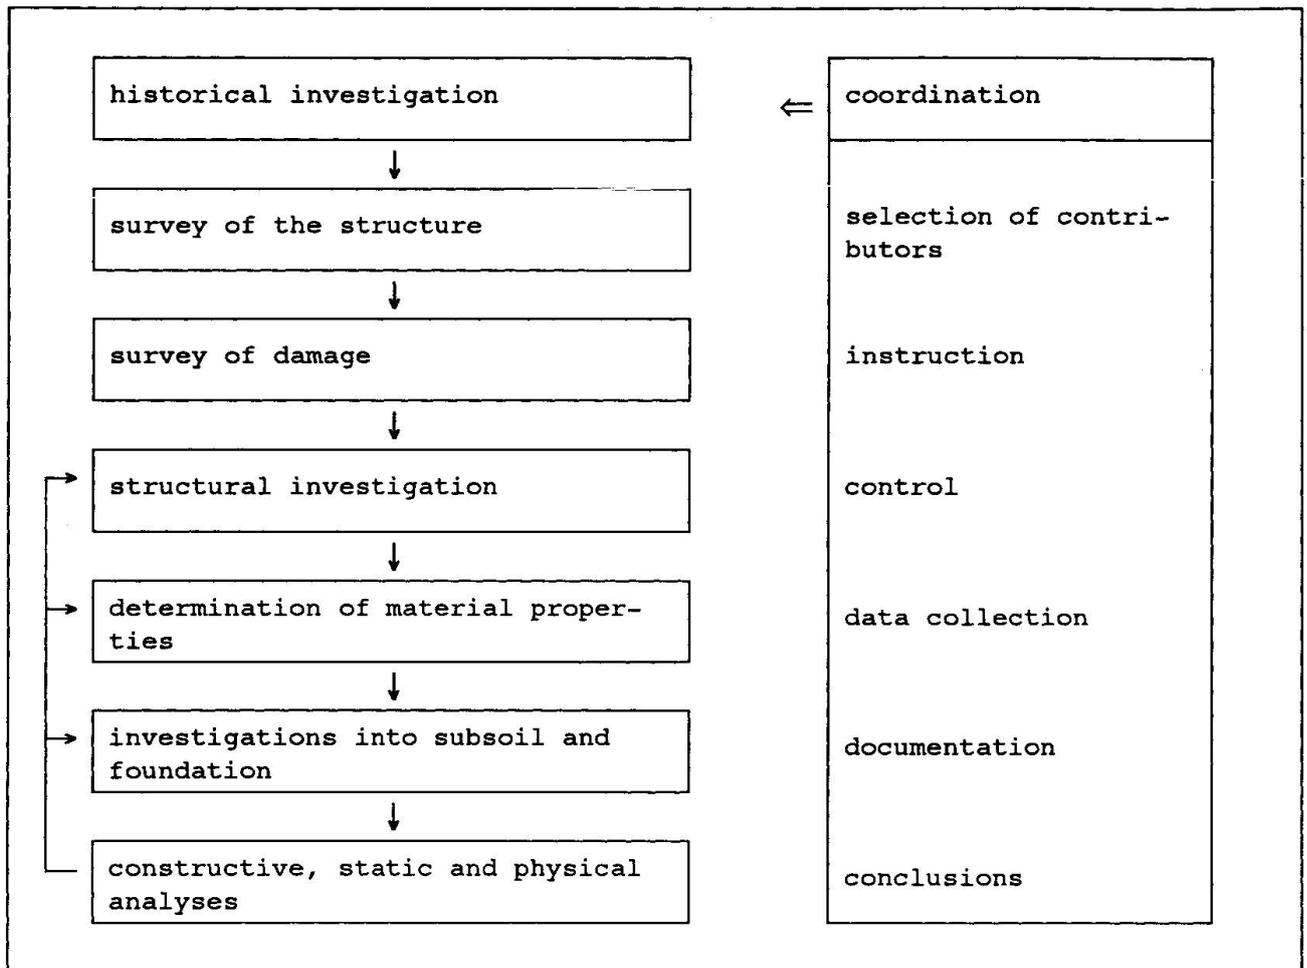
Fig. 1: Survey and evaluation of historic buildings

When dealing with complex buildings, the appraisal and the assessment of their structural condition should be done step-by-step in a well coordinated way (fig. 1). The indirect investigation methods must be integrated into the overall concept, since the necessary documentation should be available for their use. Also, the investigation aims must be determined beforehand.

The survey of damage includes the mapping of visible damage to the structure, for example deformations, cracks, disintegrated areas as well as specific surface characteristics, for example the detachment of flakes, sanding, discoloration and efflorescence. Need may arise to trace the development of the damages in the course of time by continuous or periodic monitoring.

Structural investigations are directed at the composition and structure of the parts. Very often the visual inspection of the surface informs about the materials used and the binding. In order to gain information about the interior, i. e. possible voids, multiple leaves or discontinuities, interventions into the building are necessary, e. g. drillings. In this context, indirect methods offer a non-destructive or only partially destructive way to gain data covering huge areas.

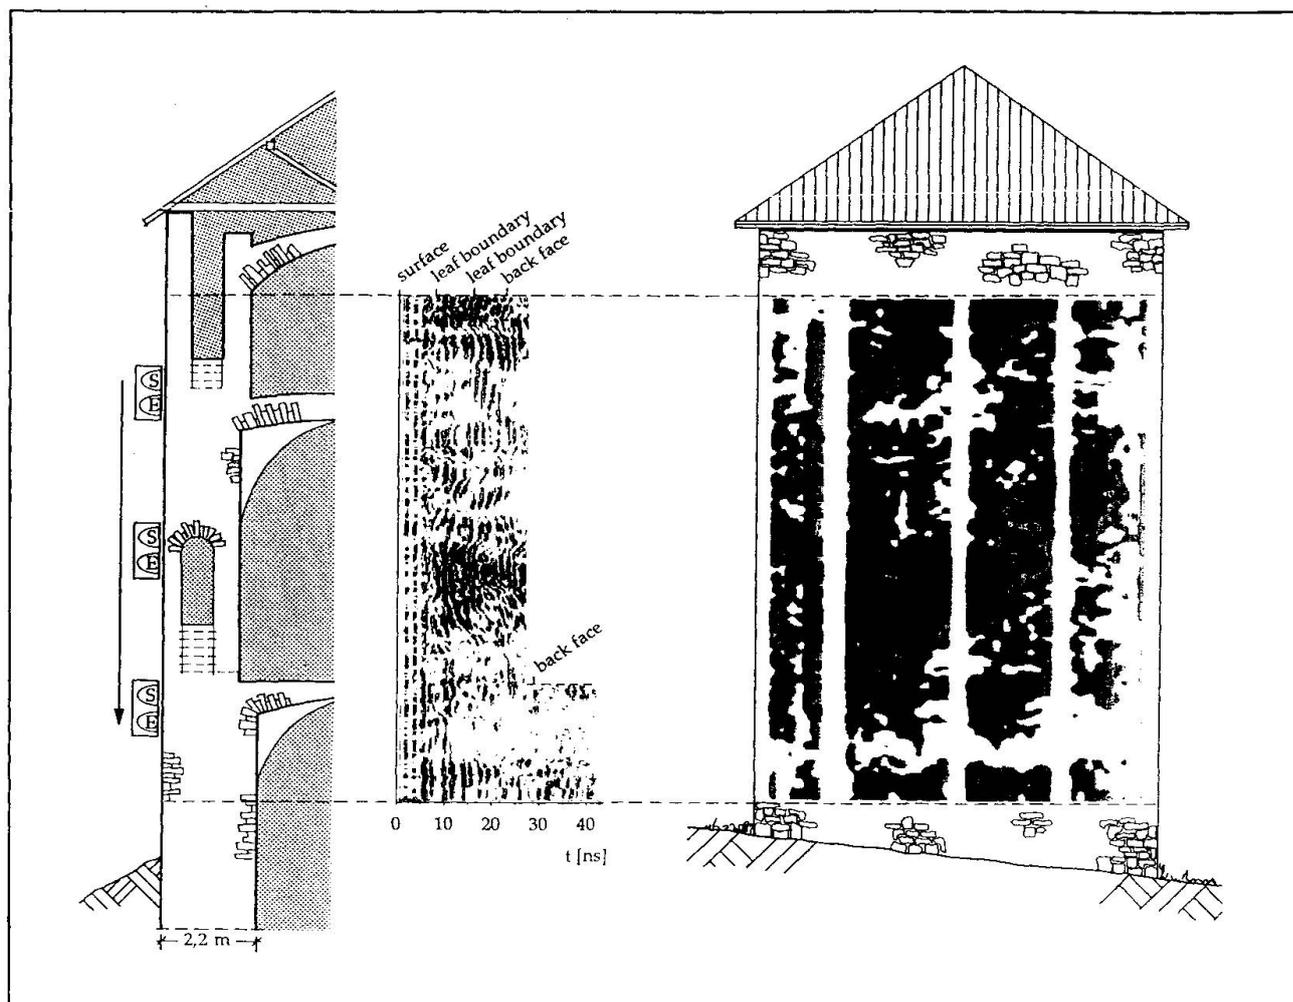
**Fig. 2:** Radar investigation on the wall of a medieval tower; left: cross section and radargram, right: view of the wall with radar data

The moisture content of masonry materials is determined on the basis of their relative permittivity which in turn is calculated from the velocity of the electromagnetic waves when penetrating the part. In general, these calculations necessitate a transmission arrangement consisting of transmitter and receiver, which means that both surfaces of the structural part must be accessible. Because of the high measurement volume, smooth lateral moisture profiles do result that present the lateral moisture distribution in a realistic way.

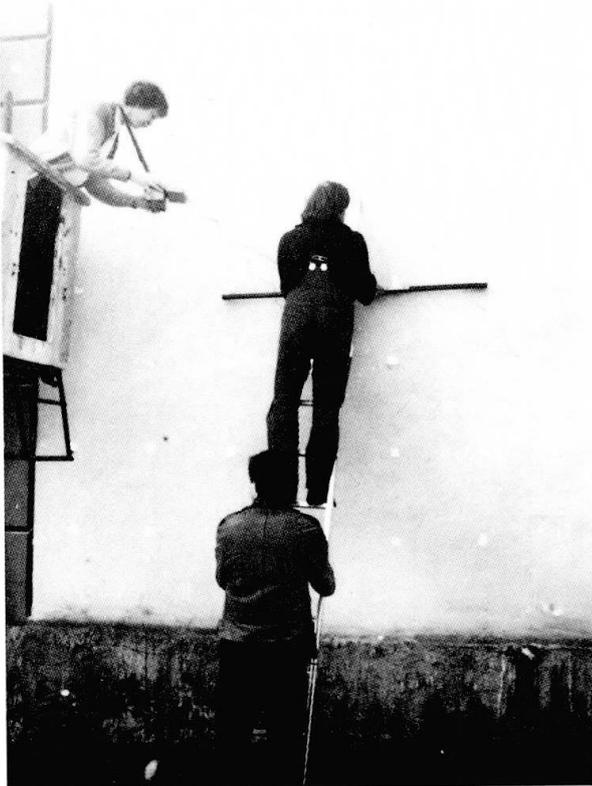
**Fig. 3:** Investigation with the geoelectric method

In the geoelectric investigation method, an electrical direct-current field is induced in the test zone by means of two or more electrodes. The current within the circuit of the equipment, the voltage between the two probes (which pick up the potential difference at the surface) and a specific factor, which is derived from the configuration used, are the parameters from which the specific electrical resistivity of the material is calculated. The value depends mainly on the two parameters 'moisture content' and 'concentration of dissolved salts' [4, 6, 7, 8].

Therefore, it is not acceptable to state quantitative moisture contents directly, even if this is done in the case of moisture meters (see 4.8). However, it is possible to detect moist zones by mapping the specific electric resistivities, e. g. by using the Wenner arrangement as shown in figures 3 and 4.

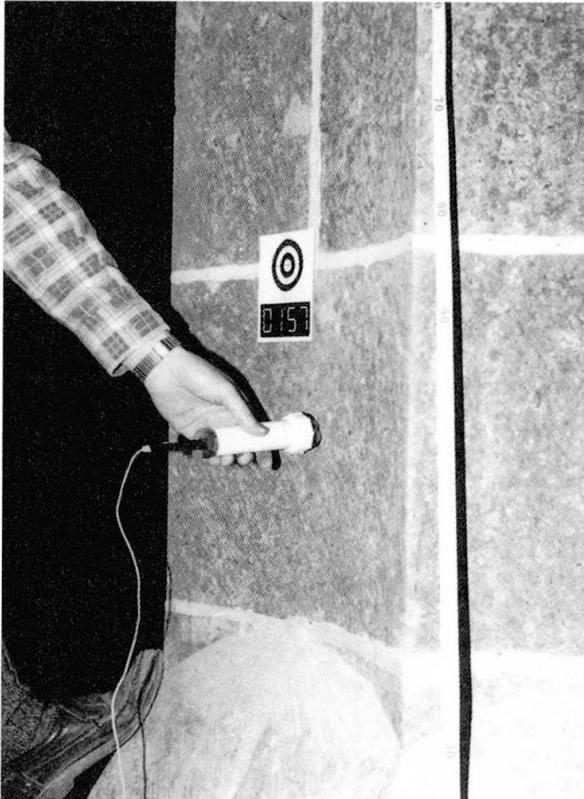
Fig. 5: Investigation with the self-potential method

A special variant of the geoelectric technique, the self-potential method, is based on the principle that iron corrosion generates an electric field that is picked up by two probes [9]. This method is very suitable for the detection of active corrosion processes. However, precondition is that the location of enclosed metals is known and that one of the probes is placed directly at it.

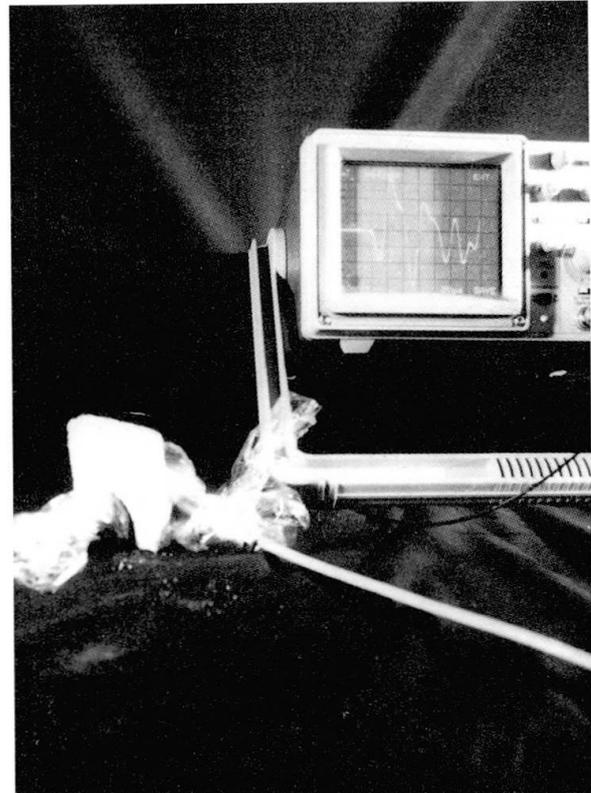
Fig. 8: Ultrasonic measurement to determine the mechanic properties of mortar

Further research work is necessary to increase the knowledge as to whether measuring the velocity of ultrasonic waves allows statements about the strength of stones or masonry (fig. 8). While the relation between the velocity of elastic waves and material properties has been proven physically for homogenous materials, the transformation into a measurement method that can be used under real conditions has not yet taken place [12, 13, 14, 15, 16].

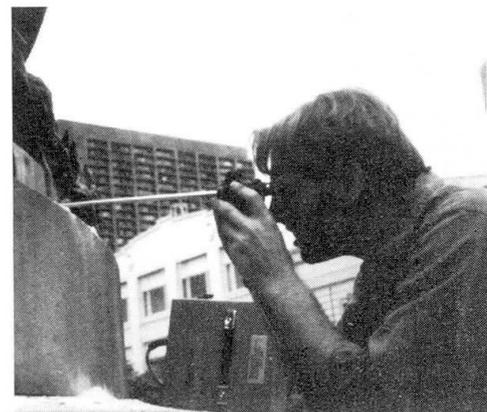
Fig. 2 - Fiberoptic Borescope

Inspection openings are destructive, but they are also the surest, and often the only way, to verify the condition of the internal parts of a structure. Sometimes the inside of a structure can be observed in a less destructive manner by using a fiberoptic borescope. The instrument's light transmitting wand is inserted into a 12 mm diameter drilled hole. The interior can then be viewed through the eyepiece on the end of the wand. The observations can be documented by a camera that attaches to the eyepiece (Fig. 2).

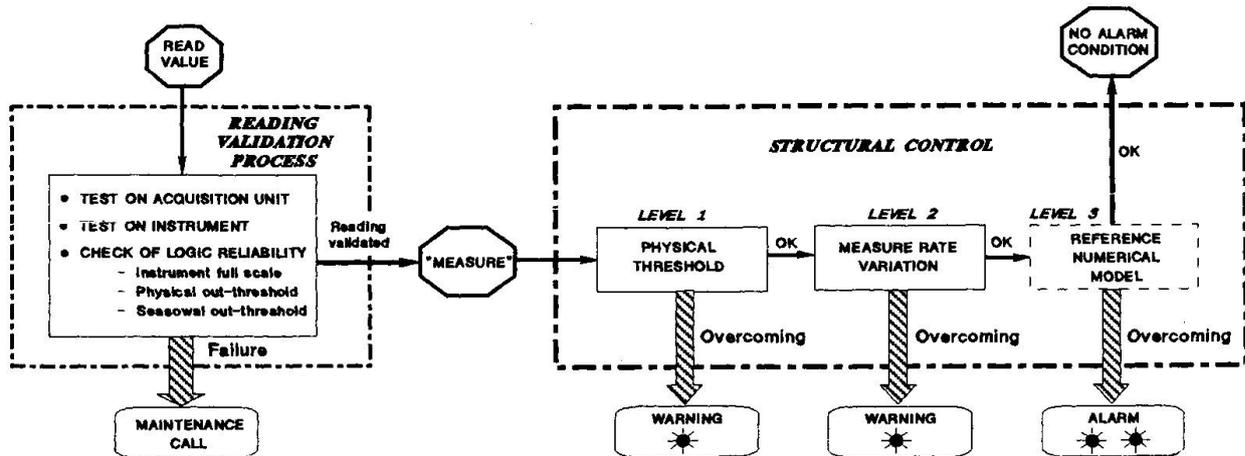
Figure 2: On line control architecture

Different criteria have been determined to identify different situations. Each read value is subjected to a validation and control procedure carried out on the automatic monitoring system. The architecture of the control is showed in Fig. 2.

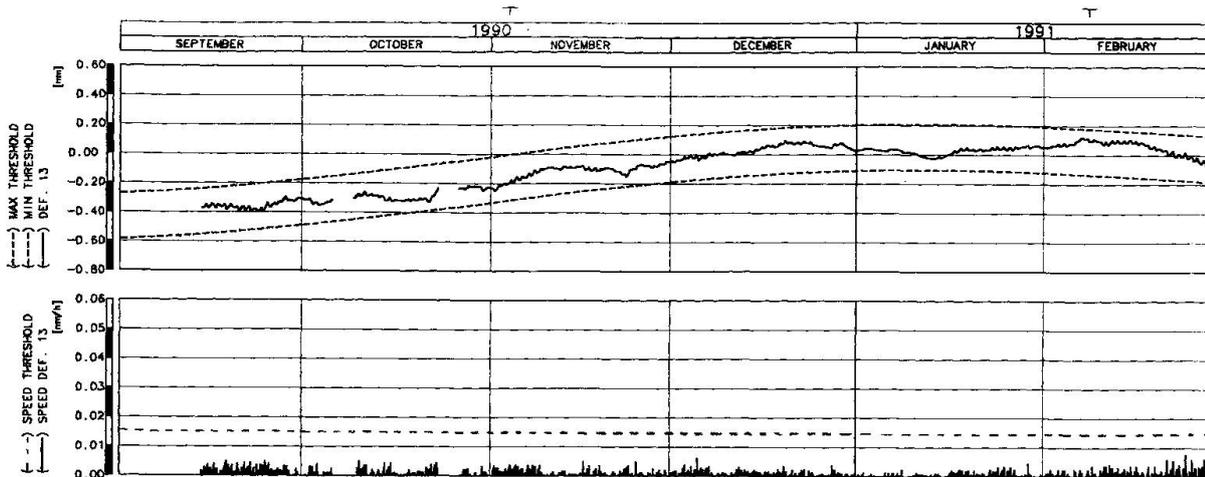
Figure 3: An example of periodic threshold of the measures.

Figure 3a shows the opening-closure history of a crack (solid line), read in the dome of the Cathedral, together with the established threshold bounding values (dotted lines). Figure 3b gives the same information on the opening-closure variation rate: the dotted line is the maximum threshold value.

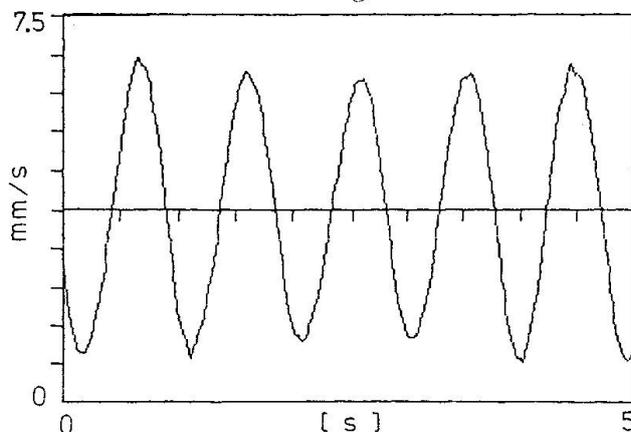
Bild 6: Zeitverlauf der Bogenschwingung (volles Geläut)

Die wesentliche Erregerfrequenz der großen Glocke liegt bei  $f = 1,05 \text{ Hz}$ . Betrug die Schwingungsamplituden vor dem Umbau maximal  $s_x = \pm 1,8 \text{ mm}$ , so gingen sie auf  $s_x = \pm 0,8 \text{ mm}$  nach dem Abtragen der Querwand herunter. Um zu vermeiden, daß nach der Sanierung wieder Resonanzschwingungen auftreten, soll zwischen dem Turm und dem neu aufgemauertem Wandteil ein Luftschlitz gelassen werden.

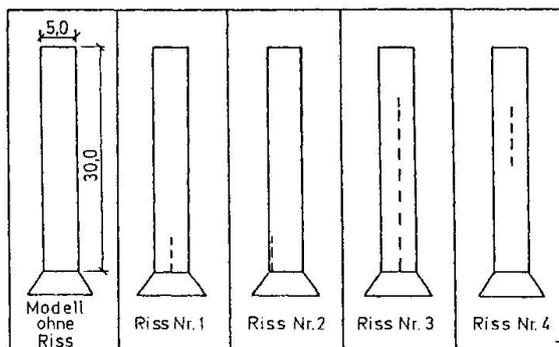
Bild 7: Darstellung der Risse

Da vom Kirchturm verlässliche Baupläne vorlagen, (Masseverteilung und Trägheitsmomente) wurde ein mathematisches Modell aufgestellt. (FE-Modell *NASTRAN*) Das Ausgangsmodell hatte einen E-Modul von  $E = 3,3 \cdot 10^3\text{ MN/m}^2$  für das Mauerwerk. Die berechneten Eigenfrequenzen lagen etwa 20% unterhalb der gemessenen Frequenzen. Wird ein E-Modul von  $E = 4,5 \cdot 10^3\text{ MN/m}^2$  im Modell verwandt, so ergeben sich die Eigenfrequenzen, die auch bei der Messung ermittelt worden waren.

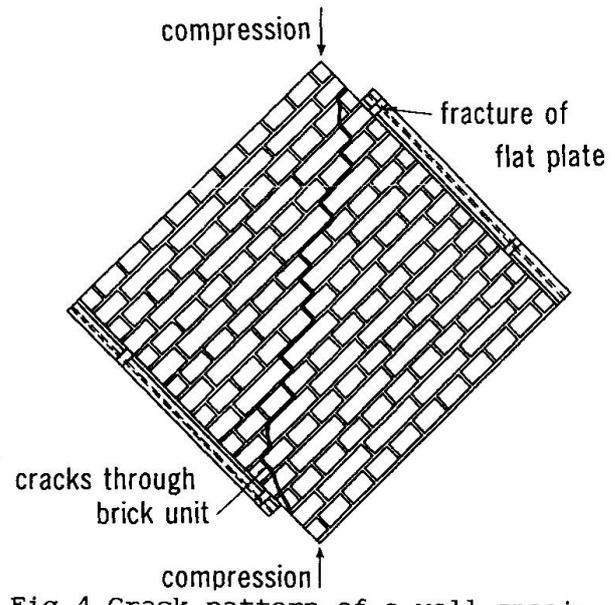
Fig.4 Crack pattern of a wall specimen

Shear force - shear strain relationships of the specimens are shown in Fig. 3. Representative crack pattern after the testing is shown in Fig. 4. The new pure brick masonry walls (Specimens BW1 and BW2) showed very brittle failure. When a diagonal crack appeared in the wall, load was completely lost simultaneously. Most of cracks were observed along joints of the brick masonry. The old pure brick masonry wall (Specimen BW0) showed more ductile manner because the measurement point of

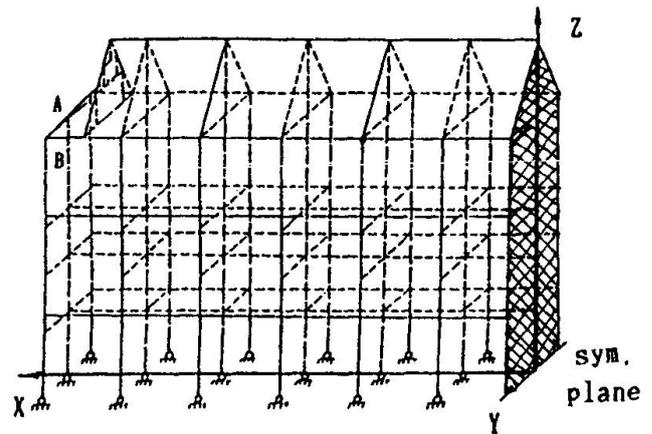
Fig.8 The FEM Model of the Front Tower

as Fig.8. The number of beam elements, flexible elements and nodes is 208, 162 and 280, respectively. The value of the flexible elements will be determined afterward. Because the columns of the structure have no other connections with the base stones but are only set upon it, hinges were used as the boundary condition. The nodes located in the symmetrical plane are constrained, as shown in Fig.9.

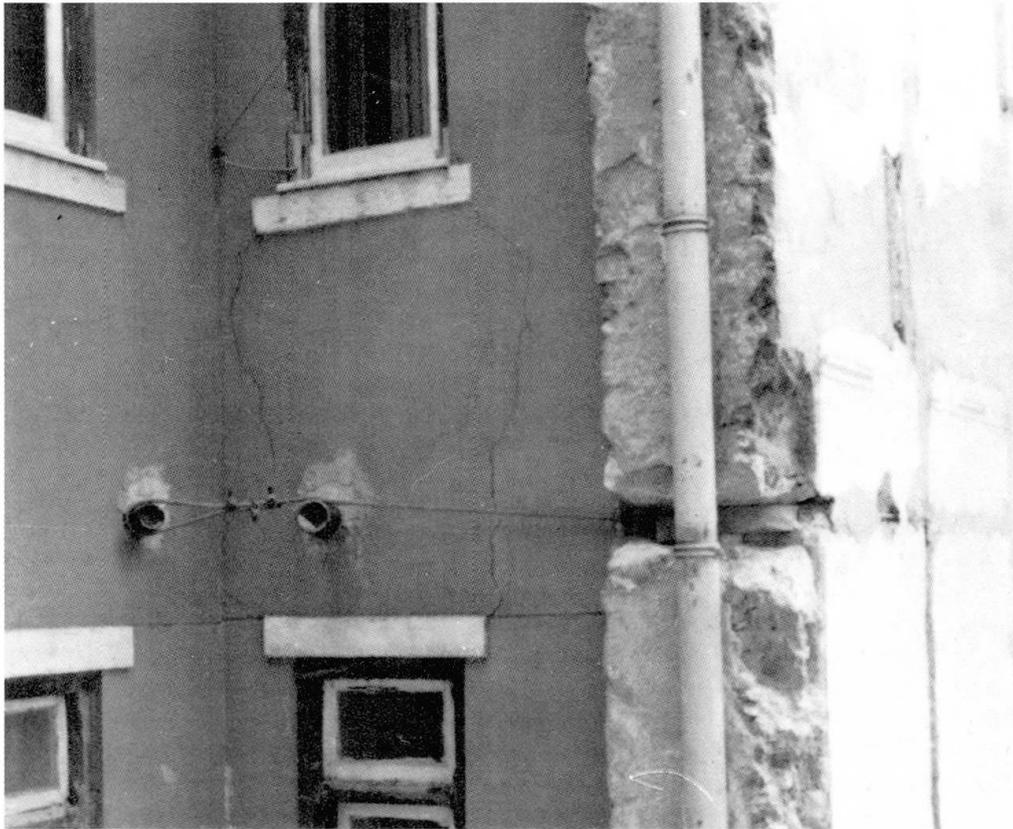
Fig. 2: Damaged masonry wall due to demolition of an adjoining building

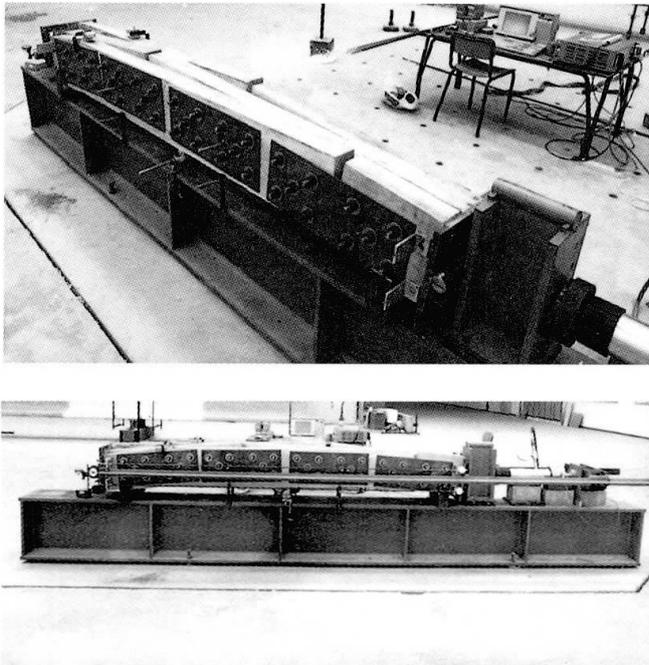
Fig.8 The model and the loading device of the test

The Figure shows also the loading device able to simulate the load conditions of the element in the real structure, known by the results of the 3-D elastic analysis previous mentioned. In figure 9 some particulars of the instrumentation are shown.

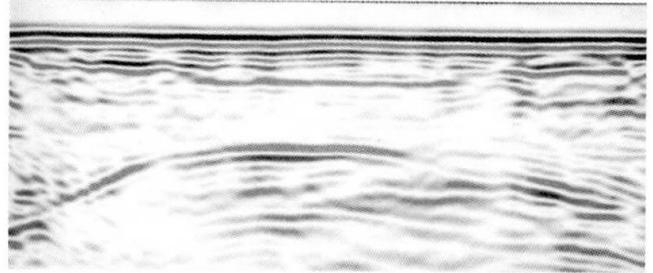
Fig. 4 Radar Output, Computer Enhanced Image of Data From Fig. 3

The radar equipment is expensive to purchase, requires a highly skilled operator and must be compiled with a sophisticated computer software program. Of course this is all quite expensive. In addition, there are several potential technical pitfalls such as accurate calibration of the pulse propagation velocity in a given material and errors due to the manual towing of the transducer across the surface.

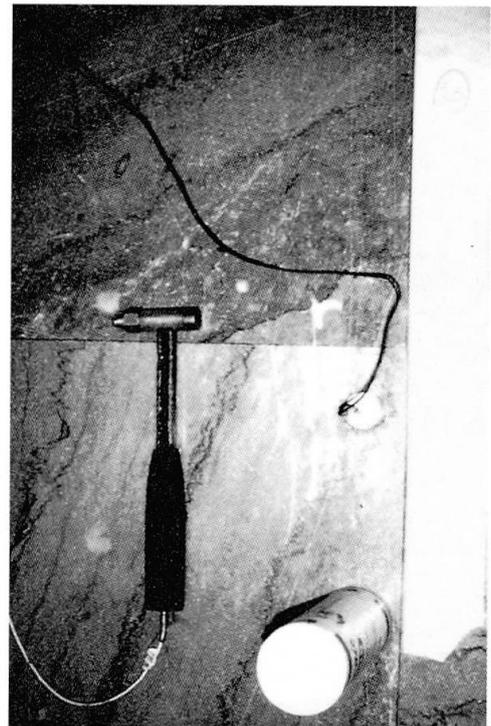
Fig. 5 Impact Echo Equipment

The equipment produced good data for reading thicknesses and integrity on granite and sandstone columns, veneer walls, and brick walls less than 600 mm thick. A steel column behind granite facing was located using this technique but the orientation of the flanges was not discernible. Brick walls over 600 mm thick could not be fully measured. Multiple layers (terrazzo floor over setting bed over brick) did not produce good results; brick arches and beams were not detected as they were using radar. The equipment is best used to detect cracking parallel to the surface (in this case, stone). Optimum

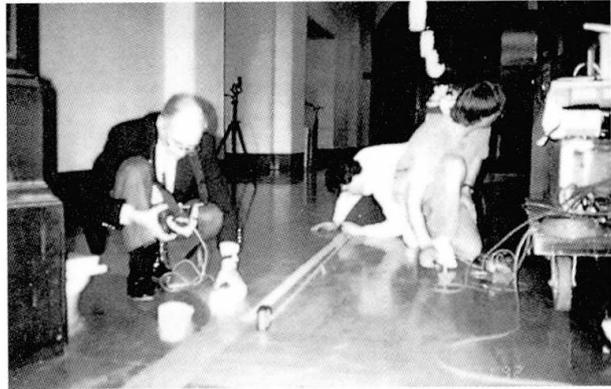
Fig. 10 Magnetic Detection & SASW Equipment

Costs are quite low for the equipment. The less expensive Fisher instrument worked just as well as the higher cost Profometer instrument for these purposes. Electromagnetic detection is recommended for use with all other methods to ascertain whether hidden objects are metallic. Specially trained operators are not required.

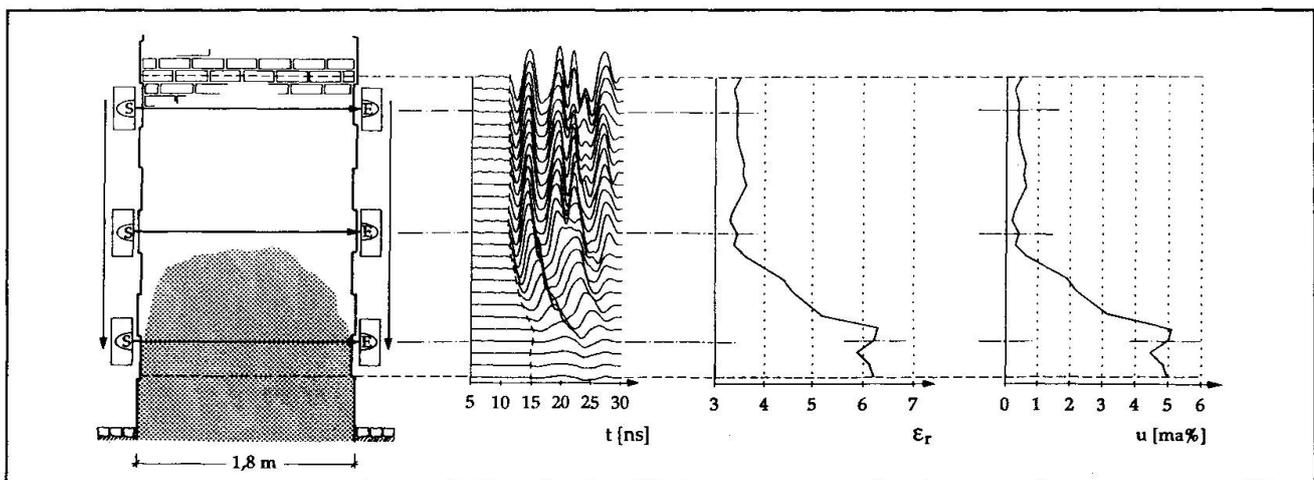
**Fig. 4:** The transmission arrangement on a column with rising moisture; schematic cross section, received signals, relative permittivity and moisture profile (S..transmitter, E..receiver, ↓..direction of profiling)

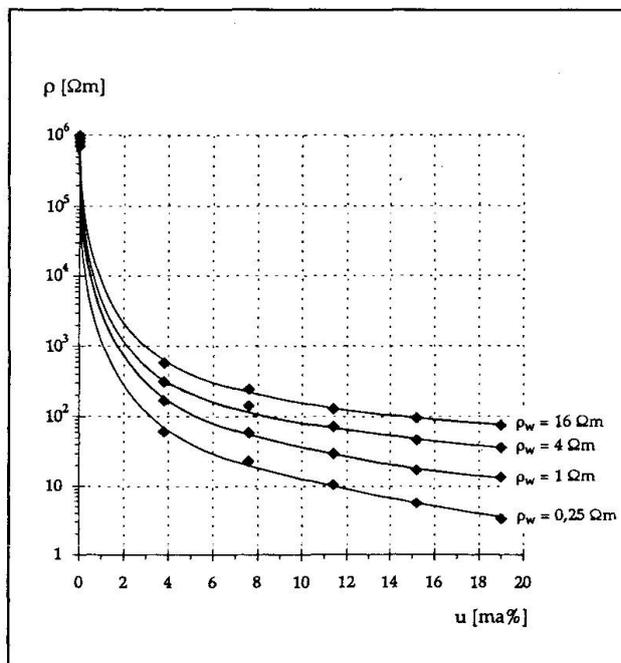
**Fig. 5:** Dependence of the electric resistivity  $\rho$  of brick on the gravimetric moisture content  $u$ ; parameter  $\rho_w$  is the resistivity of the porous aqueous solution

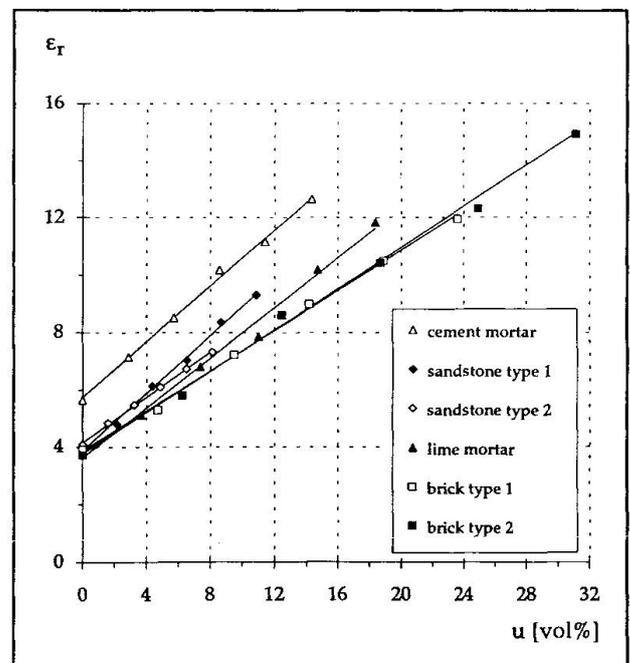
**Fig. 6:** Dependence of the relative permittivity  $\epsilon_r$  of different materials on the volumetric moisture content  $u$

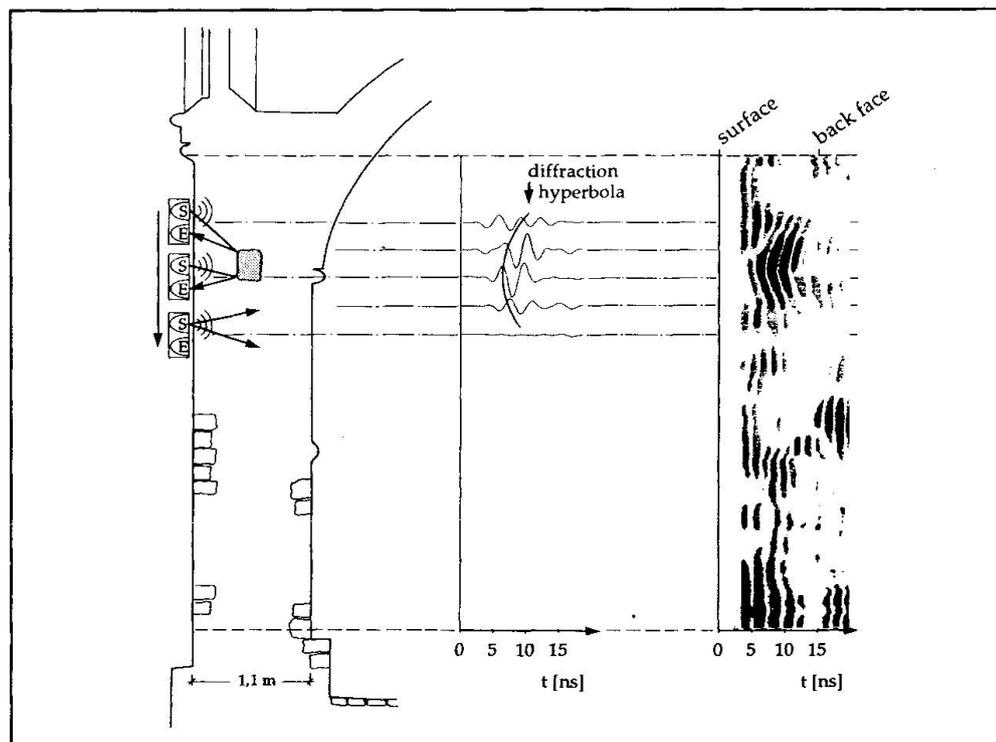
**Fig. 9:** The detection of anomalies with the reflection arrangement; wall cross section of the Matthiaskapelle in Kobern/Mosel, receiver signal and radargram

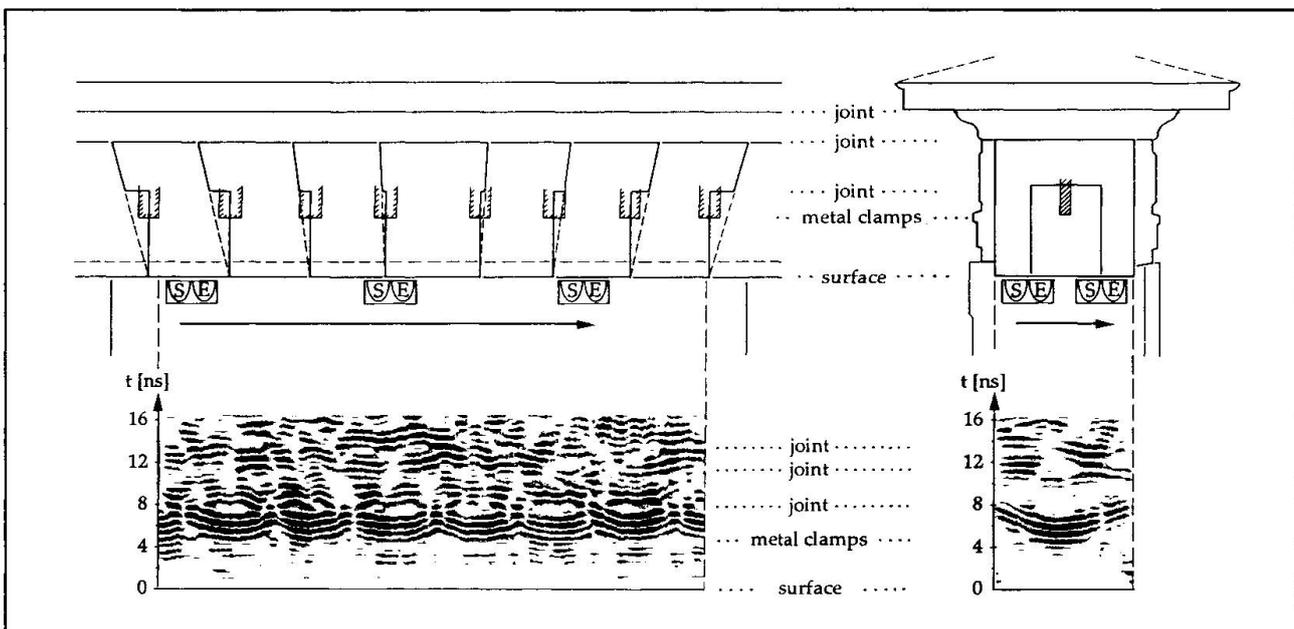
Fig. 10: Longitudinal and transversal cross section of the beam of the Jägertor in Potsdam and corresponding radargrams

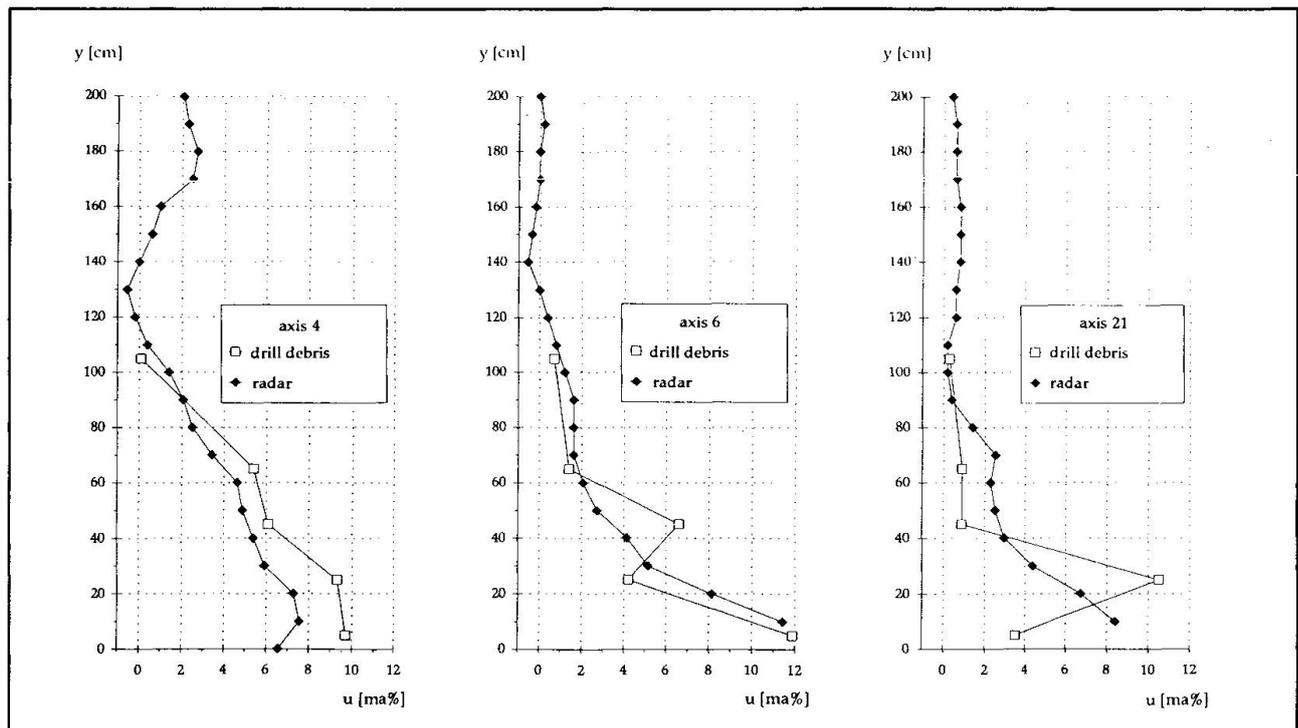
Fig. 11: Moisture content  $u$  of a brick wall at 3 cross sections, determined with radar or the gravimetric method on drill debris

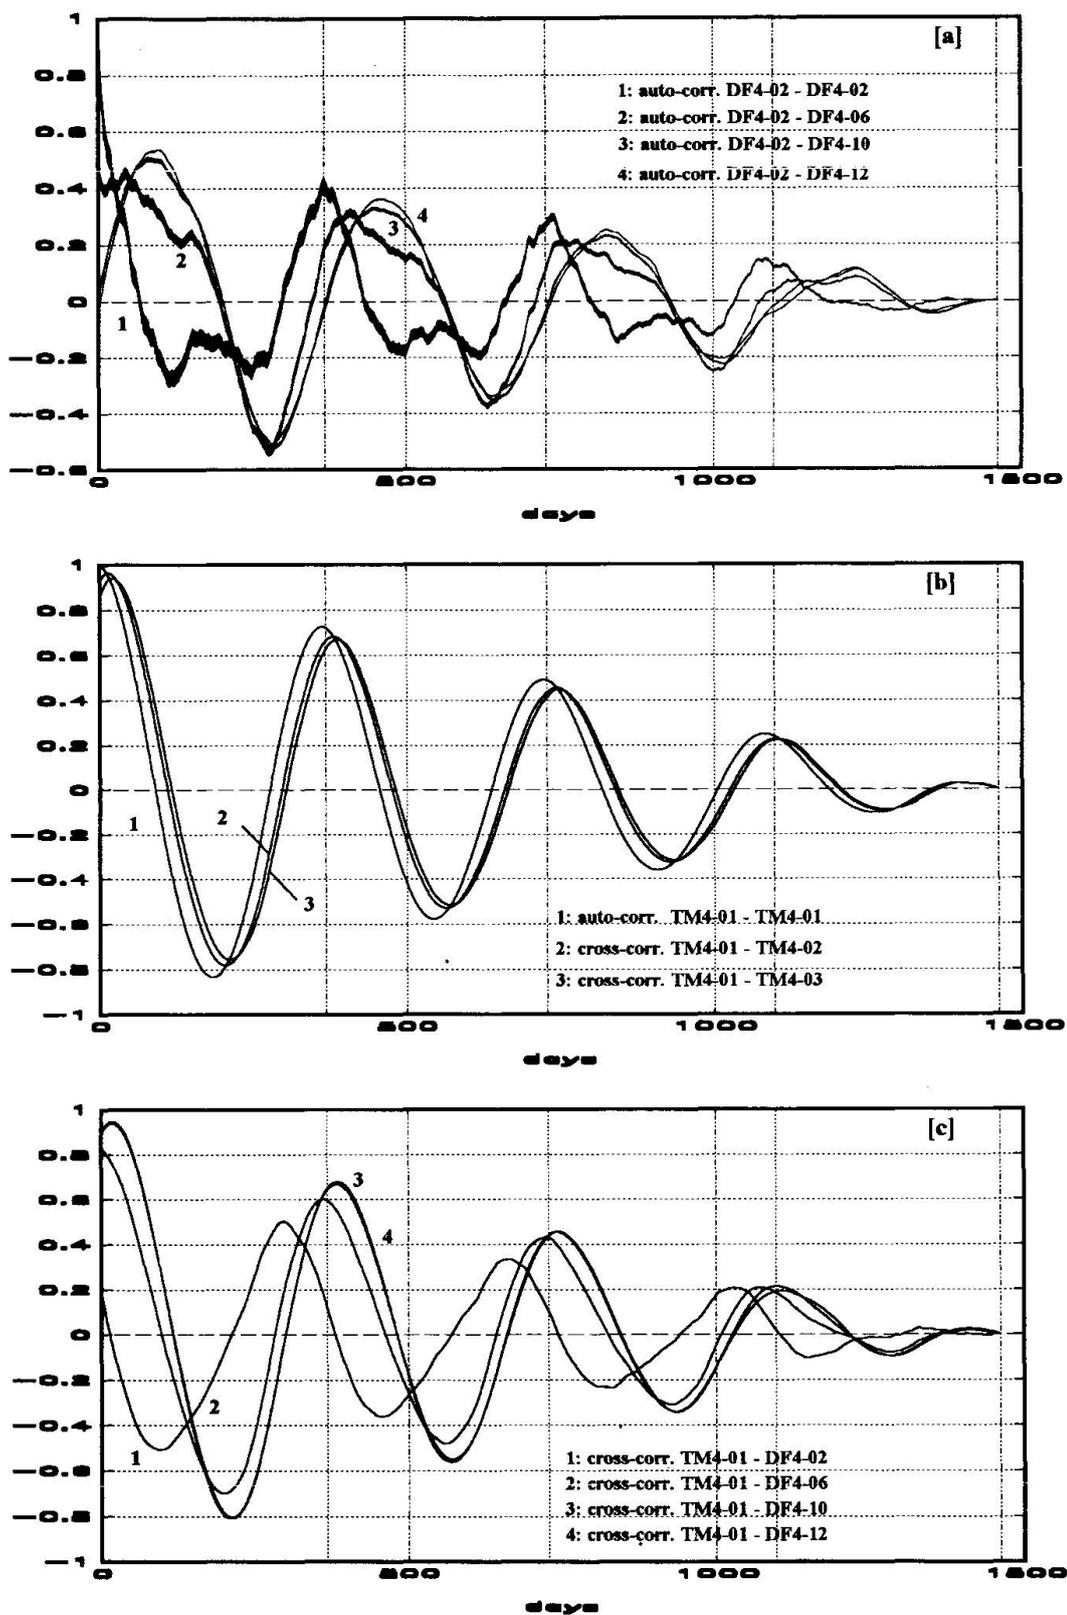
Figure 1: Correlation analyses on data recorded in web no. 4:  
 [a]: correlation between data recorded by deformers  
 [b]: correlation between data recorded by termometers  
 [c]: correlation between data recorded by termometers and deformers

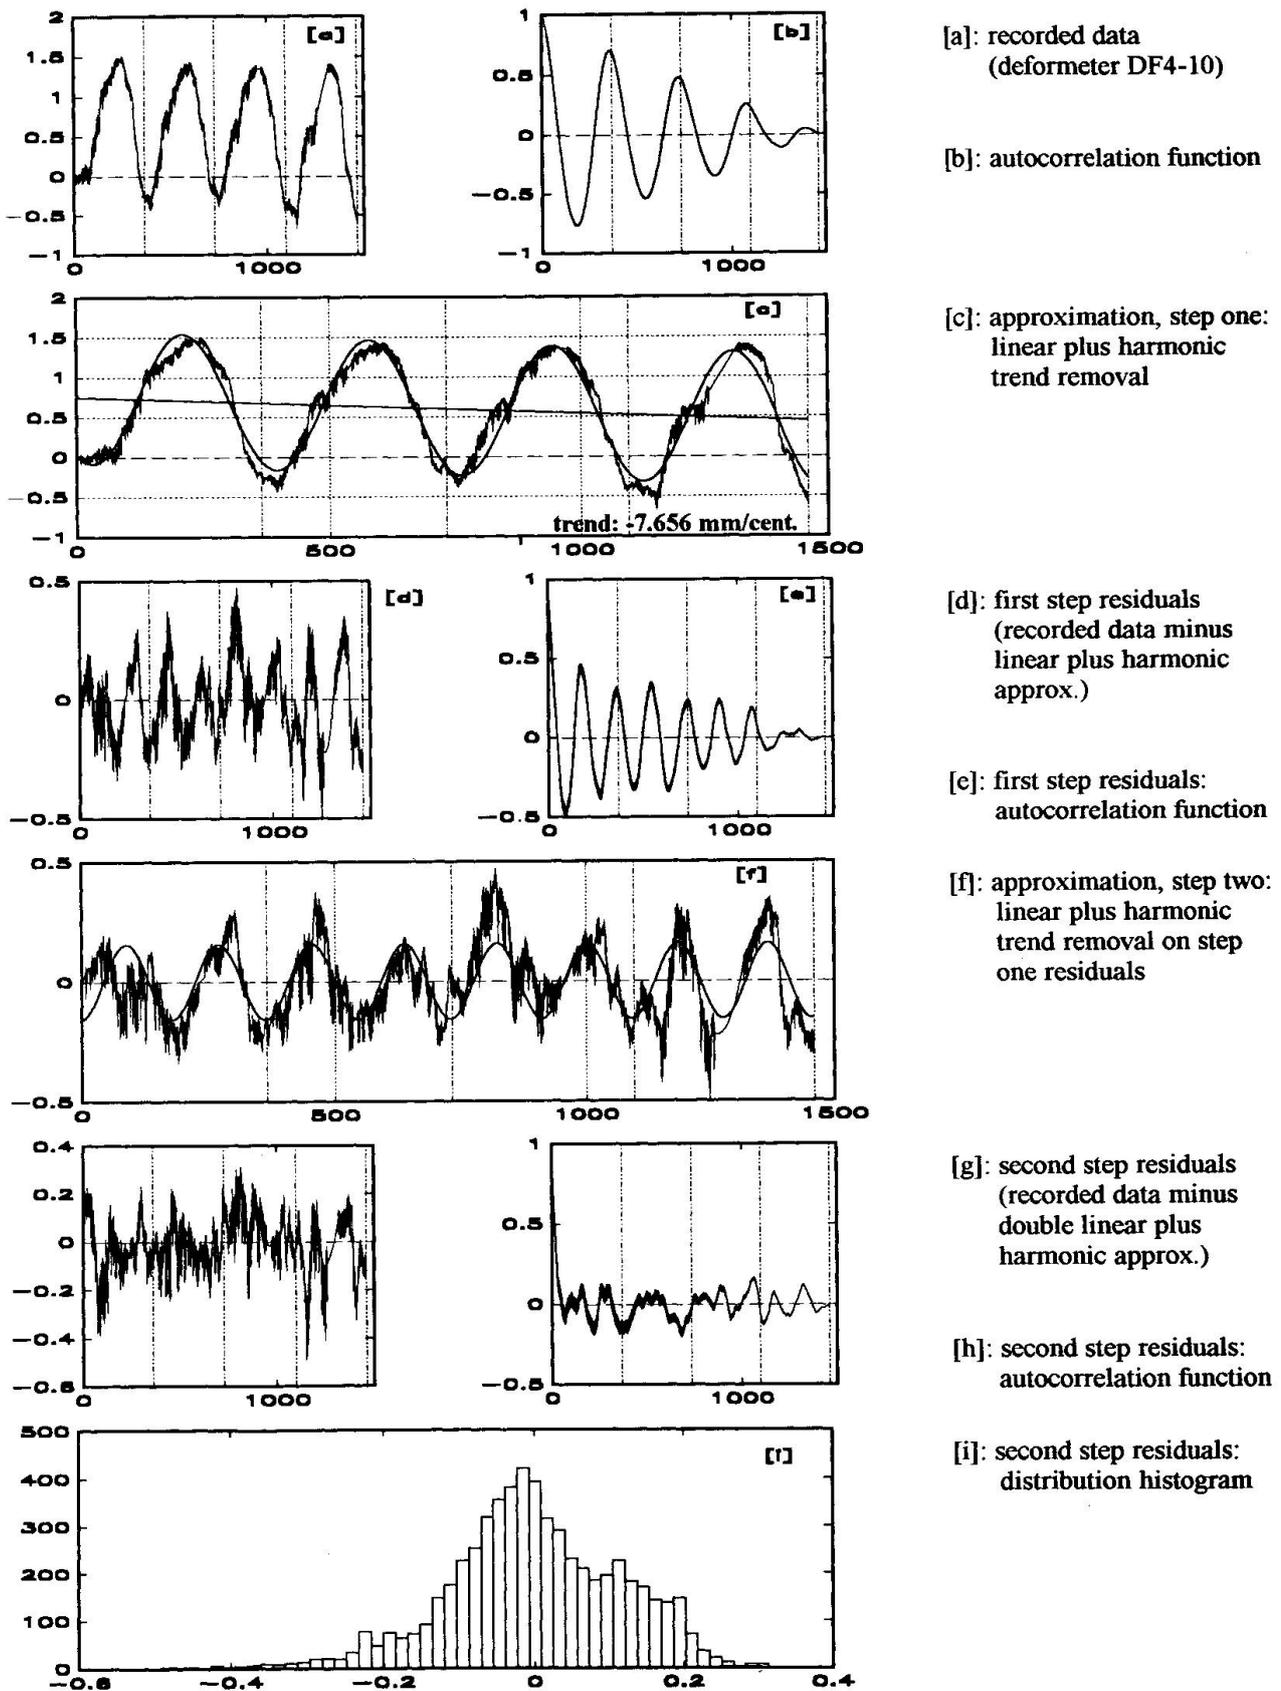
Figure 2: Trend removal procedure; application on data recorded by deformeter no. DF4-10 (web no. 4, internal dome, lower part [negative values=cracks opening])

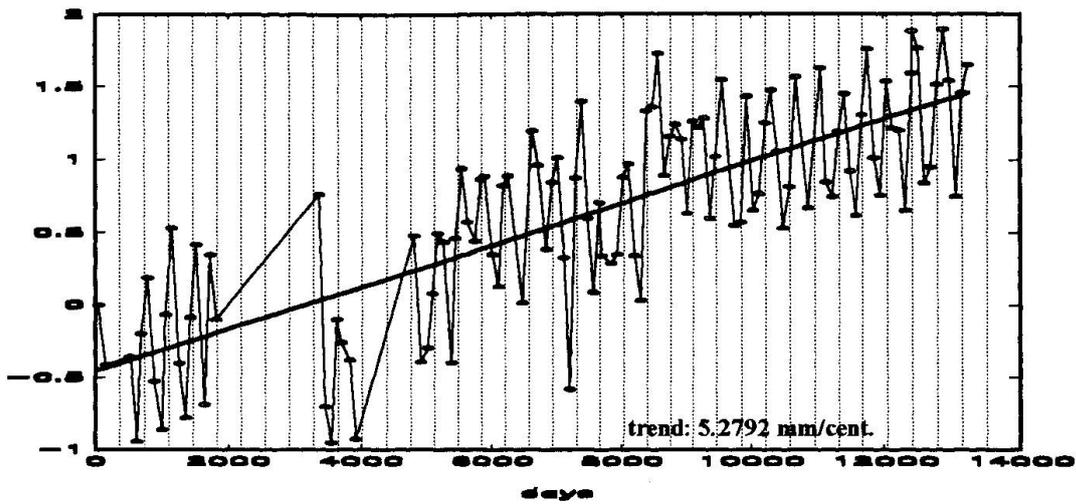
Figure 3: O.D. data (years 1956-1992), base no. 5: linear regression (values in mm [positive values=cracks opening])

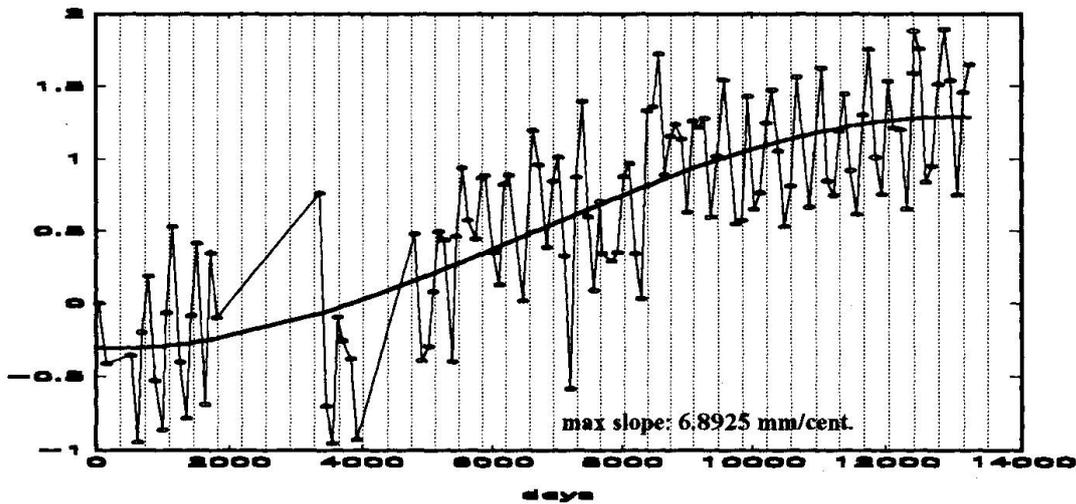
Figure 4: O.D. data (years 1956-1992), base no. 5: cubic regression (values in mm [positive values=cracks opening])

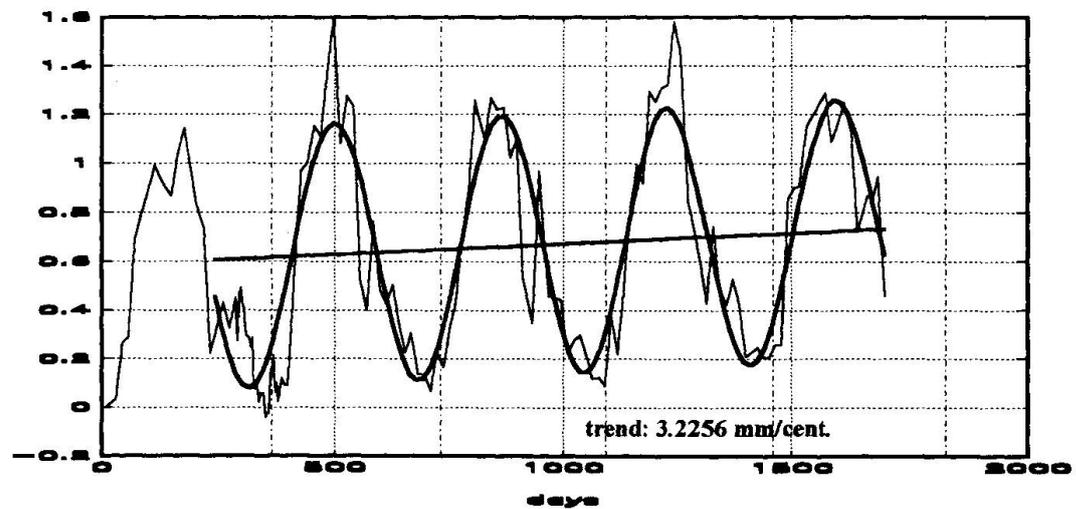
Figure 5: trend analysis of S.B.A.A. data (years 1956-1992), deformer no. 6, web no. 4: linear plus harmonic approximation (values in mm [positive values=cracks opening])

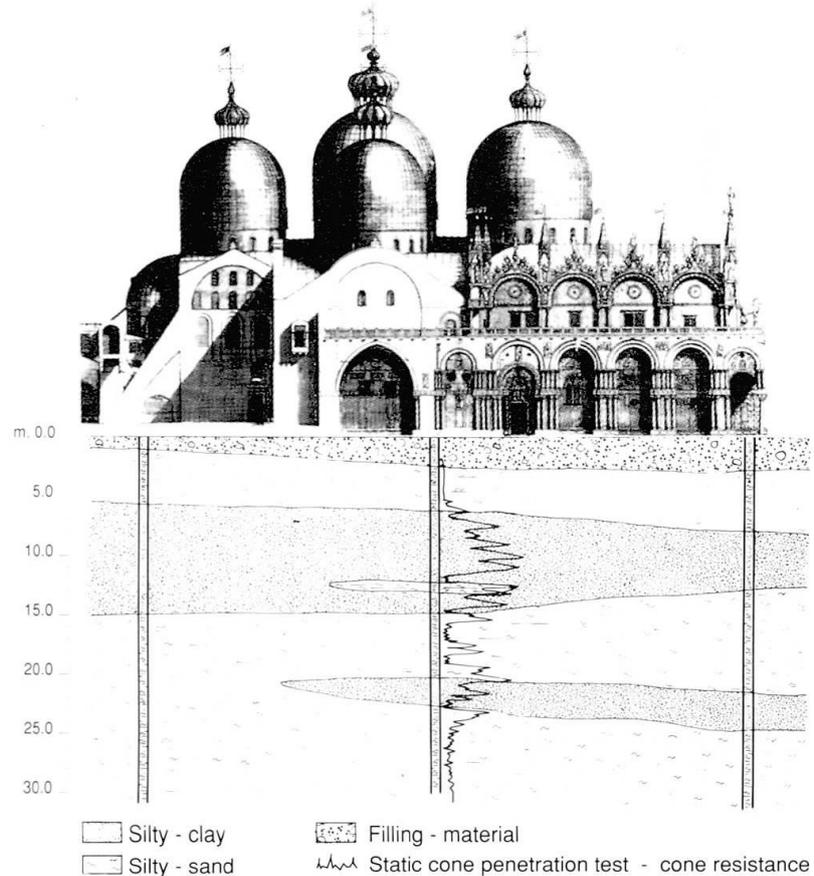
Fig. 2 - Stratigraphic profile along the North side of the Basilica. The results of static cone penetration tests are presented

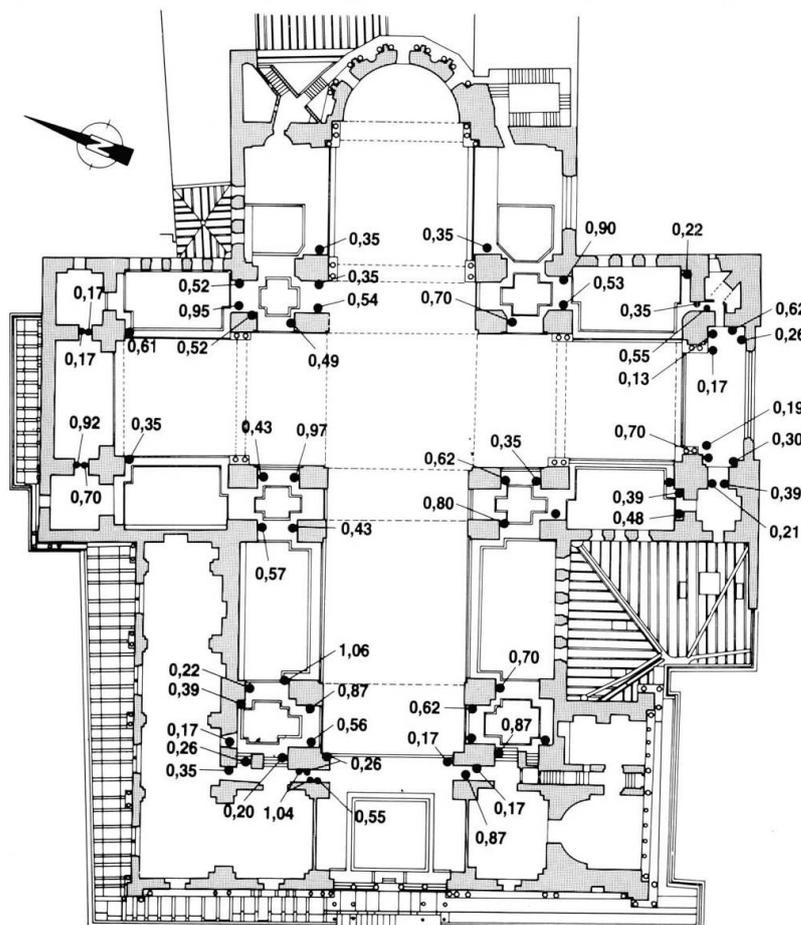
Fig. 8 - General lay-out of the flat-jack testing point with the indication of the measured states of stress

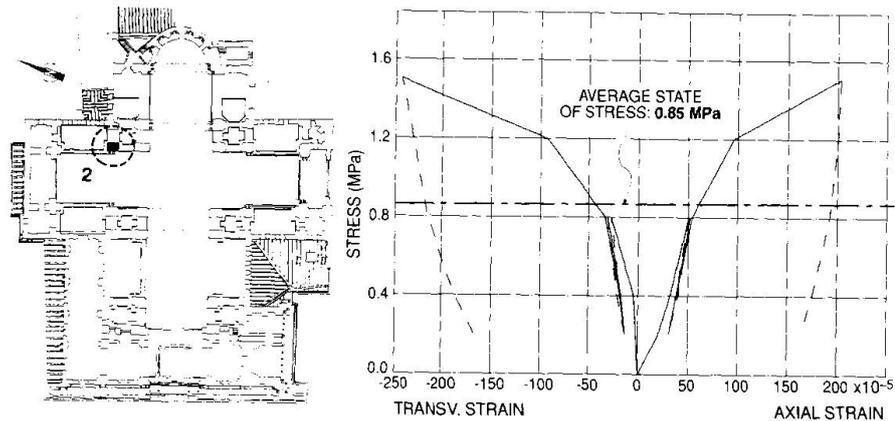
Fig. 9 - Stress-strain diagrams obtained by flat-jack tests on the pillar n. 2 with the indication of the measured state of stress
