**Zeitschrift:** IABSE reports = Rapports AIPC = IVBH Berichte  
**Band:** 70 (1993)

## Indirect Methods of Investigation for Evaluating Historic Masonry

### Fritz WENZEL

### Martin KAHLE

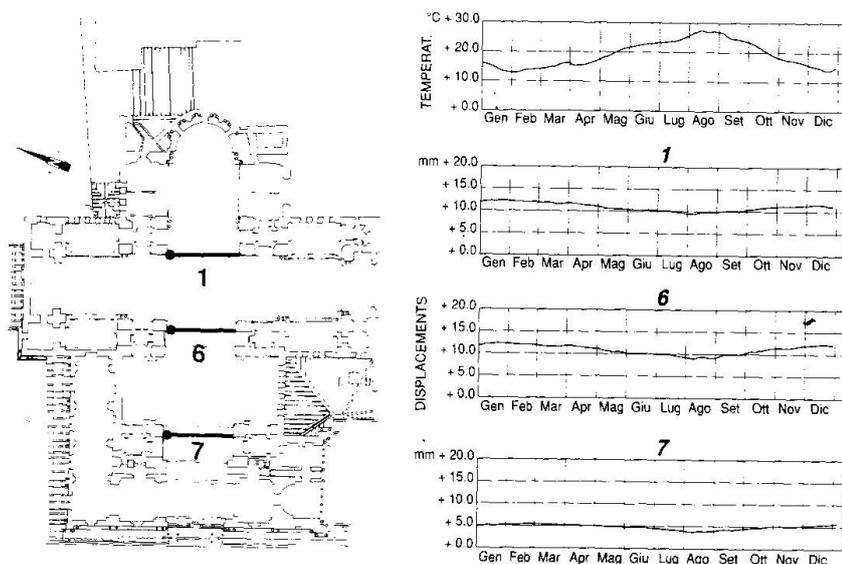
Fig. 10 - Diagrams of the relative horizontal displacements of some pillars during the first year of observation

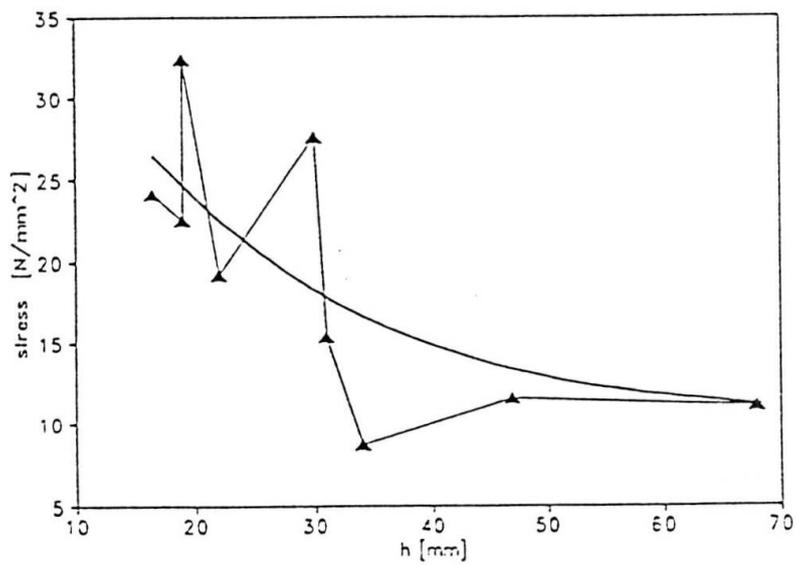
Fig. 1 - Strength as a function of the specimen height.

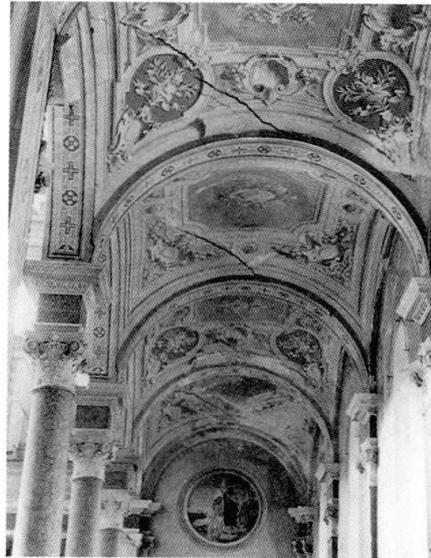
Fig. 3 - Fissures in the thin vaults of the side aisles.
