Diagnosis of Damage in a Wooden Vaulted Structure

Paola RONCA

The methodology adopted in the diagnostic phase to understand the causes of the static anomalies in the wooden vaulted roof of the 'Palazzo della Loggia' in Brescia is illustrated. The paper underlines the usefulness for a correct diagnostic engineering interpretation of a mutual exchange of information between numerical and experimental findings. In particular, the realistic description of the constitutive law of the structural elements - needed in the numerical analysis - has been based upon particular experimental tests.

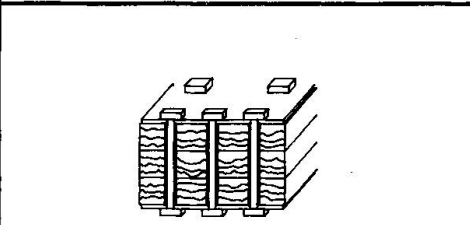
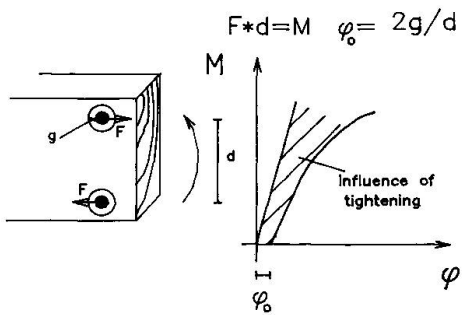
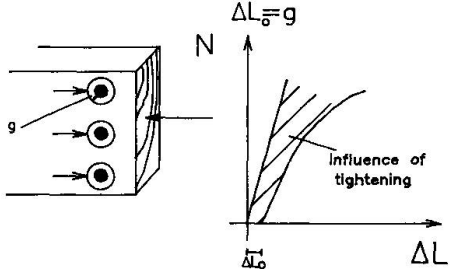
TABLE I

Structural head joint	Force of tightening	Influence of deformed holes of the bolts

<p>Section A-A</p>

<p>$F \cdot d = M \quad \phi_0 = 2g/d$</p>

<p>Section B-B</p>

<p>$\Delta L_0 = g$</p>

holes is summarized for a typical head joint. More discussion and analytical consideration about the influence of each cause on the local behaviour of the joint may be found in [4].

The maximum tightening force has been calculated such as the bolts on each head joint are able to transfer the axial force N by friction. According with Coulomb friction law and assuming the value of 0.35 for the friction angle, the maximum tightening force, in the case of an axial force N of about 7,000 Kg, must be equal to 700 Kg on each bolts ($N/3$ on the single lumber, see table I).

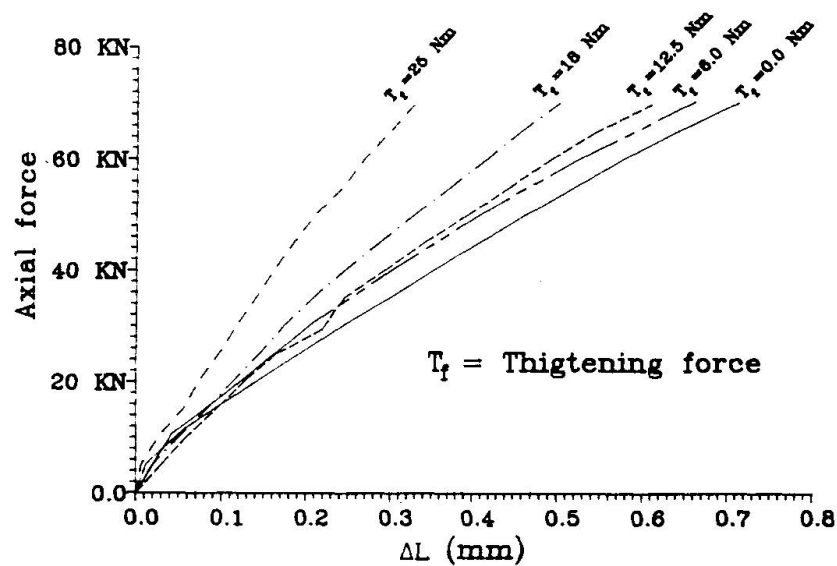
Fig.10 P- ΔL experimental behaviour
for different tightening force

bolts ($g=0$ in table I). The figure 10 shows the behaviour of the element loaded by an increasing axial load centered at the two ends of the element (as shown in fig.8). Each curve represents the P- ΔL behaviour for a definite tightening action. The diagram for the highest value of tightening is linear elastic; in this case the maximum axial deformation of the element is of the same order of an equal monolytical wood element ($\Delta L_{exp}=0.3$ mm, $\Delta L_{mon.}=0.24$ mm). In the other cases of less tightening forces, it has possible to read from the shape of the diagrams an initial minor rigidity due, probably, to local deformation of the wood subject to the pressure of the bolts.

As mentioned we refer here just on a first series of results, as a part of a more comprehensive investigation. In any case on the basis of these experimental results it is possible to make a first quantitative hipotesis on the influence of the tightening action on the deformability of the basic element of the arch. As a constitutive non linear elastic law of the element, such results have been implemented in the numerical analysis of the principal arch. The figure 11 shows the deformed shape of the arch in the case of $T_r=700$ and $T_r=0$ (referred to the moment of the torquemeter $T_r=25$ Nm and $T_r=0$ respectively).
