Diagnosis of Damage in a Wooden Vaulted Structure

Paola RONCA

Assoc. Professor
Politecnico di Milano
Milan, Italy

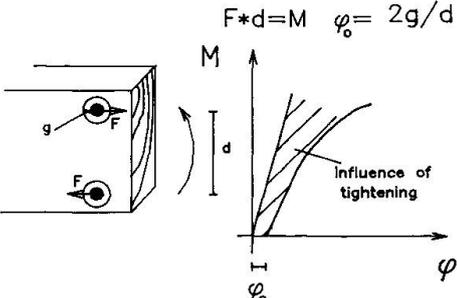
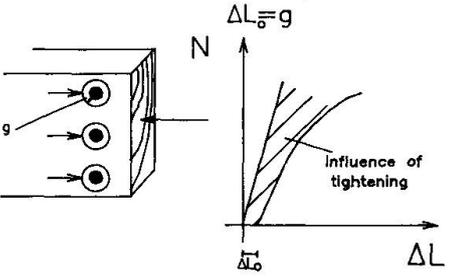
TABLE I

Probably all these causes occur, the combination of which determines the actual flexural and axial rigidity of the joints and is responsible of the weakness of the structure. In table I the influence on the constitutive law of the tightening action, together with the probably non calibrated size of the

Structural head joint	Force of tightening	Influence of deformed holes of the bolts

holes is summarized for a typical head joint. More discussion and analytical consideration about the influence of each cause on the local behaviour of the joint may be found in [4].

The maximum tightening force has been calculated such as the bolts on each head joint are able to transfer the axial force N by friction. According with Coulomb friction law and assuming the value of 0.35 for the friction angle, the maximum tightening force, in the case of an axial force N of about 7,000 Kg, must be equal to 700 Kg on each bolts ($N/3$ on the single lumber, see table I).

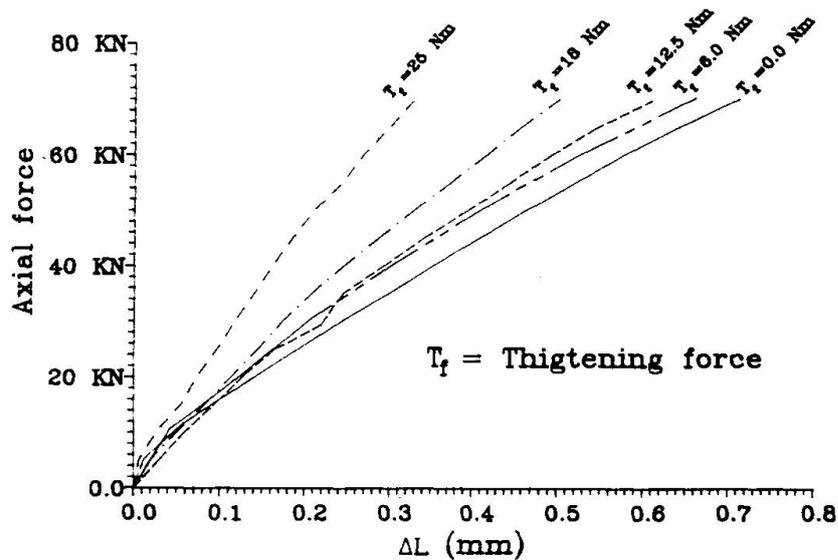
Fig.10 P- ΔL experimental behaviour for different tightening force

bolts ($g=0$ in table I). The figure 10 shows the behaviour of the element loaded by an increasing axial load centered at the two ends of the element (as shown in fig.8). Each curve represents the P- ΔL behaviour for a definite tightening action. The diagram for the highest value of tightening is linear elastic; in this case the maximum axial deformation of the element is of the same order of an equal monolytical wood element ($\Delta L_{exp} = 0.3$ mm, $\Delta L_{mon.} = 0.24$ mm). In the other cases of less tightening forces, it has possible to read from the shape of the diagrams an initial minor rigidity due, probably, to local deformation of the wood subject to the pressure of the bolts.

As mentioned we refer here just on a first series of results, as a part of a more comprehensive investigation. In any case on the basis of these experimental results it is possible to make a first quantitative hipotesis on the influence of the tightening action on the deformability of the basic element of the arch. As a constitutive non linear elastic law of the element, such results have been implemented in the numerical analysis of the principal arch. The figure 11 shows the deformed shape of the arch in the case of $T_r=700$ and $T_r=0$ (referred to the moment of the torquemeter $T_r=25$ Nm and $T_r=0$ respectively).
