Zeitschrift: IABSE reports = Rapports AIPC = IVBH Berichte

Band: 70 (1993)

Rubrik: Posters: session 2

Posters - Session 2

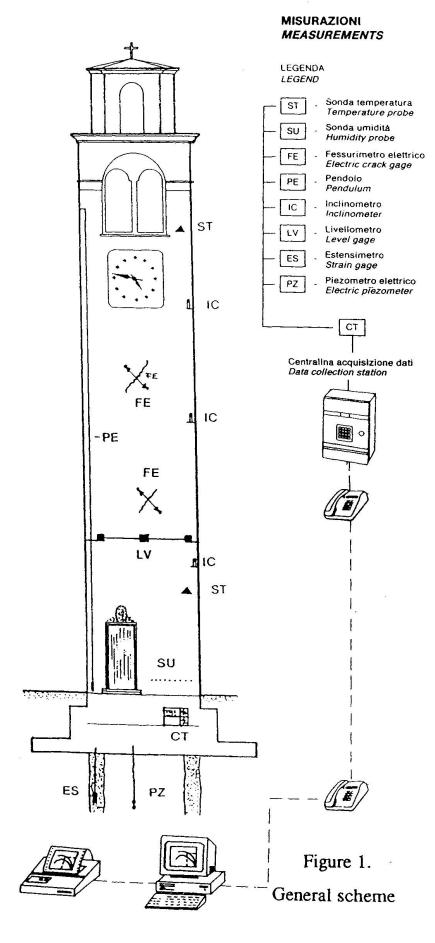
In the example (Figure 1) we examine the actual possibilities to control a church tower. Transducers continuously measure the variations of: width of cracks, temperature, moisture content, global and partial verticality, stresses, strains, relative displacements. All the transducers are connected to a central controller that by modem release actual values of measured parameters.

This arrangement of instrumentation allows to evaluate the evolving of deterioration in the time and also to study the importance of the cyclic variation of temperature and moisture content of the walls and foundations.

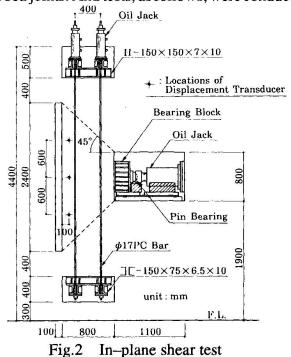
Fig.1 In-plane flexural test

- a. In-plane flexureal and shear tests of the walls (Fig.1 and 2);
- b. Double shear tests on cubes loaded parallel to the horizontal joints (Fig. 3);
- c. Compressive tests on cubes loaded perpendicular to the horizontal joints; and
- d. Compressive, splitting and modulus of rupture tests on individual bricks

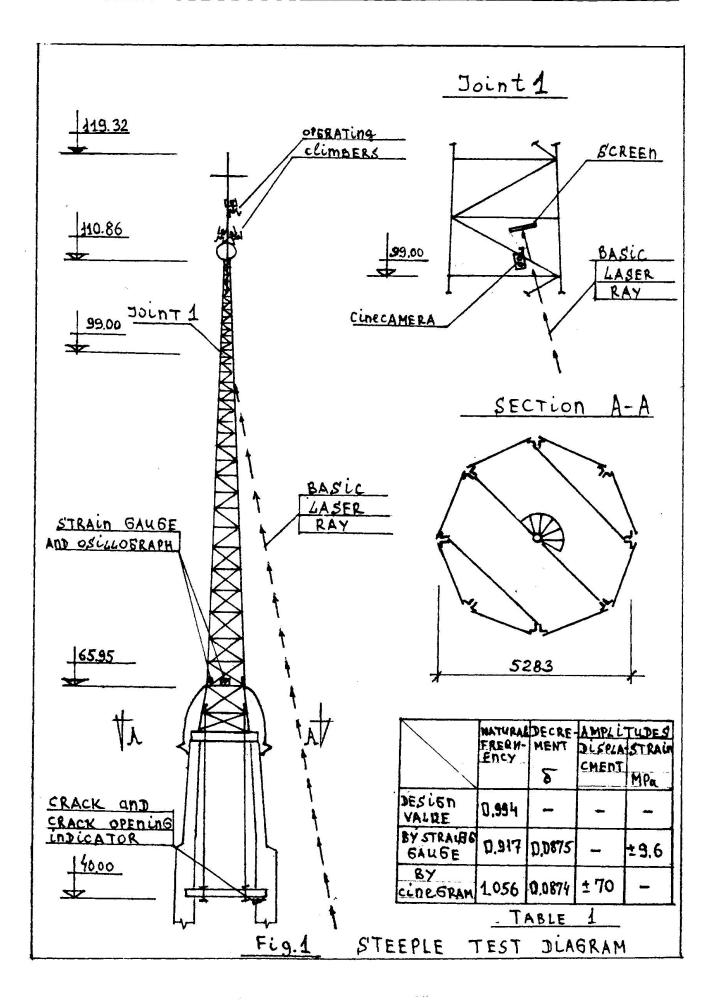
The dynamic loading tests of the steeple structures were performed for experimental determination of the following:

- natural frequency of the first mode of oscillation and its comparison with the design mode;
- decrement of oscillation for calculation of dynamic forces;
- values of the revealed crack;
- an oscillograph and a cinecamera started working simultane-ously with the radio command. The tests were performed eight times.

The diagram of the tests is shown in Fig. 1. The results are presented in Table 1.

In the cracked area at an elevation of 40.0 m, vertical displacement was recorded of the steel supporting beam relative to the brick masonry with an amplitude of \pm 0.01 mm at a maximum amplitude of the steeple 70 mm at an el. of + 115.0.
