**Zeitschrift:** IABSE reports = Rapports AIPC = IVBH Berichte  
**Band:** 70 (1993)

**Rubrik:** Posters: session 2

## **Posters - Session 2**

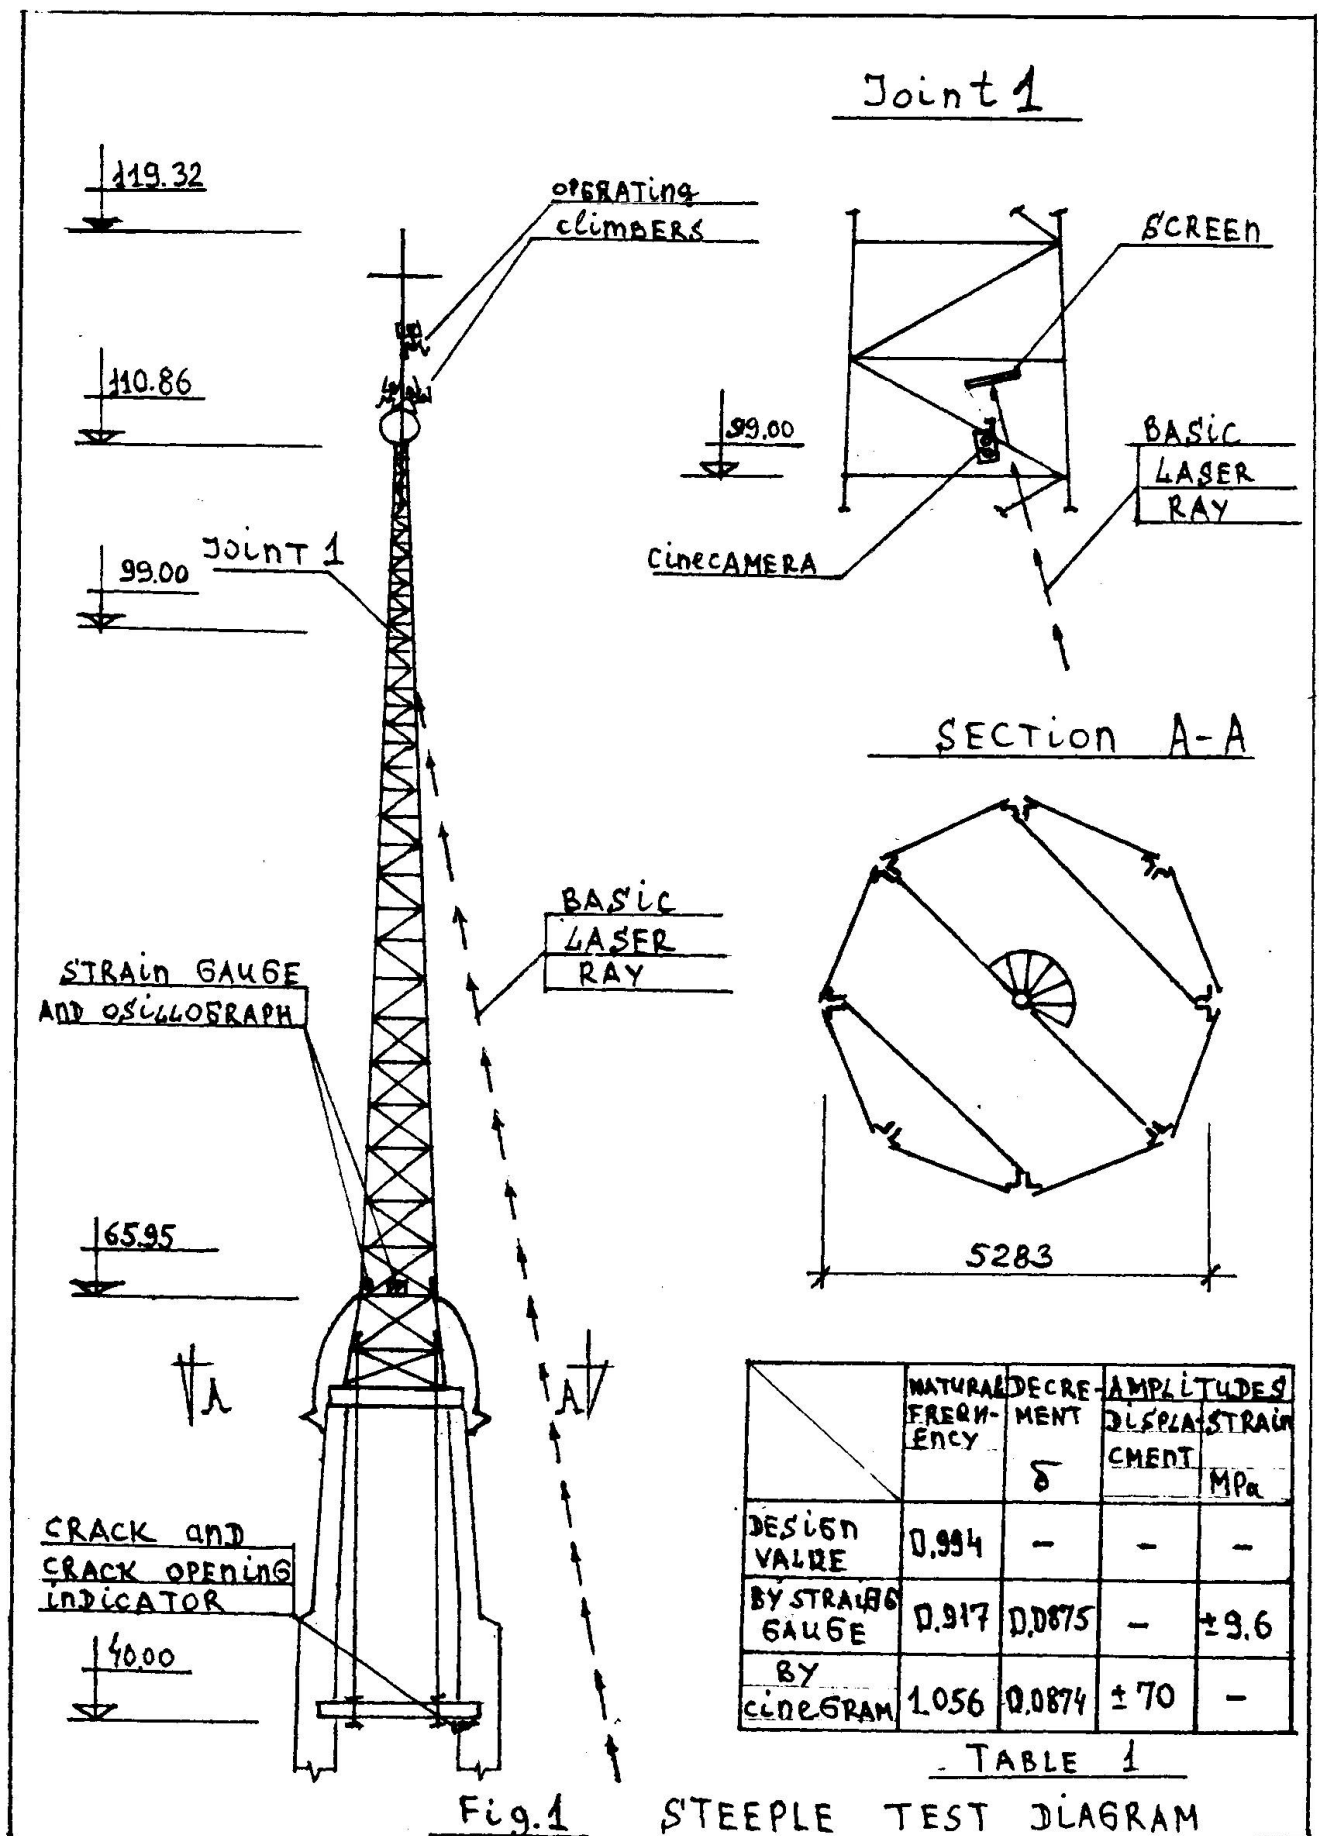
In the cracked area at an elevation of 40.0 m, vertical displacement was recorded of the steel supporting beam relative to the brick masonry with an amplitude of  $\pm 0.01$  mm at a maximum amplitude of the steeple 70 mm at an el. of + 115.0.

The diagram of the tests is shown in Fig. 1. The results are presented in Table 1.
