Zeitschrift: IABSE reports = Rapports AIPC = IVBH Berichte
Band: 70 (1993)

Rubrik: Posters: session 2

Posters - Session 2

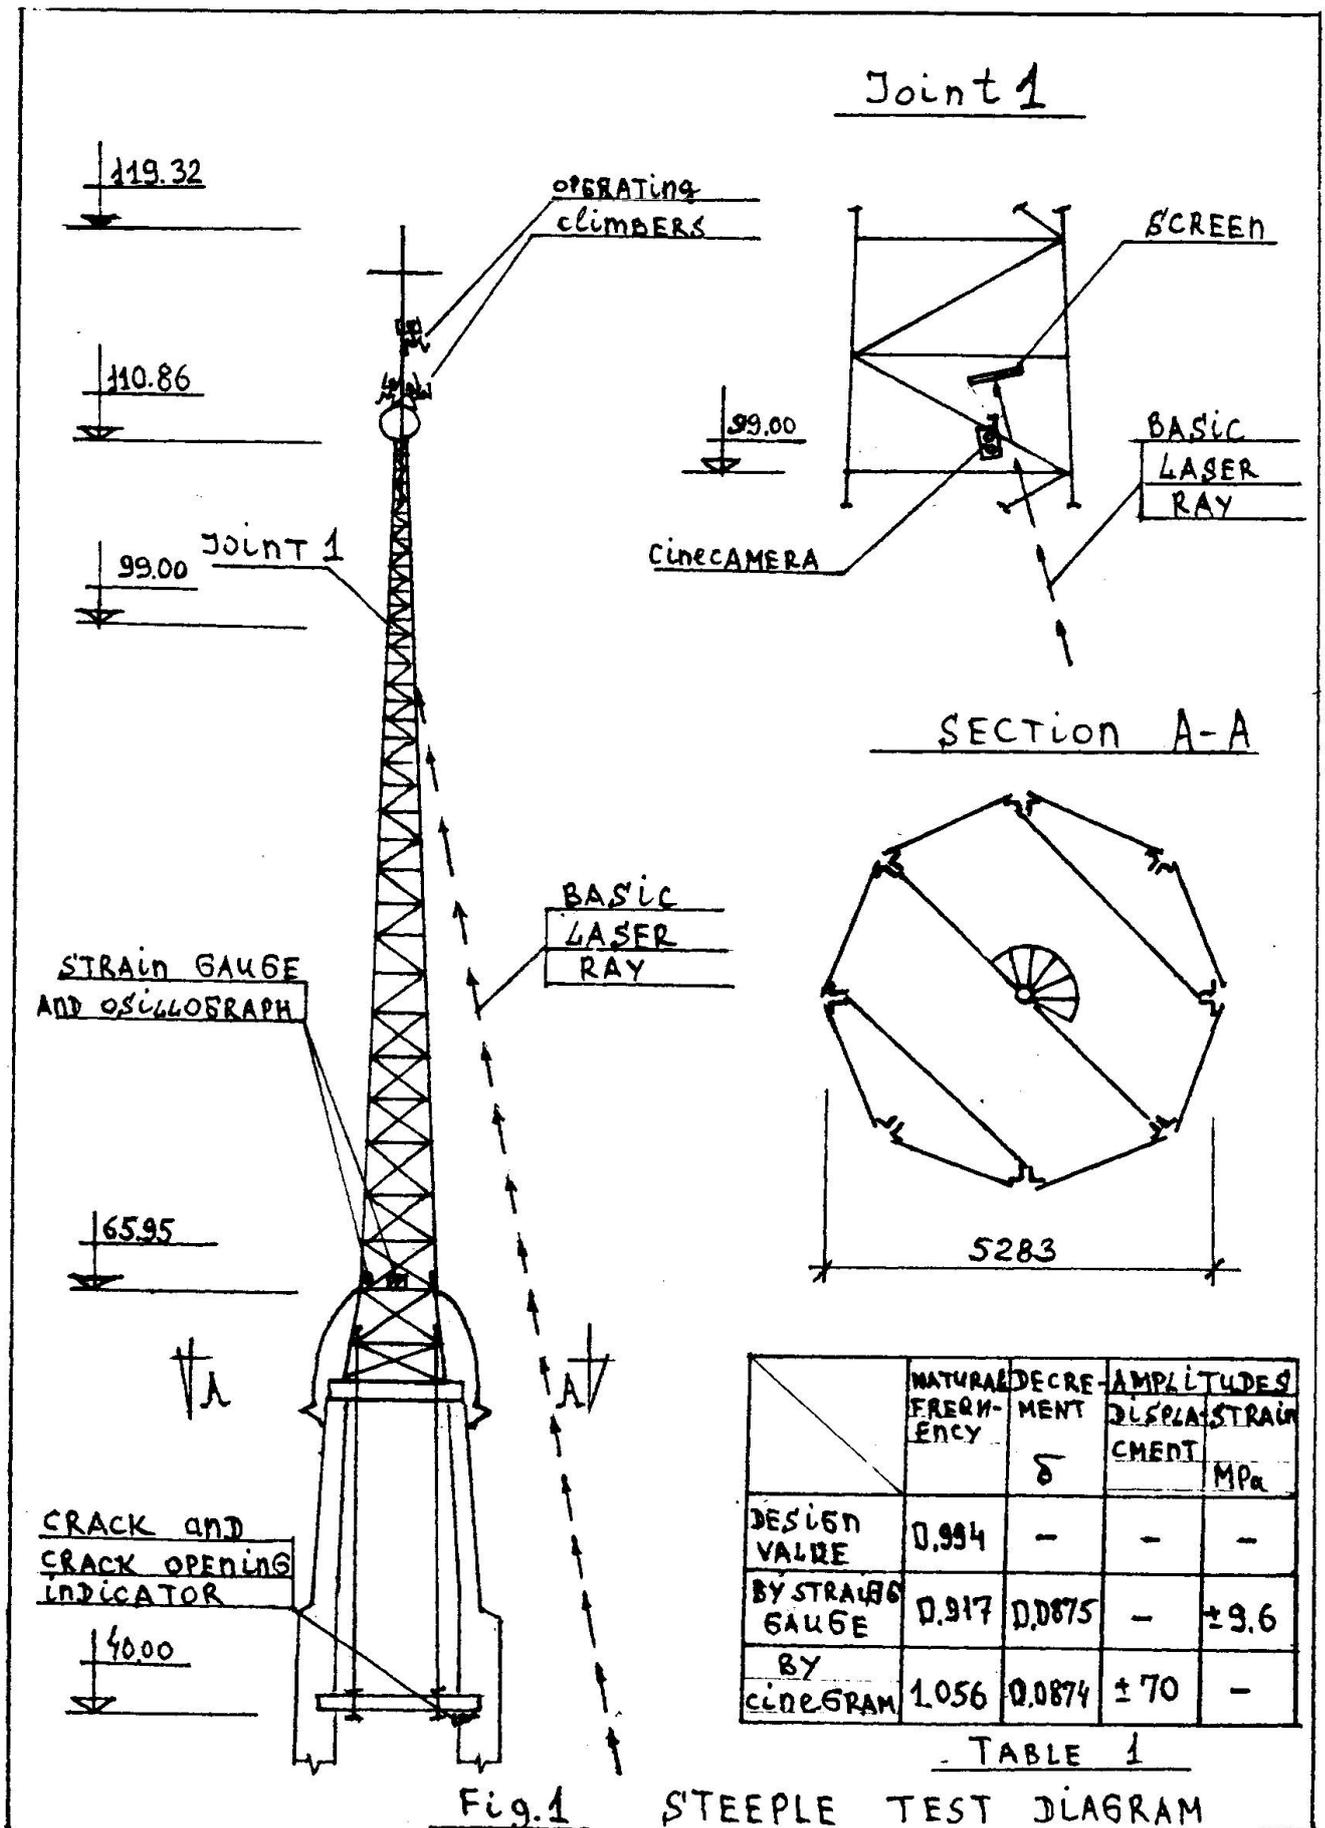
In the cracked area at an elevation of 40.0 m, vertical displacement was recorded of the steel supporting beam relative to the brick masonry with an amplitude of ± 0.01 mm at a maximum amplitude of the steeple 70 mm at an el. of + 115.0.

The diagram of the tests is shown in Fig. 1. The results are presented in Table 1.
