Zeitschrift: IABSE reports = Rapports AIPC = IVBH Berichte
Band: 70 (1993)

Rubrik: Posters: session 2

Automatic Monitoring of Buildings Deterioration

Strength Assessment of a Brick Masonry Building of 1895

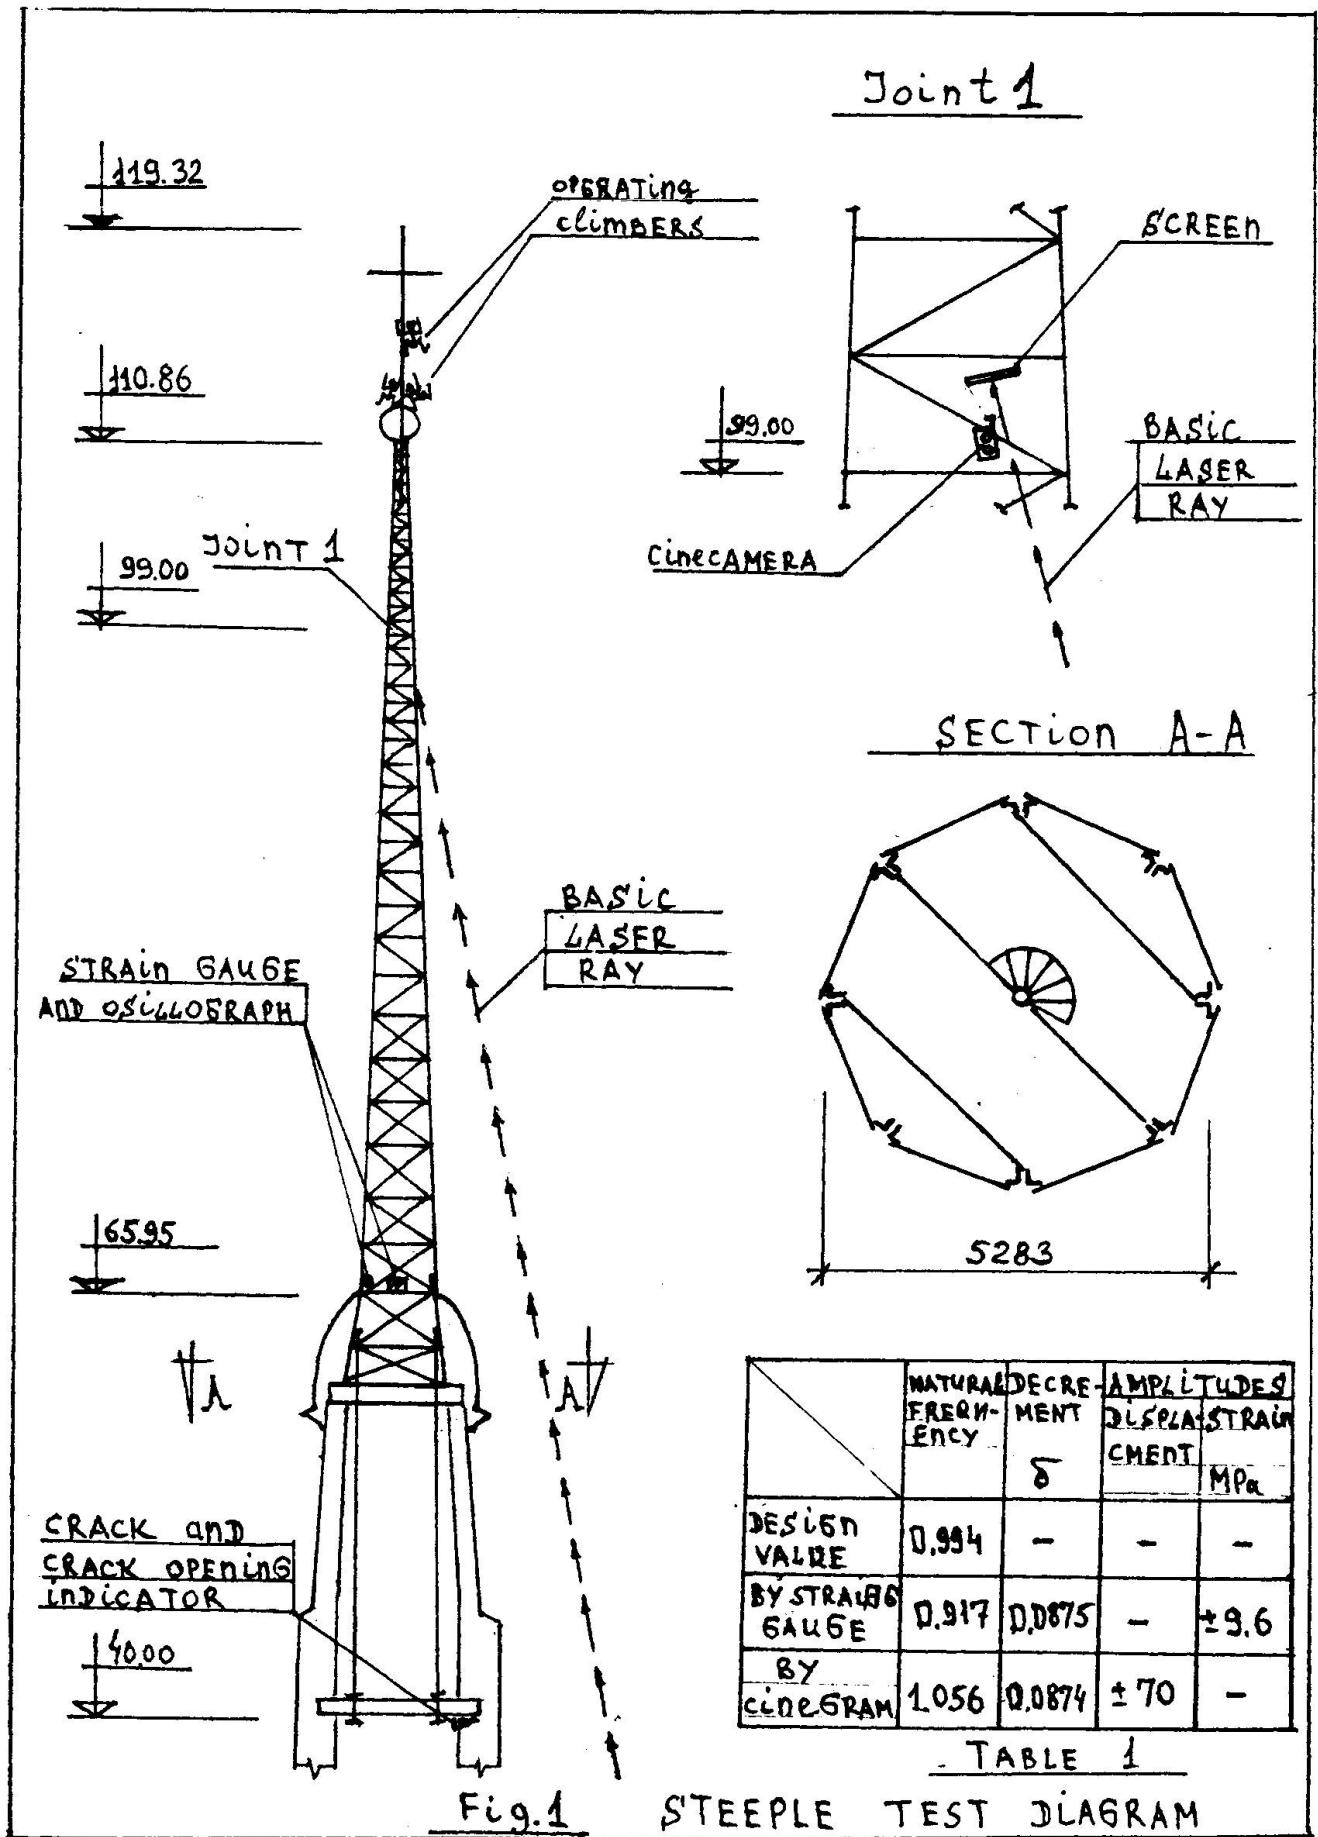
In the cracked area at an elevation of 40.0 m, vertical displacement was recorded of the steel supporting beam relative to the brick masonry with an amplitude of ± 0.01 mm at a maximum amplitude of the steeple 70 mm at an el. of + 115.0.

The diagram of the tests is shown in Fig. 1. The results are presented in Table 1.
