Survey of Statical Conditions of Churches in Rome

Marco MENEGOTTO

Sergio TREMI PROIETTI

In this context, the writers have been commissioned by the Ministry of Public Works to undertake surveys and investigations on the statical conditions of three main basilicae in the heart of Rome: St. Augustine's, St. John of the Florentines' and the Gesù.

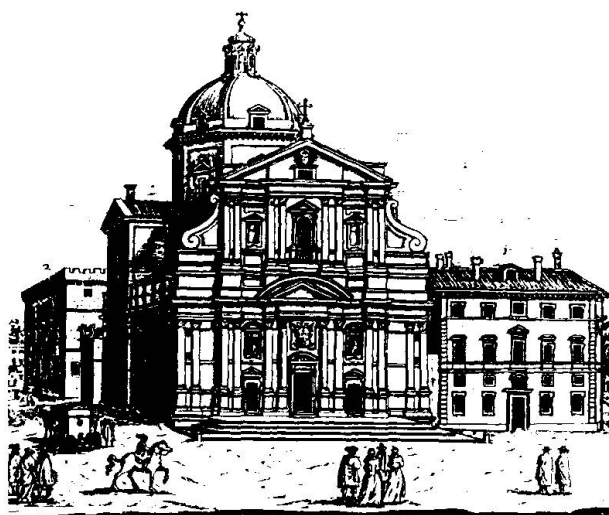
St John of the Florentines' was built by the state of Florence in the beginnings of the 16th Century and completed in the following, involving several of the most important architects of the time. It lies on the Tiber left bank, opposite the Vatican. A large foundation plate was built into the river bed, then without embankments (see the engraving), giving the church a length appropriate to its importance.

Subsequent architects chose different layouts among centric and longitudinal plans, while construction was going on. Finally, the longitudinal scheme prevailed with A. da Sangallo. Some older structures were incorporated such as those of a chapel; but they are not on the same plate as the church and may suffer differential settlements, also due to the high changes in water level of the nearby river.

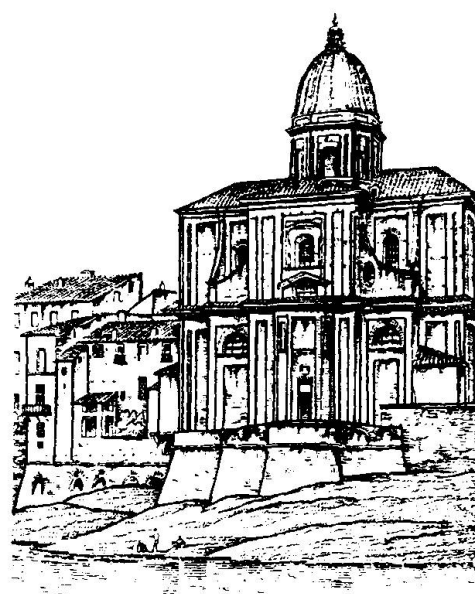
The dome is low, not to impose upon the view of the façade; it had masonry ribs also on the inner face, that were demolished in the 17th century for frescoing the ceiling (a report says that the masonry of the vault was *good and strong*, needing no ribs!).
