**Artikel:** Survey of statical conditions of churches in Rome  
**Autor:** Menegotto, Marco / Tremi Proietti, Sergio  
**DOI:** <https://doi.org/10.5169/seals-53305>

## Survey of Statical Conditions of Churches in Rome

In this context, the writers have been commissioned by the Ministry of Public Works to undertake surveys and investigations on the static conditions of three main basilicae in the heart of Rome: St. Augustine's, St. John of the Florentines' and the Gesù.

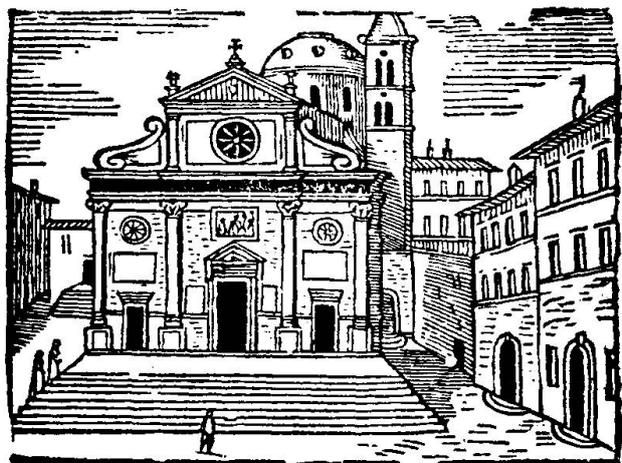
In 18th century, the structure was in bad shape, with severe cracks in the central part, including the drum

sustaining the dome. Then, L. Vanvitelli completely renovated it, consolidating all foundations, dismantling the whole dome and replacing the old bell-tower (both still appearing in the engraving).

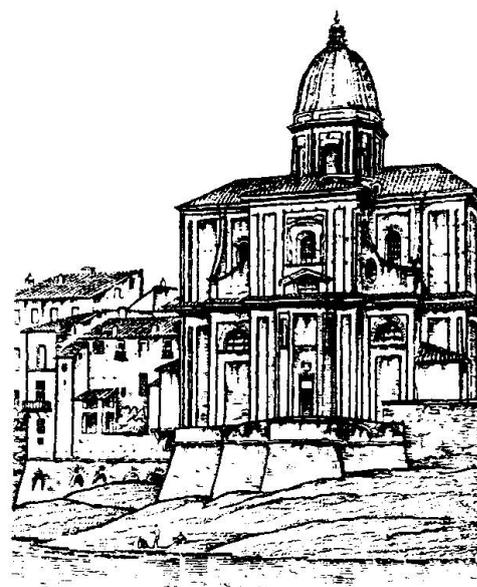
**St John of the Florentines'** was built by the state of Florence in the beginnings of the 16th Century and completed in the following, involving several of the most important architects of the time. It lies on the Tiber left bank, opposite the Vatican. A large foundation plate was built into the river bed, then without embankments (see the engraving), giving the church a length appropriate to its importance.
