Artikel: Survey of statical conditions of churches in Rome

Survey of Statical Conditions of Churches in Rome

In this context, the writers have been commissioned by the Ministry of Public Works to undertake surveys and investigations on the statical conditions of three main basilicae in the heart of Rome: St. Augustine's, St. John of the Florentines' and the Gesù.

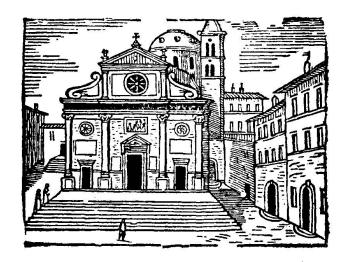
In 18th century, the structure was in bad shape, with severe cracks in the central part, including the drum

sustaining the dome. Then, L.Vanvitelli completely renovated it, consolidating all foundations, dismantling the whole dome and replacing the old bell-tower (both still appearing in the engraving).

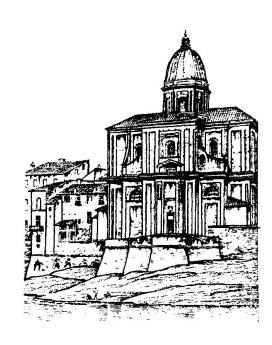
St John of the Florentines' was built by the state of Florence in the beginnings of the 16th Century and completed in the following, involving several of the most important architects of the time. It lies on the Tiber left bank, opposite the Vatican. A large foundation plate was built into the river bed, then without embankments (see the engraving), giving the church a lenght appropriate to its importance.

Subsequent architects chose different layouts among centric and longitudinal plans, while construction was going on. Finally, the longitudinal scheme prevailed with A. da Sangallo. Some older structures were incorporated such as those of a chapel; but they are not on the same plate as the church and may suffer differential settlements, also due to the high changes in water level of the nearby river.

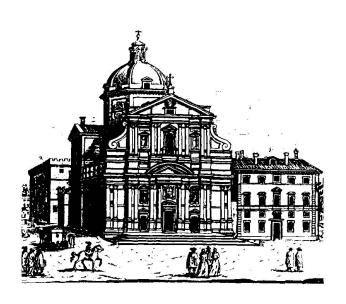
The Gesù (the Holy Name of Jesus'), Mother-Church of the Society of Jesus, is perhaps the most important Renaissance church in Rome. A small chapel, S. Maria della Strada, assigned to the Society on the site, was soon demolished, yielding place to the new majestic architecture. Several designs were examined,

including Michelangelo's, implying various positions, before the actual one by G. Della Porta was agreed upon, its façade rising in front of the *Papal Street* and chancel in the place of the former chapel.
