**Artikel:** Structural aspects in restoring monuments

Autor: Croci, Giorgio

## Structural Aspects in Restoring Monuments

Giorgio CROCI Prof. Univ. 'La Sapienza' Rome, Italy

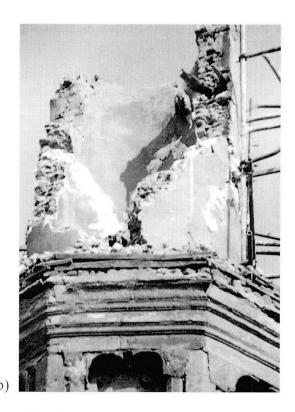
Fig. 7 Minarets in Cairo: weakness (a) and slenderness (b), often worsened by out-of-plomb

Another "reversible" intervention has been proposed for the reinforcement of some leaning minarets in Cairo, where six prestressed vertical cables will be placed along the interior perimeter, only creating small holes to cross the steps (figure 7).

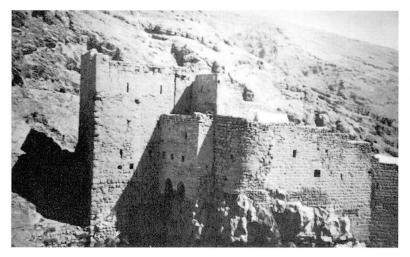
Fig. 11 Monastry of Mar Mousa in Siria: deteroration of the masonry and dangerous disintegration of the stone basement

In some situations, such as the Monastry of Mar Mousa in Syria (figure 11) deterioration is so high that it will be very difficult to reduce the risks to a level that a modern society requires using ancient technologies alone, especially regarding the precarious conditions of the foundations.

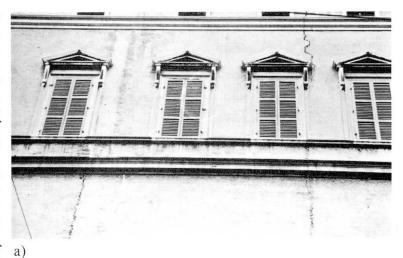
Fig. 12 The Ducal Palace of Modena: relevant cracks in the walls due to soil settlements (a), special device for cutting walls (b) and the realization of joints (c)

The Ducal Palace of Modena (figure 12) was affected by significant subsidence phenomena. Fifteen years ago the problem was solved by making vertical cuts in the Palace following the main cracks in the walls, the movement joints that have been thus created allow the building to follow the soil settlements without further relevant stresses or cracking to the structure. The result has been completely satisfactory.

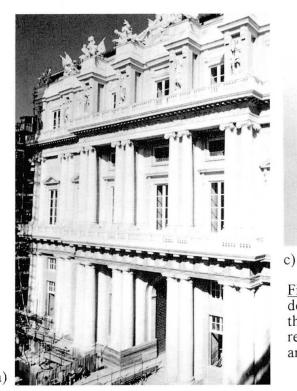
13 The Ducal Pala

Fig. 13 The Ducal Palace of Genoa: the outward deformation of the façade (a) created by a loss in the curvature of the voult (b); the intervention (c) realized the connection between the opposite walls and support by means of springs (d) to the vault

The Ducal Palace of Genoa (figure 13) suffered from foundation deformations that affected the main facade creating a loss of curvature in the main vault of the salon; the problem required the creation of an efficient connection between the opposite façades and the assurance of the stability of the vault. This was resolved by the placing of a steel arched beam, placed between the vault and the roof. This arched beam works simultaneously as a tie between the walls (for this reason an appropriate stiffness is required) and as a support for the vault by means of a) small connecting rods. A monitoring system, installed for a year, checked the intervention and particularly the stresses in the connecting rods; the results showed important thermal effects which lead to the replacement of the rods with springs, in order to maintain a constant supporting force. The monitoring system has been thus not only a way of control, but also a support for the final design.

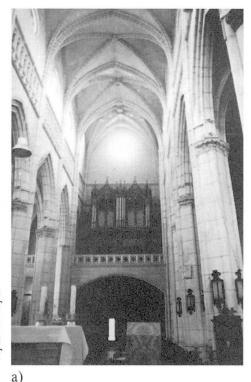
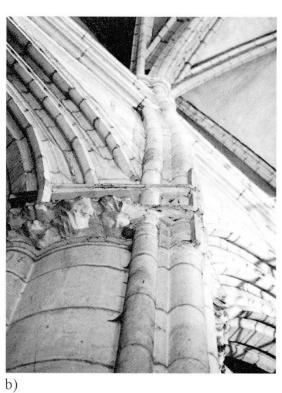
Fig. 17 The Cathedral of Vitoria in Spain (a) and the huge deformations of the columns (b)

We want to mention, finally, that new technology can be very useful when the recovery of a deformation or out-of-plumb is required A system of jacks connected with a monitoring system, is currently being used while work is in progress on the foundations of the St. Michael Palace in Rome. A similar system is used to control the archeological excavation works beneath the foundations of small houses built centuries ago over the roman amphitheatre of Ancona (figure 16): a serie of provisonial steel elements created under the foundations, step by step, allow the progression of the excavation before choosing the final solution. In the Cathedral of Vitoria in Spain (figure 17)

provisional steel elements connected to a monitoring system are going to be used to recover the huge deformations created by ancient soil settlements.

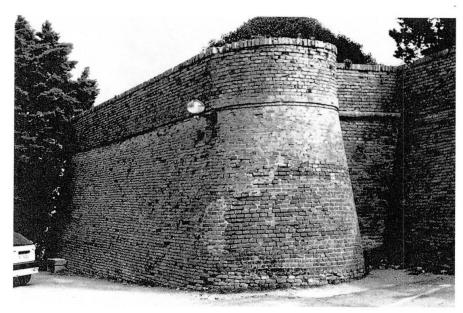
<u>Fig. 19</u> A view of the Urbino walls (a), a collapsed zone where it is possible to see the poor condition of the masonry (b, c)

A similar problem is posed in the restoration of the historical walls of Urbino (figure 19), largely damaged and with a part that has recently collapsed. Calculations following the usual Code on the retaining walls show that the earth pressures are higher than the Urbino walls are capable of supporting; the designers and administrators have been left with a difficult choice, between accepting lower safety levels, thereby breaking the law carrying out interventions that will presumably be stronger than substantially necessary thus modifying the original conception
