Zeitschrift: IABSE reports = Rapports AIPC = IVBH Berichte
Band: 70 (1993)

Artikel: Structural aspects in restoring monuments
Autor: Croci, Giorgio
DOI: <https://doi.org/10.5169/seals-53277>

Structural Aspects in Restoring Monuments

Giorgio CROCI

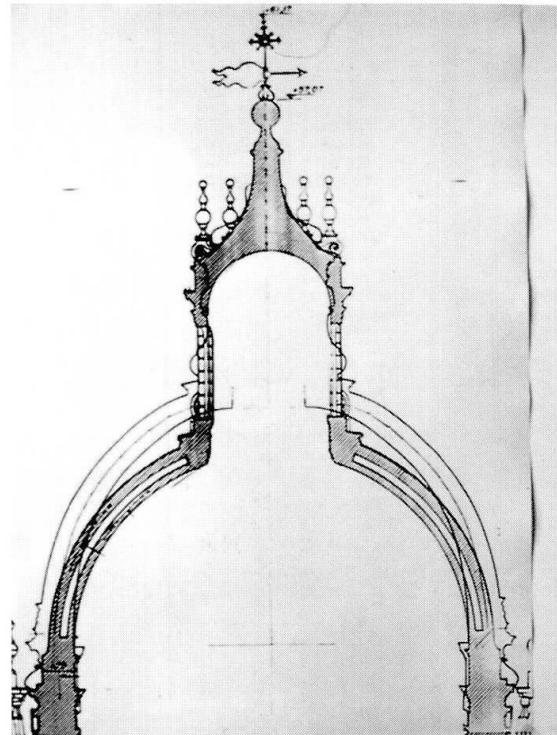
Fig. 1 Comparison between the shapes of St. Ignatius and St. Charles domes

Positions of the thrust within the thickness of the external shell, along the meridians, taking account of the reduced resistance of the sections

a) The Past. It is often useful to evaluate the safety levels of the original situation in order to understand if it was adequate at the time and if only subsequent deterioration or unexpected phenomena (earthquakes, soil settlements etc..) caused damage and failure. This evaluation helps us to find what the specific cause was. For example, in the case of the dome of St. Ignatius of Loyola in Spain, the structural analysis of the original "designed" form shows an irrational in the dome's shape, which is too hemispherical with a very heavy lantern on top; this causes high circumferential stresses which generated the meridian cracks that are visible today. Although in the case of the St. Charles cathedral in Rome the crack pattern was similar, it was found, by means of a mathematical model, that as the shape was higher (figure 1), the dead loads could not have produced the cracks, not even taking into account thermal effects and seismic actions (in particular the strong earthquake of 1703). Further and deeper analysis, the observation of the cracks on the drum and

the deformations of the cornice have shown that ancient soil deformations have been the determining factor; a monitoring system has shown that the deformations are now stabilized.

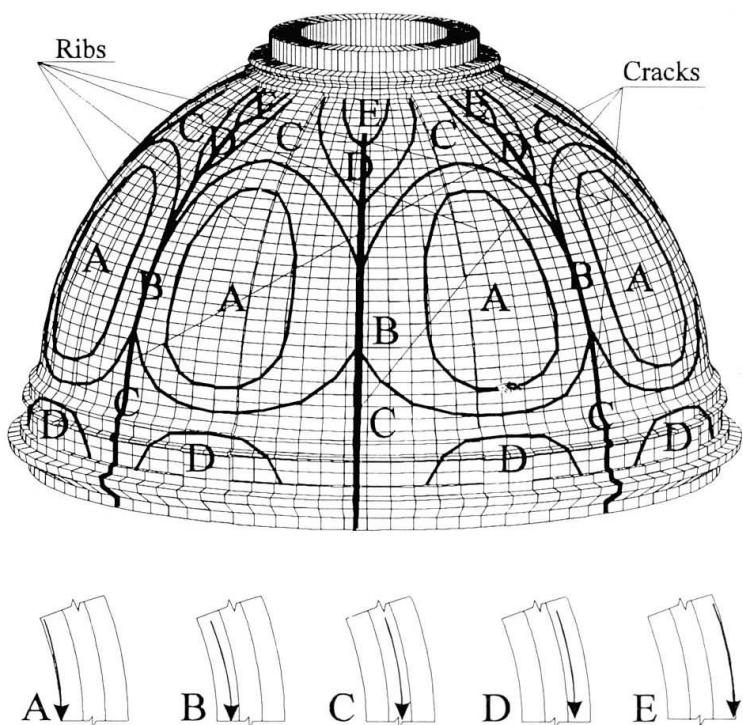
Fig. 2 St. Ignatius dome, cracks distribution and the results from a non-linear mathematical model

b) The Present. The assessment of the present situation is the prerequisite for every intervention decision. In the above-mentioned dome of St. Ignatius, taking account of the cracks along the meridians, the analysis has shown large bending moments in the meridian arches, that result from the loss of circumferential continuity, and hence significant tensile stresses; thus we were obliged to develop a more sophisticated non-linear analysis that showed that only part of the section is in

compression and that the safety levels are inadequate (figure 2).

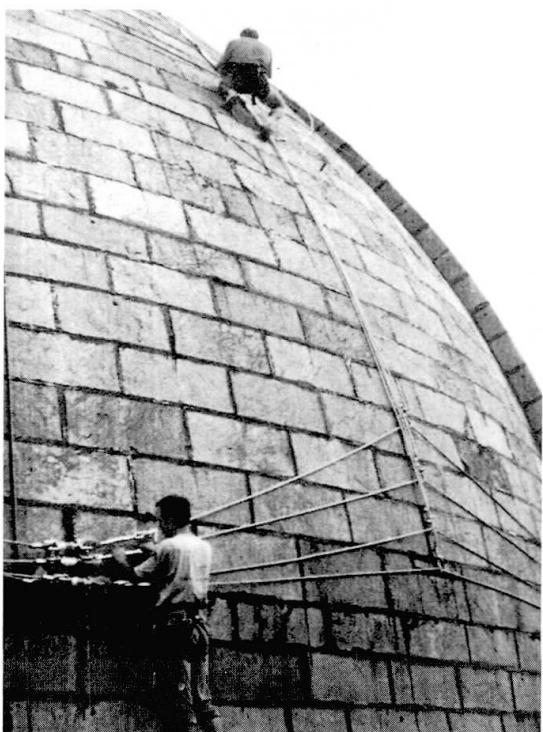
Fig. 3 Prestressed stainless steel circumferential cables

c) The Future. The evaluation of the safety levels corresponding to various possible interventions gives not only a measure of the improvement of the behaviour, but also helps in the choice of the most appropriate criteria. In the Loyola dome it was easy to establish that prestressed circumferential cables are able to provide the radial pressure necessary to substantially compress the meridian section (figure 3).

In the dome of St. Ignatius of Loyola, small prestressed stainless steel cables, normally used to sustain the masts of sailing boats, were used, having the advantages of economy and durability (figure 3); In the basilica of St. Mary of the Angels in Assisi synthetic fibre ropes of polypropylene, made by Retiflex, were used in the exterior walls (figure 14), with the double purpose of giving transversal resistance to the walls and connecting them to the façade; an appropriate pretension assured the immediate efficiency, while the very low modulus of elasticity (approx. 20,000 kg/cm²) of the same order of or less than that of the masonry, avoids zones of stress concentration and does not modify the stress distribution in the compressed zones.

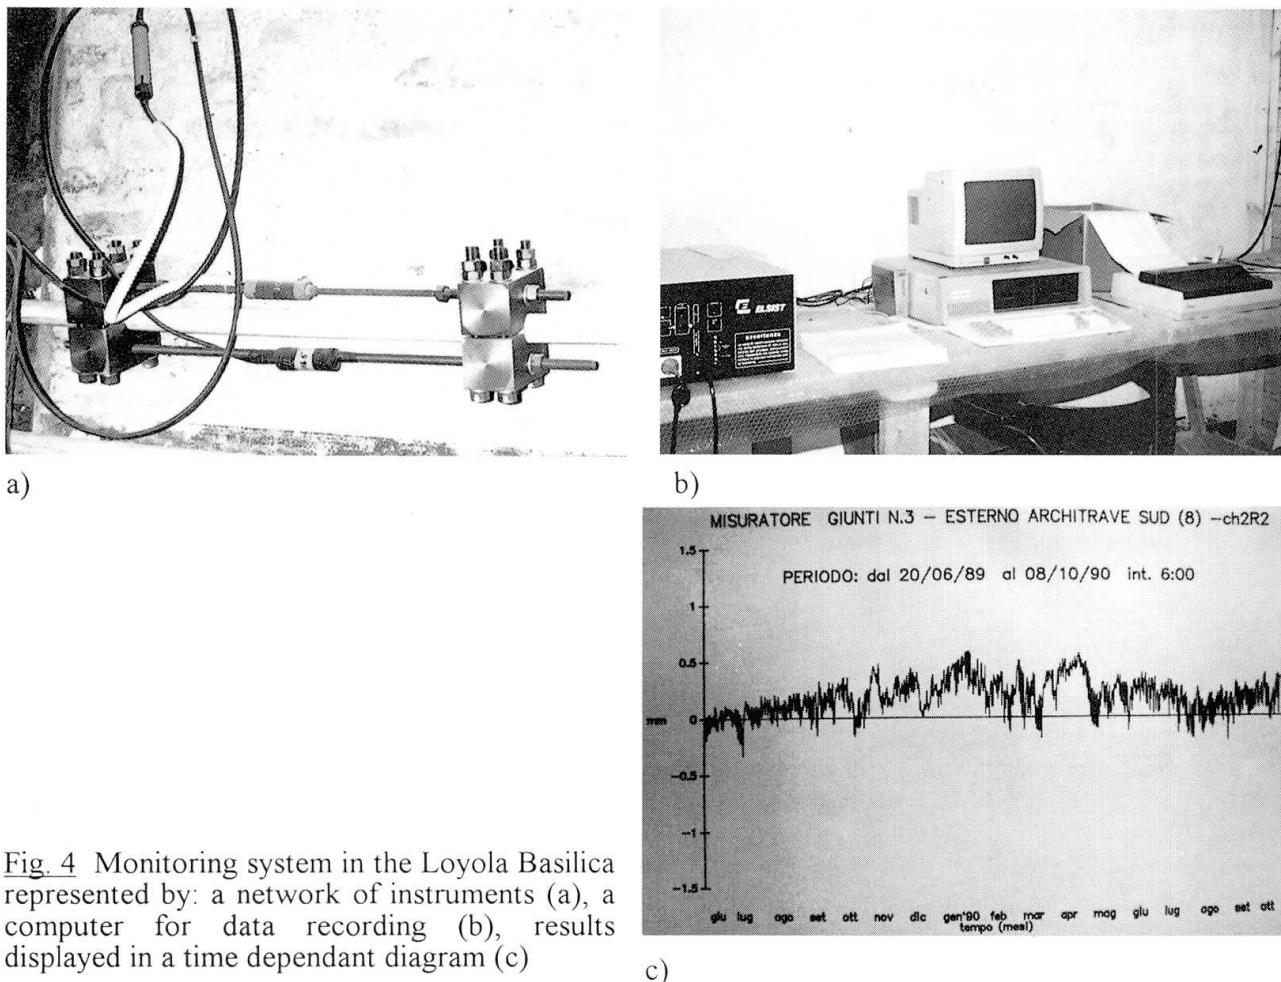
Fig. 4 Monitoring system in the Loyola Basilica represented by: a network of instruments (a), a computer for data recording (b), results displayed in a time dependant diagram (c)

a) Observation of the reality. This process, which we may call the "empirical-qualitative method", lies in the survey of the monument as it stands today, through the observation of the quality of the materials, the crack and failure patterns, the foundation system, the ground morphology, etc.; this knowledge can be supported by chemical and mechanical tests and by data recorded on a monitoring system in order to highlight the evolution of various phenomena (figure 4).

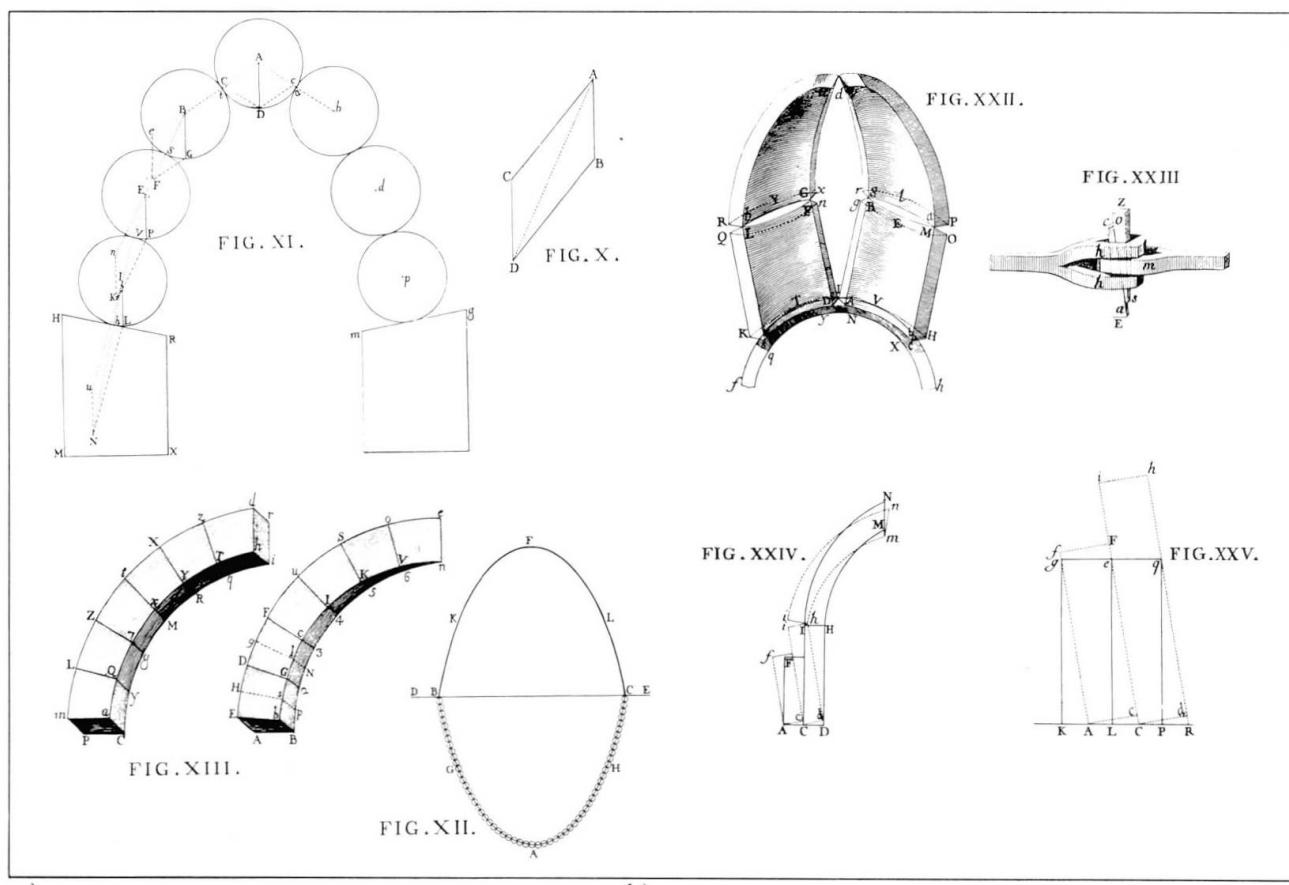
Fig. 5 Structural analysis of St. Peter's dome from Poleni's "Historical Records of the Great Dome of the Temple" - Vatican 1748: a) theory of the curve of thrust, b) application of the principle of virtual work

This attitude tends to eliminate any argument between the supporters of the "theoretical" and "empirical" approaches that has continued throughout the centuries. One of the first disputes of this kind took place in 1742 when Pope Benedict XIV asked the opinion of "three Neopolitan Mathematicians" on the damages found of the dome of St. Peter's. The method they followed, that in a certain way sanctioned the official entry of science and mathematics into a field previously dominated by practice and experience, was extremely interesting: instead of using polygons of forces, they applied a primitive principle of virtual work to the dome, reduced to a rough mechanism, the cracks being likened to joints or hinges (figure 5). The results showed that the existing conditions did not ensure equilibrium and immediately became points of discussions; critics from among the

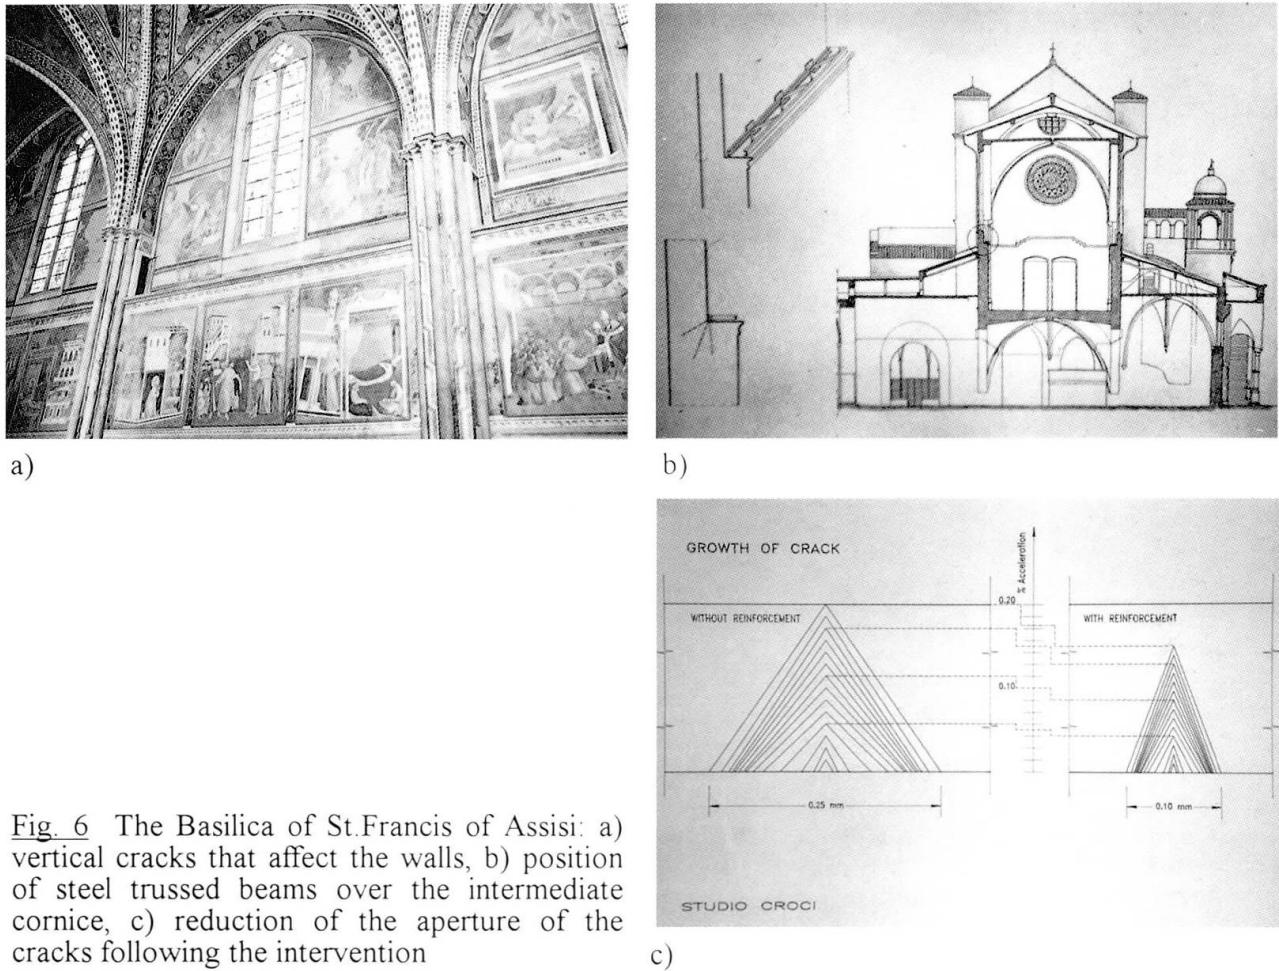
Fig. 6 The Basilica of St. Francis of Assisi: a) vertical cracks that affect the walls, b) position of steel trussed beams over the intermediate cornice, c) reduction of the aperture of the cracks following the intervention

for the possibility of their removal. In principle this philosophy is correct, taking account of the fact that judgements are not always sufficiently reliable and it therefore seems useful to allow for the possibility of applying better techniques and materials that will become available. This kind of philosophy has been proposed in the restoration of the basilica of St. Francis in Assisi, where it was revealed that earthquake forces, and in particular the component normal to the lateral walls, created cracks in the walls which support the Giotto frescos. Reinforcement has been designed in order to limit deformability and thus the damages that periodically affects the frescos; this reinforcement consists of a steel trussed beam placed over the cornice. The restraints between the steel beam and the walls are realized by oleodynamic devices so that relative movements are allowed under normal conditions, but the restraints become rigid, and thus effective, under dynamic actions (figure 6).

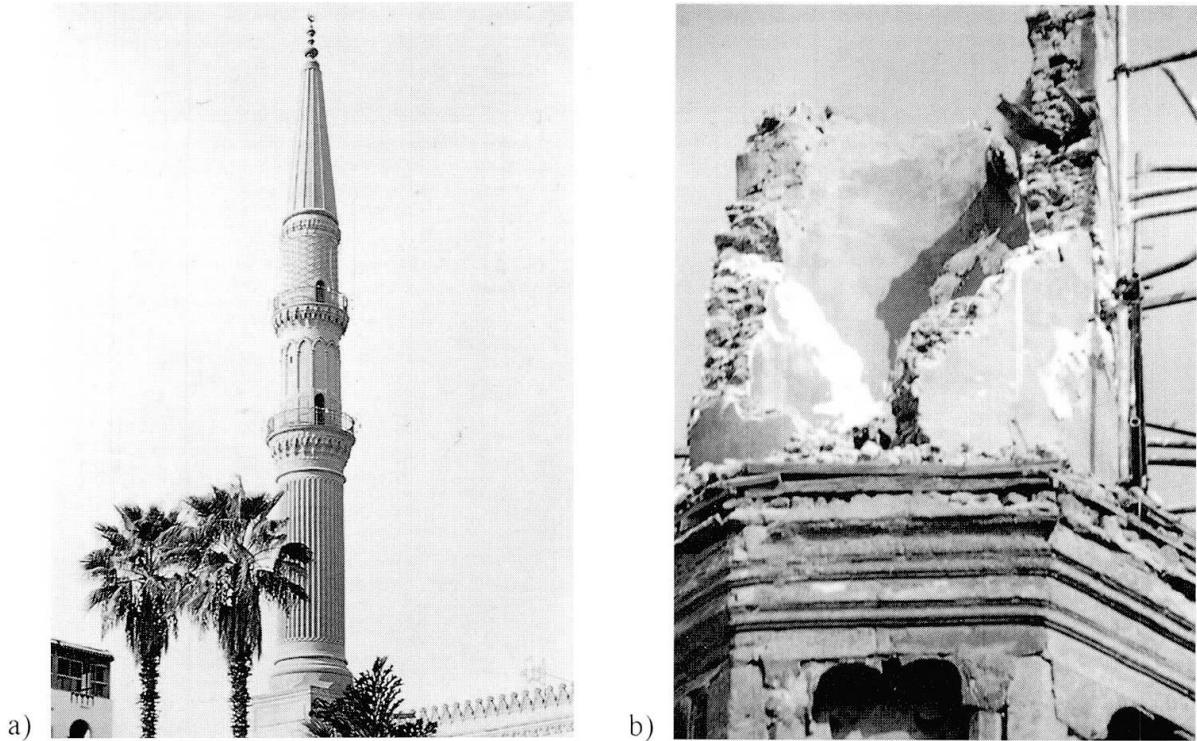
Fig. 7 Minarets in Cairo: weakness (a) and slenderness (b), often worsened by out-of-plumb

Another "reversible" intervention has been proposed for the reinforcement of some leaning minarets in Cairo, where six prestressed vertical cables will be placed along the interior perimeter, only creating small holes to cross the steps (figure 7).

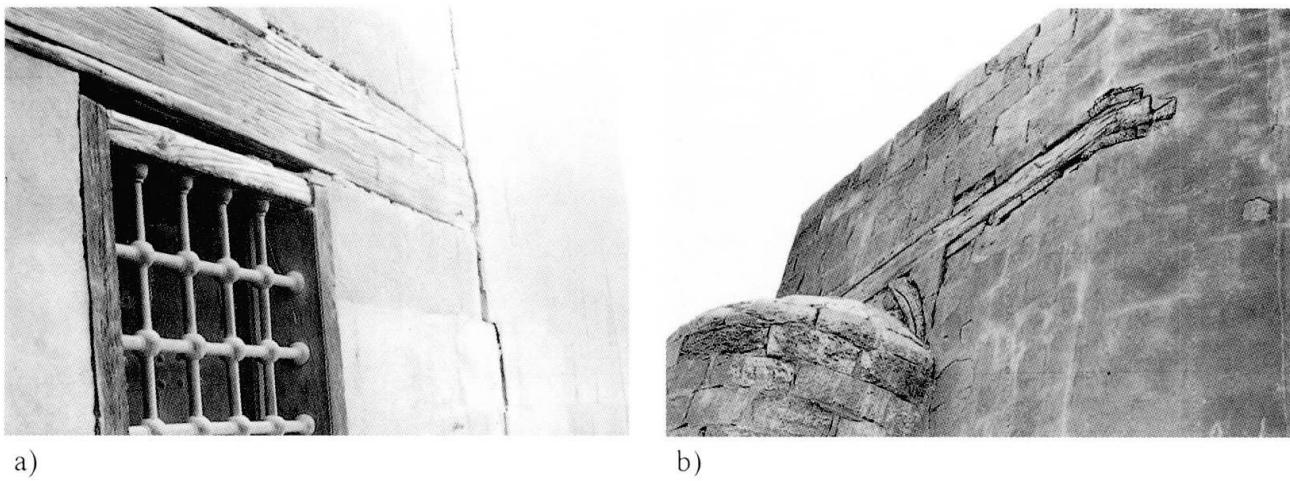
Fig. 8 Wood chains to connect the walls (a) and to counteract the thrust at the base of a dome (b)

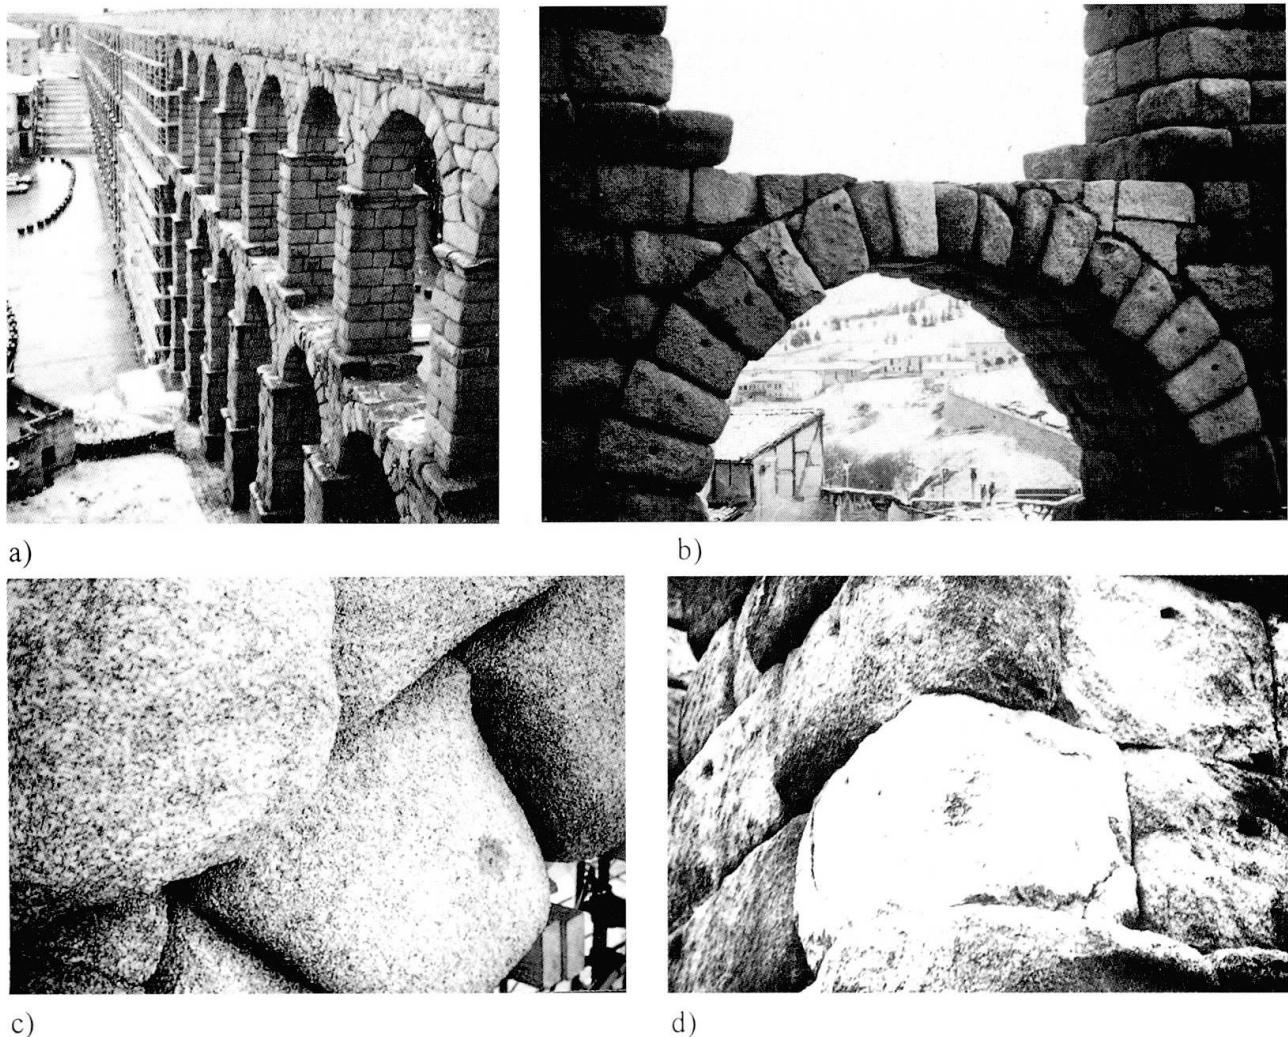
Fig 9 The Aqueduct of Segovia (a), where the perfect equilibrium of arches (b) has not been compromised by the rounding of the blocks edges by two thousand years of snow, rain and eolic action (c), but whose survival is at risk from pollution (d)

traffic pollution (figure 9); the granite blocks, superposed without mortar allow small adjustments for the redistribution of stresses and do not contrast the thermal deformations. Restoration works must never change this behaviour and it will be necessary to reorganize the traffic in the downtown to radically solve the problem. The more than four thousand year old Chefren Pyramid (figure 10) only suffers from the consequences of a very slow but continuous eolic erosion, fortunately in dry conditions; the fall of some blocks during the earthquake of October 1992 is only the result of a lack of maintenance; it will not be necessary to use especially strong structures to fix the blockwork, but it will be sufficient to recreate the connections using the original materials and techniques, that have so successfully defied the millenia.

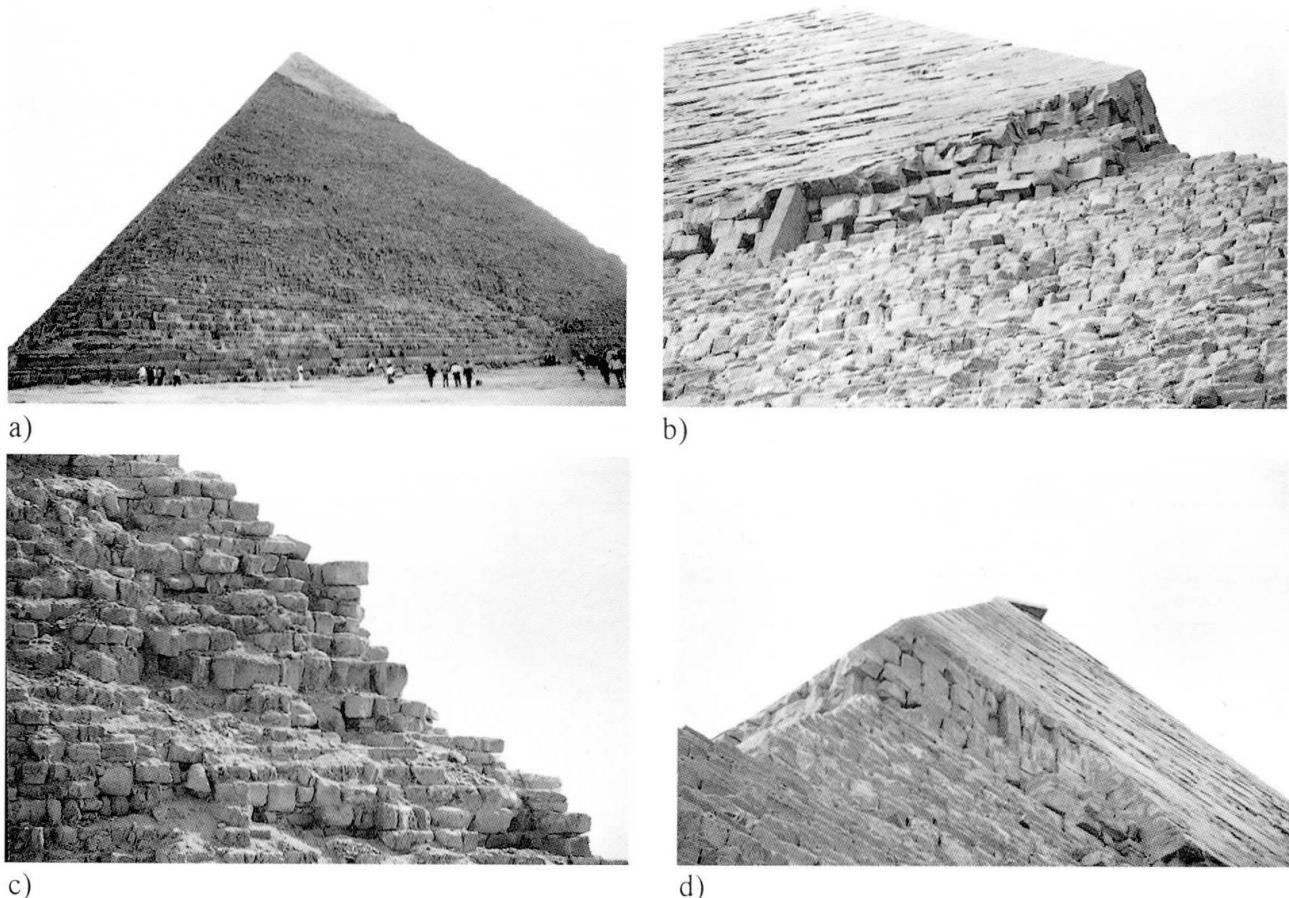
Fig. 10 The Chefren Pyramid (a) suffers from a lack of maintenance; the progressive destruction of the weak mortar and the more fragile blocks (b) has created dangerous conditions (c). The earthquakes have accentuated this situation, making some blocks fall and moving the very top (d)

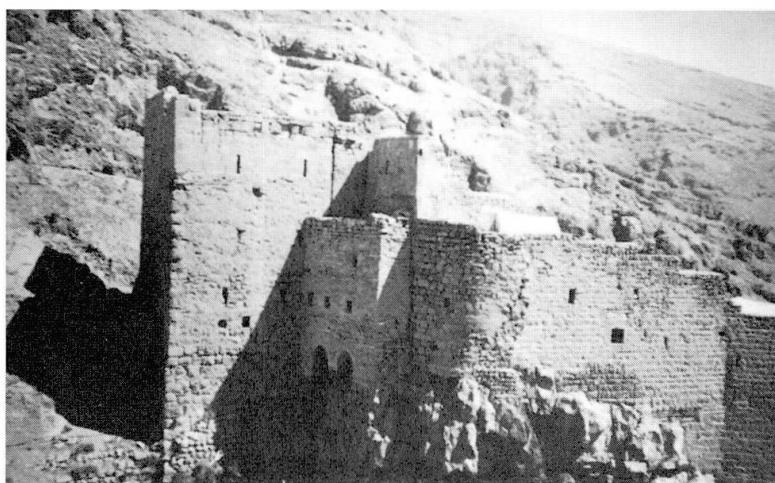
Fig. 11 Monastery of Mar Mousa in Siria: deterioration of the masonry and dangerous disintegration of the stone basement

In some situations, such as the Monastery of Mar Mousa in Syria (figure 11) deterioration is so high that it will be very difficult to reduce the risks to a level that a modern society requires using ancient technologies alone, especially regarding the precarious conditions of the foundations.

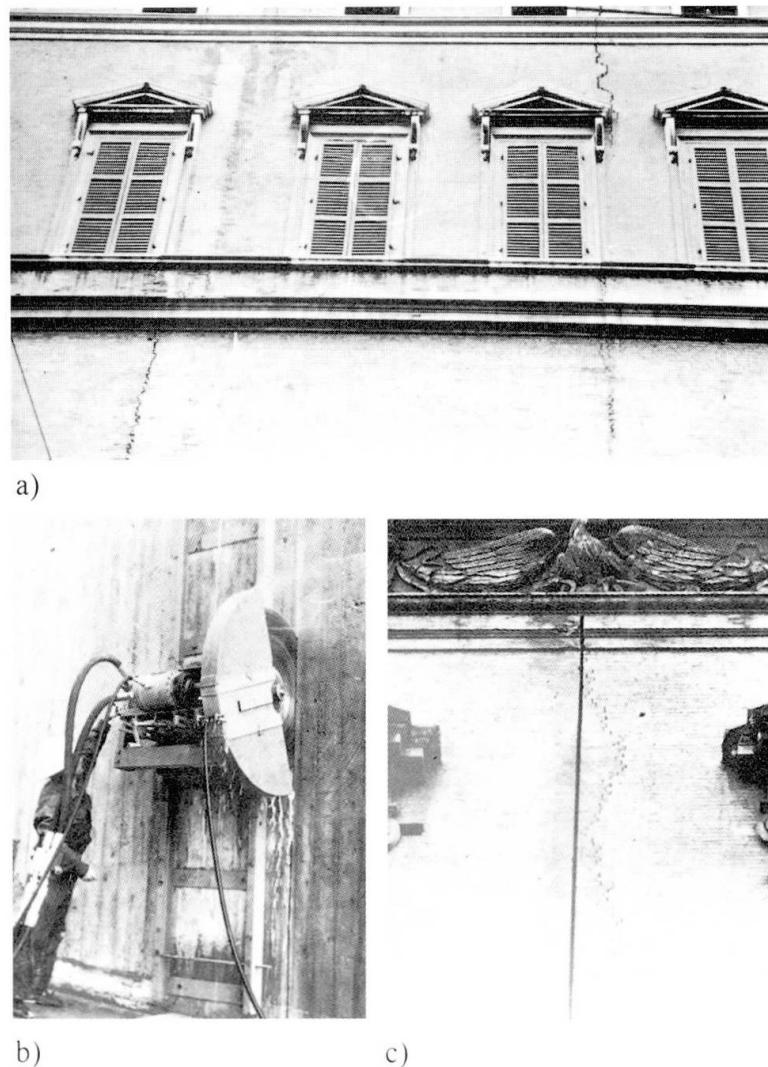
Fig. 12 The Ducal Palace of Modena: relevant cracks in the walls due to soil settlements (a), special device for cutting walls (b) and the realization of joints (c)

The Ducal Palace of Modena (figure 12) was affected by significant subsidence phenomena. Fifteen years ago the problem was solved by making vertical cuts in the Palace following the main cracks in the walls, the movement joints that have been thus created allow the building to follow the soil settlements without further relevant stresses or cracking to the structure. The result has been completely satisfactory.

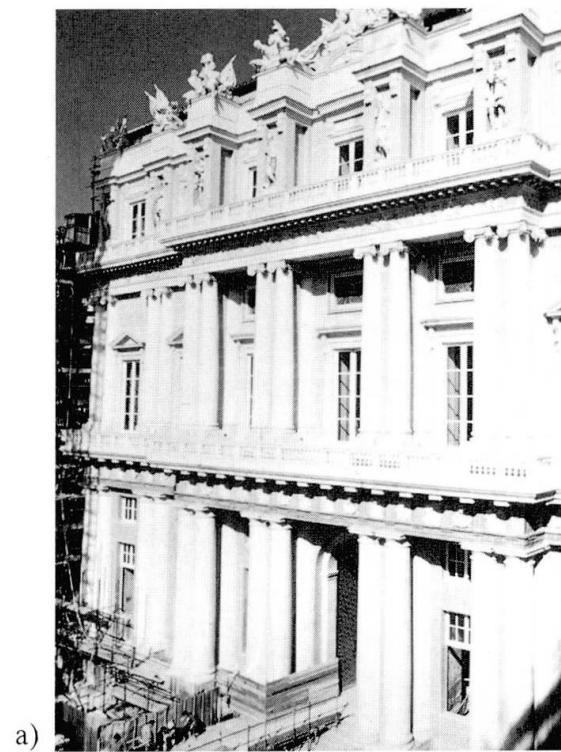
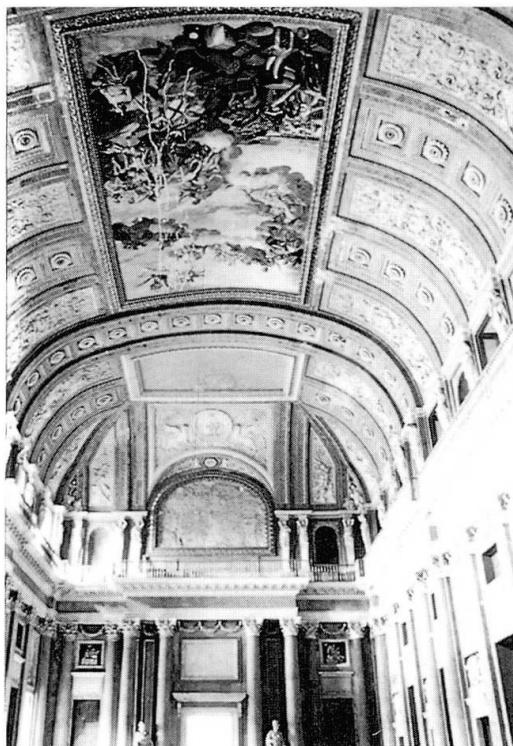
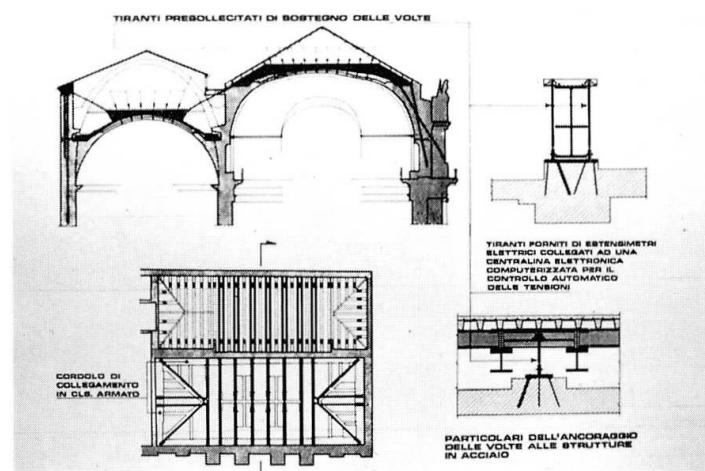
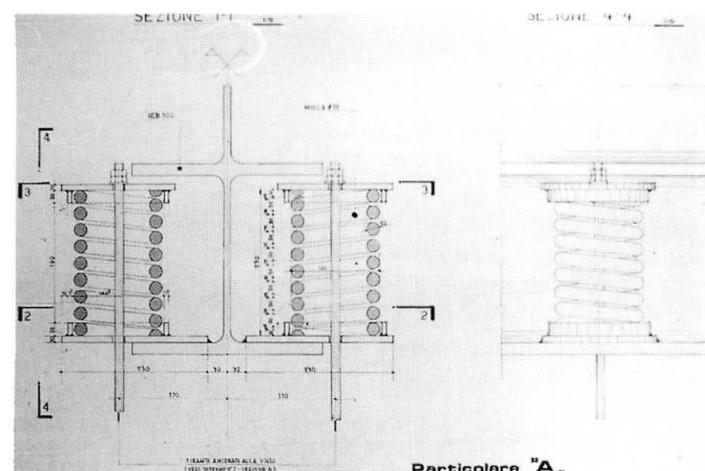
Fig. 13 The Ducal Palace of Genoa: the outward deformation of the façade (a) created by a loss in the curvature of the vault (b); the intervention (c) realized the connection between the opposite walls and support by means of springs (d) to the vault

The Ducal Palace of Genoa (figure 13) suffered from foundation deformations that affected the main façade creating a loss of curvature in the main vault of the salon; the problem required the creation of an efficient connection between the opposite façades and the assurance of the stability of the vault. This was resolved by the placing of a steel arched beam, placed between the vault and the roof. This arched beam works simultaneously as a tie between the walls (for this reason an appropriate stiffness is required) and as a support for the vault by means of small connecting rods. A monitoring system, installed for a year, checked the intervention and particularly the stresses in the connecting rods; the results showed important thermal effects which lead to the replacement of the rods with springs, in order to maintain a constant supporting force. The monitoring system has been thus not only a way of control, but also a support for the final design.

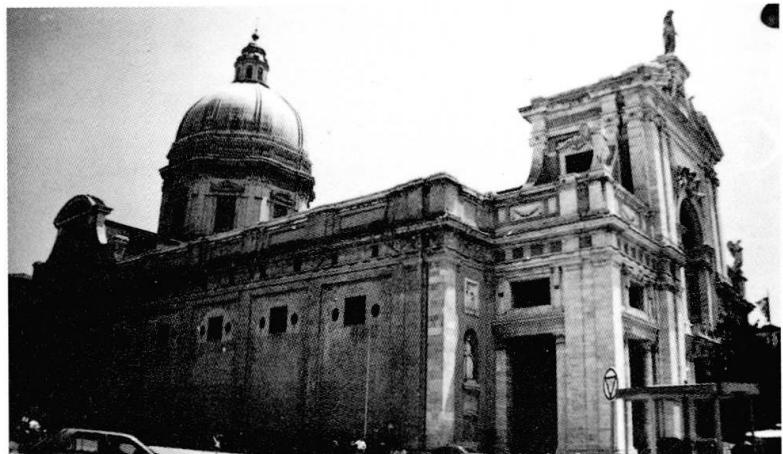
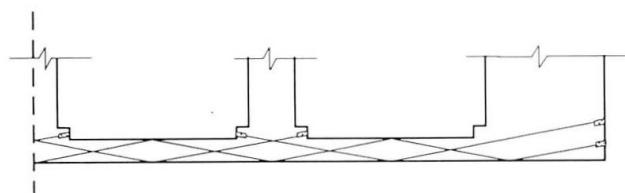
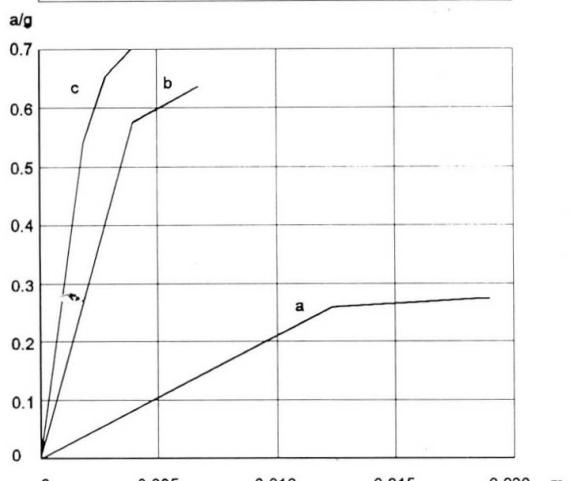
Fig. 14 St. Mary of the Angels in Assisi was affected by seismic cracks (a) and has been reinforced with synthetic fibre (b); the diagrams show the improvement in the seismic resistance capacity calculated by nonlinear analysis (c)

POSITIONING IN PLAN OF
POST - TENSIONED CABLES
AND ANCHORS

DIAGRAM ACCELERATION - DISPLACEMENTS

a: model without intervention
b: model with intervention without adherence
c: model with intervention with adherence

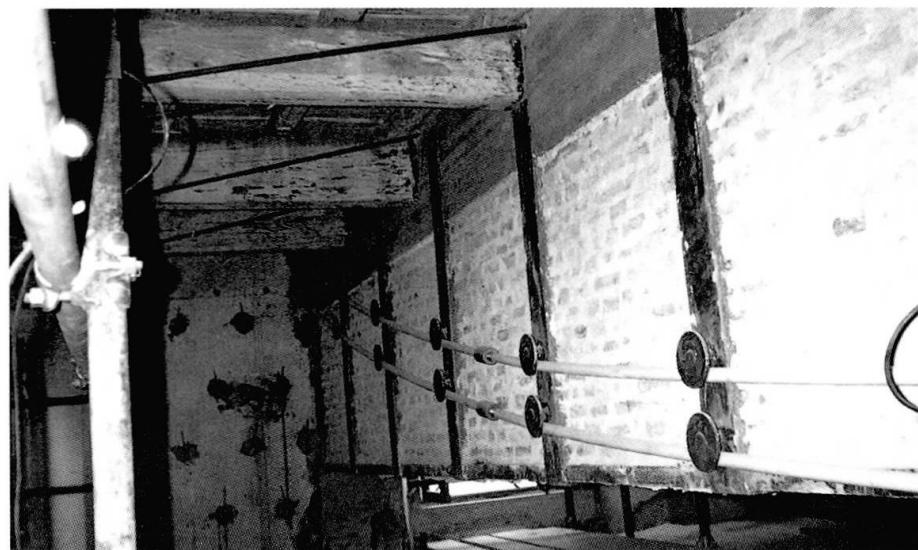
Fig. 15 Palazzo Altemps: prestressed cables to reinforce the remaining upper part of a demolished wall, working now as a "beam", to allow support for the floors above

Prestressed steel cables offer a wide range of applications: in Palazzo Altemps, in order to rid the main ancient saloon of subsequently constructed internal walls whilst supporting the floors that bear onto them, prestressed cables were used to reinforce the upper part of the walls that now work as beams (figure 15).

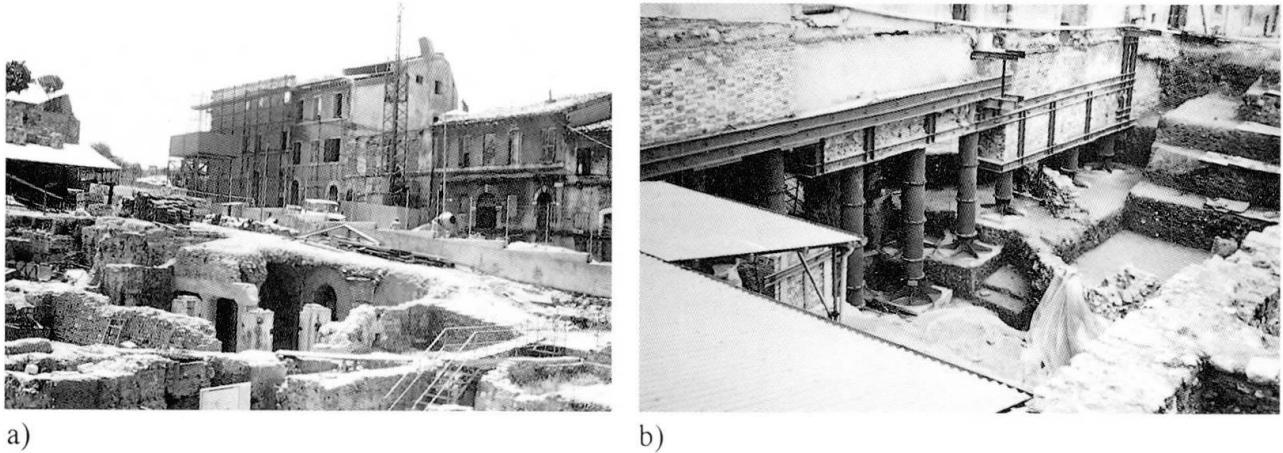
Fig. 16 The Amphitheatre of Ancona with houses built above (a) and excavation works under the foundations (b)

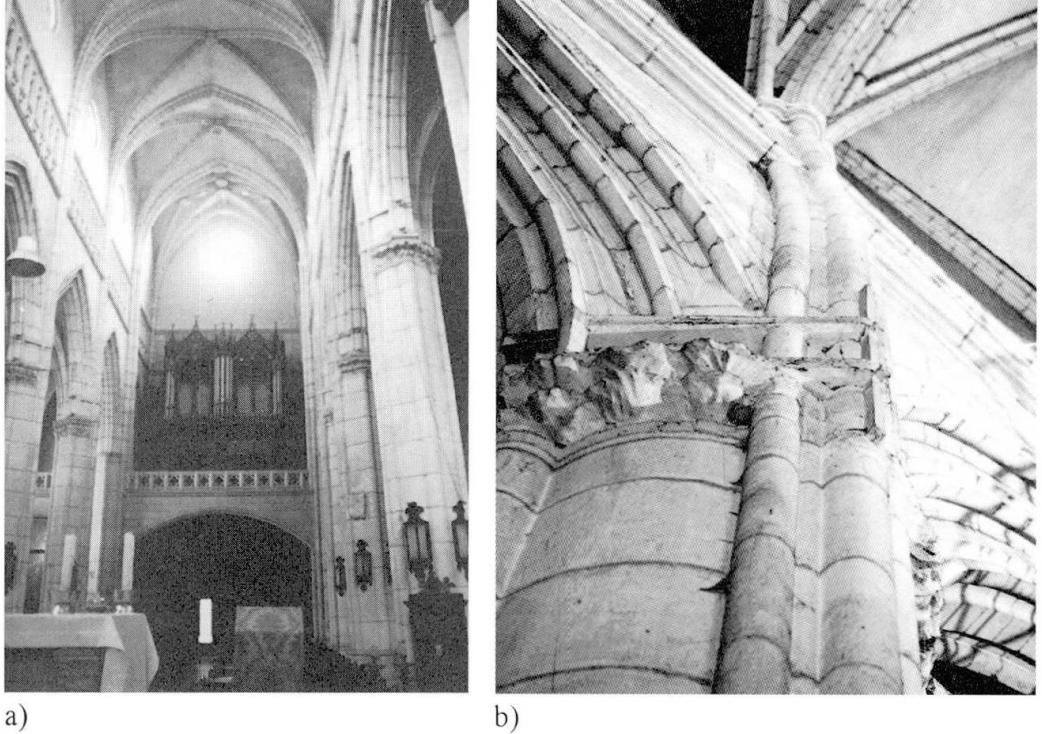
Fig. 17 The Cathedral of Vitoria in Spain (a) and the huge deformations of the columns (b)

We want to mention, finally, that new technology can be very useful when the recovery of a deformation or out-of-plumb is required. A system of jacks connected with a monitoring system, is currently being used while work is in progress on the foundations of the St. Michael Palace in Rome. A similar system is used to control the archeological excavation works beneath the foundations of small houses built centuries ago over the roman amphitheatre of Ancona (figure 16): a series of provisional steel elements created under the foundations, step by step, allow the progression of the excavation before choosing the final solution. In the Cathedral of Vitoria in Spain (figure 17)

provisional steel elements connected to a monitoring system are going to be used to recover the huge deformations created by ancient soil settlements.

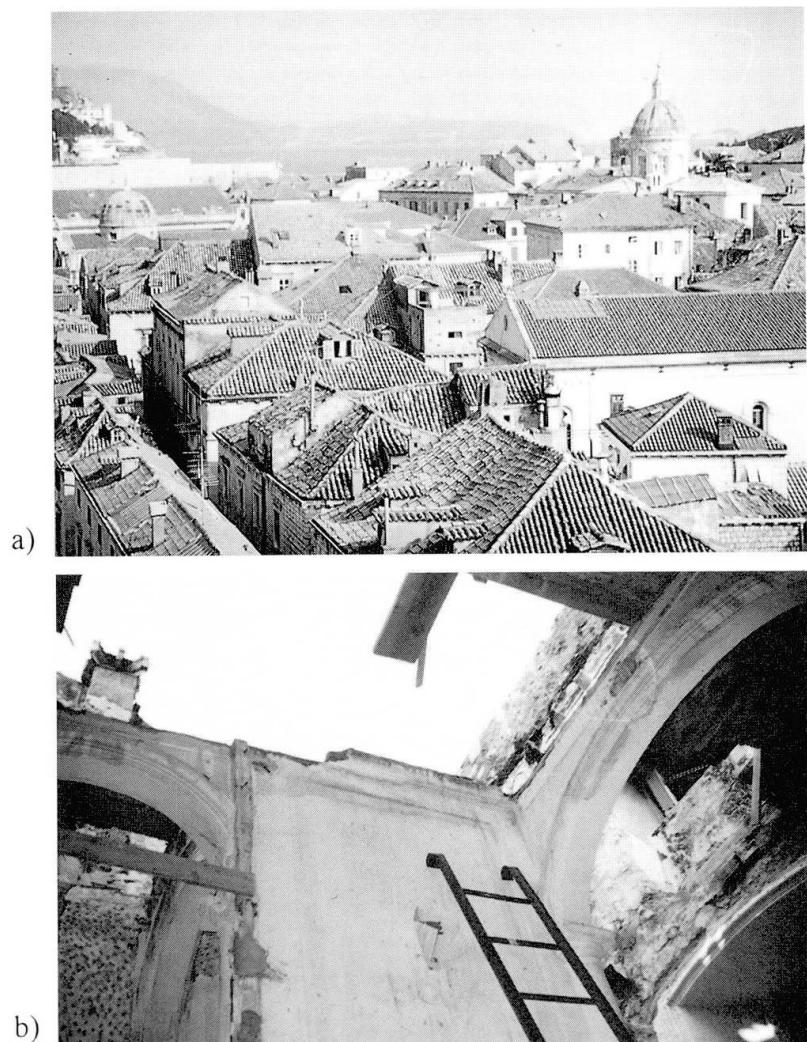
Fig. 18 A view of Dubrovnik (a) and the damages after the bombing in December 1991 (b)

It is unquestionable that a code for investigations, analysis, projects, works, controls, etc.. would not just be useful but is absolutely necessary. The lack of guidance allows us to propose solutions that are often based on arbitrary decisions without proof of the benefits or preliminary experimentation to discover the possible side effects. Besides which, as quality control is not always requested, there is no certitude that the expected results will be attained. The lack of a specific code is also the cause of misunderstanding and leads to the inappropriate use of other codes that are aimed for different purposes. The seismic codes created for new constructions or for the repair of seismic damages in ordinary buildings for example cannot be used, either for the characteristics of the actions (the behaviour of a monument under seismic loading is very particular) or for the techniques often proposed (extensive use of reinforced concrete,...). This problem occurred in Dubrovnik where, after the bombing of December 1991, we began to study various buildings with the view to designing restoration interventions (figure 18); as Dubrovnik is in a zone of strong seismic action, and we must

follow the Croatian Seismic code, we will be obliged to introduce reinforcement heavier than that required for the repair: therefore the code risks being as damaging as the bombs, creating alterations that may compromise the historical value which has been preserved for centuries.

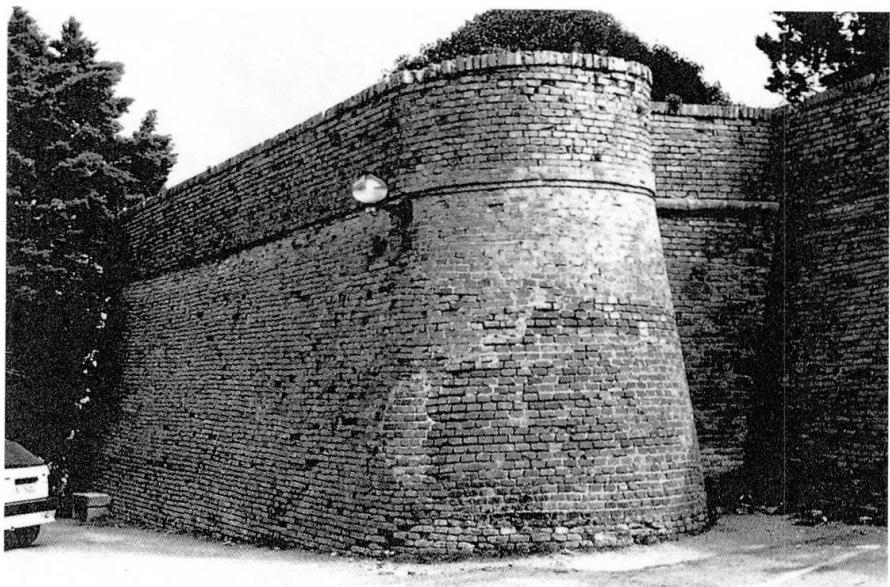
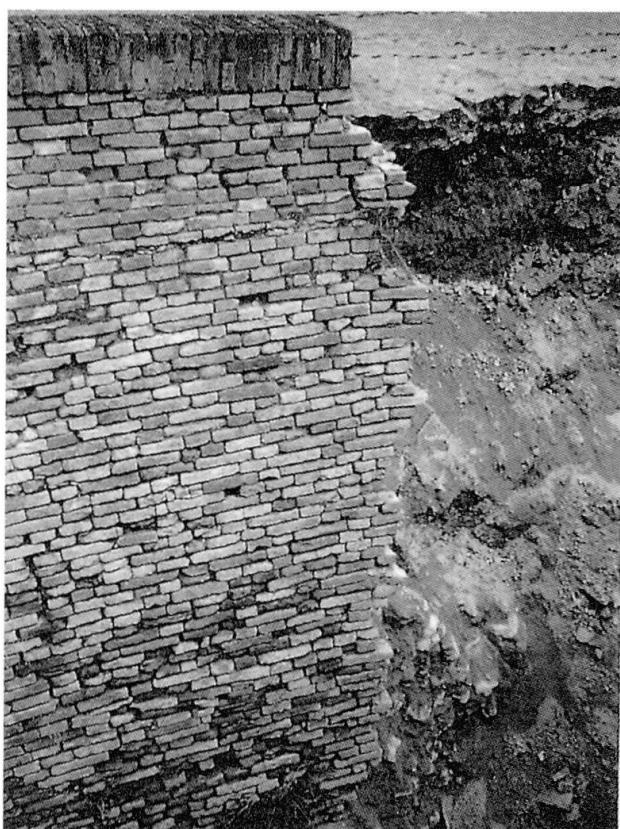
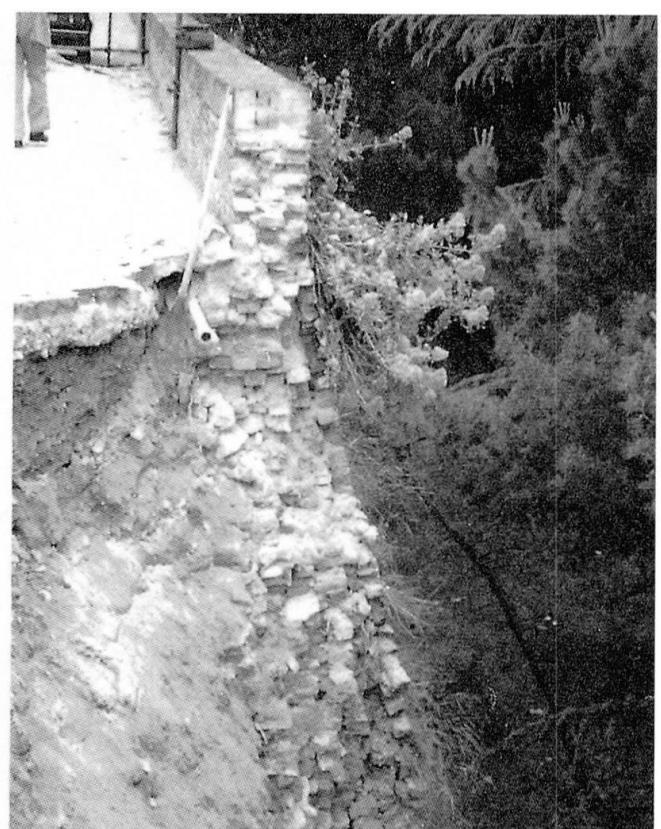
Fig. 19 A view of the Urbino walls (a), a collapsed zone where it is possible to see the poor condition of the masonry (b, c)

A similar problem is posed in the restoration of the historical walls of Urbino (figure 19), largely damaged and with a part that has recently collapsed. Calculations following the usual Code on the retaining walls show that the earth pressures are higher than the Urbino walls are capable of supporting; the designers and administrators have been left with a difficult choice, between accepting lower safety levels, thereby breaking the law or carrying out interventions that will presumably be stronger than necessary thus substantially modifying the original conception.
