Structural Aspects in Restoring Monuments

Giorgio CROCI
Prof.
Univ. 'La Sapienza'
Rome, Italy

This lecture highlights the different domains where structural engineering can contribute to the knowledge and restoration of Architectural Heritage. The assessment of the actual safety level of the monument is needed to decide on necessary measures. Objective and subjective aspects have to be taken into account. Whenever measures are needed, the advantages and disadvantages of the use of new or old materials and techniques are evaluated. The convenience of reversibility is examined. Finally, possible codes will be discussed to avoid misuse of existing codes which are not suited for this kind of structures.

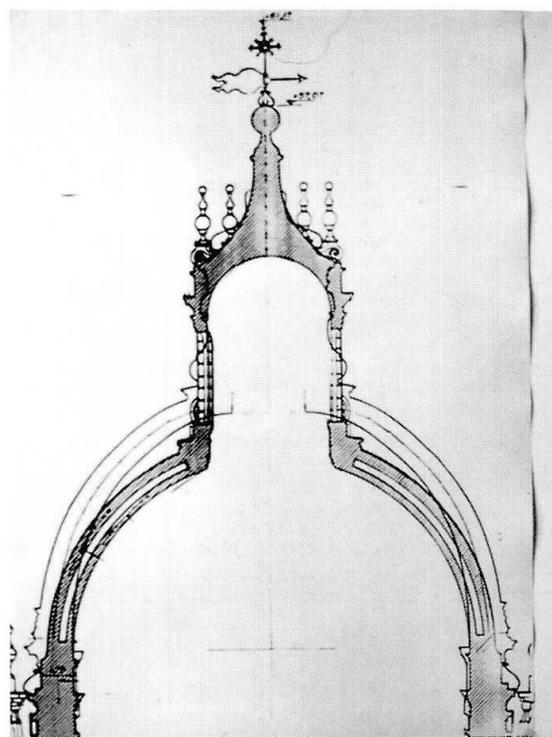
Fig. 1 Comparison between the shapes of St. Ignatius and St. Charles domes

Positions of the thrust within the thickness of the external shell, along the meridians, taking account of the reduced resistance of the sections

a) The Past. It is often useful to evaluate the safety levels of the original situation in order to understand if it was adequate at the time and if only subsequent deterioration or unexpected phenomena (earthquakes, soil settlements etc..) caused damage and failure. This evaluation helps us to find what the specific cause was. For example, in the case of the dome of St. Ignatius of Loyola in Spain, the structural analysis of the original "designed" form shows an irrational in the dome's shape, which is too hemispherical with a very heavy lantern on top; this causes high circumferential stresses which generated the meridian cracks that are visible today. Although in the case of the St. Charles cathedral in Rome the crack pattern was similar, it was found, by means of a mathematical model, that as the shape was higher (figure 1), the dead loads could not have produced the cracks, not even taking into account thermal effects and seismic actions (in particular the strong earthquake of 1703). Further and deeper analysis, the observation of the cracks on the drum and

the deformations of the cornice have shown that ancient soil deformations have been the determining factor; a monitoring system has shown that the deformations are now stabilized.

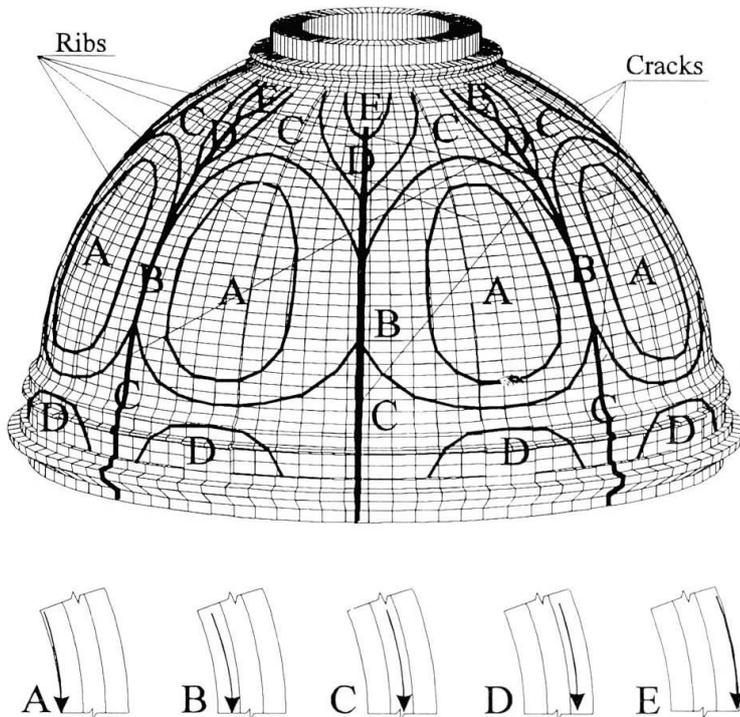
Fig. 2 St. Ignatius dome, cracks distribution and the results from a non-linear mathematical model

b) The Present. The assessment of the present situation is the prerequisite for every intervention decision. In the above-mentioned dome of St. Ignatius, taking account of the cracks along the meridians, the analysis has shown large bending moments in the meridian arches, that result from the loss of circumferential continuity, and hence significant tensile stresses; thus we were obliged to develop a more sophisticated non-linear analysis that showed that only part of the section is in

compression and that the safety levels are inadequate (figure 2).

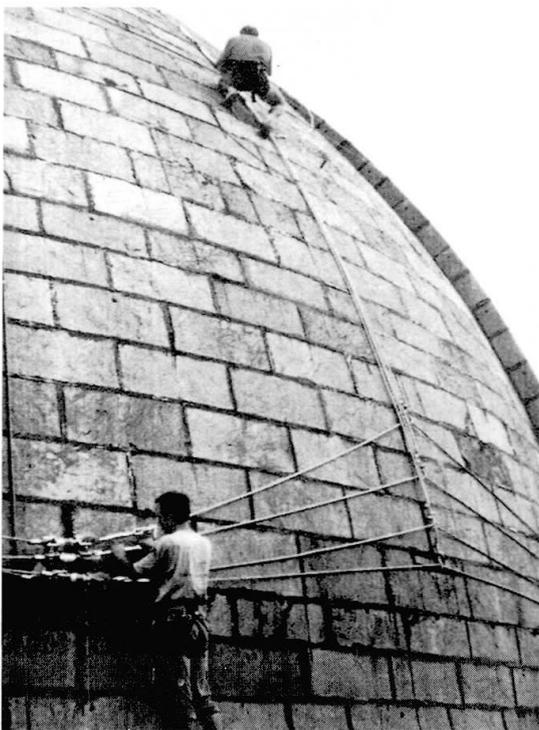
Fig. 3 Prestressed stainless steel circumferential cables

c) The Future. The evaluation of the safety levels corresponding to various possible interventions gives not only a measure of the improvement of the behaviour, but also helps in the choice of the most appropriate criteria. In the Loyola dome it was easy to establish that prestressed circumferential cables are able to provide the radial pressure necessary to substantially compress the meridian section (figure 3).

In the dome of St. Ignatius of Loyola, small prestressed stainless steel cables, normally used to sustain the masts of sailing boats, were used, having the advantages of economy and durability (figure 3); In the basilica of St. Mary of the Angels in Assisi synthetic fibre ropes of polypropylene, made by Retiflex, were used in the exterior walls (figure 14), with the double purpose of giving transversal resistance to the walls and connecting them to the façade; an appropriate pretension assured the immediate efficiency, while the very low modulus of elasticity (approx. 20,000 kg/cm²) of the same order of or less than that of the masonry, avoids zones of stress concentration and does not modify the stress distribution in the compressed zones.

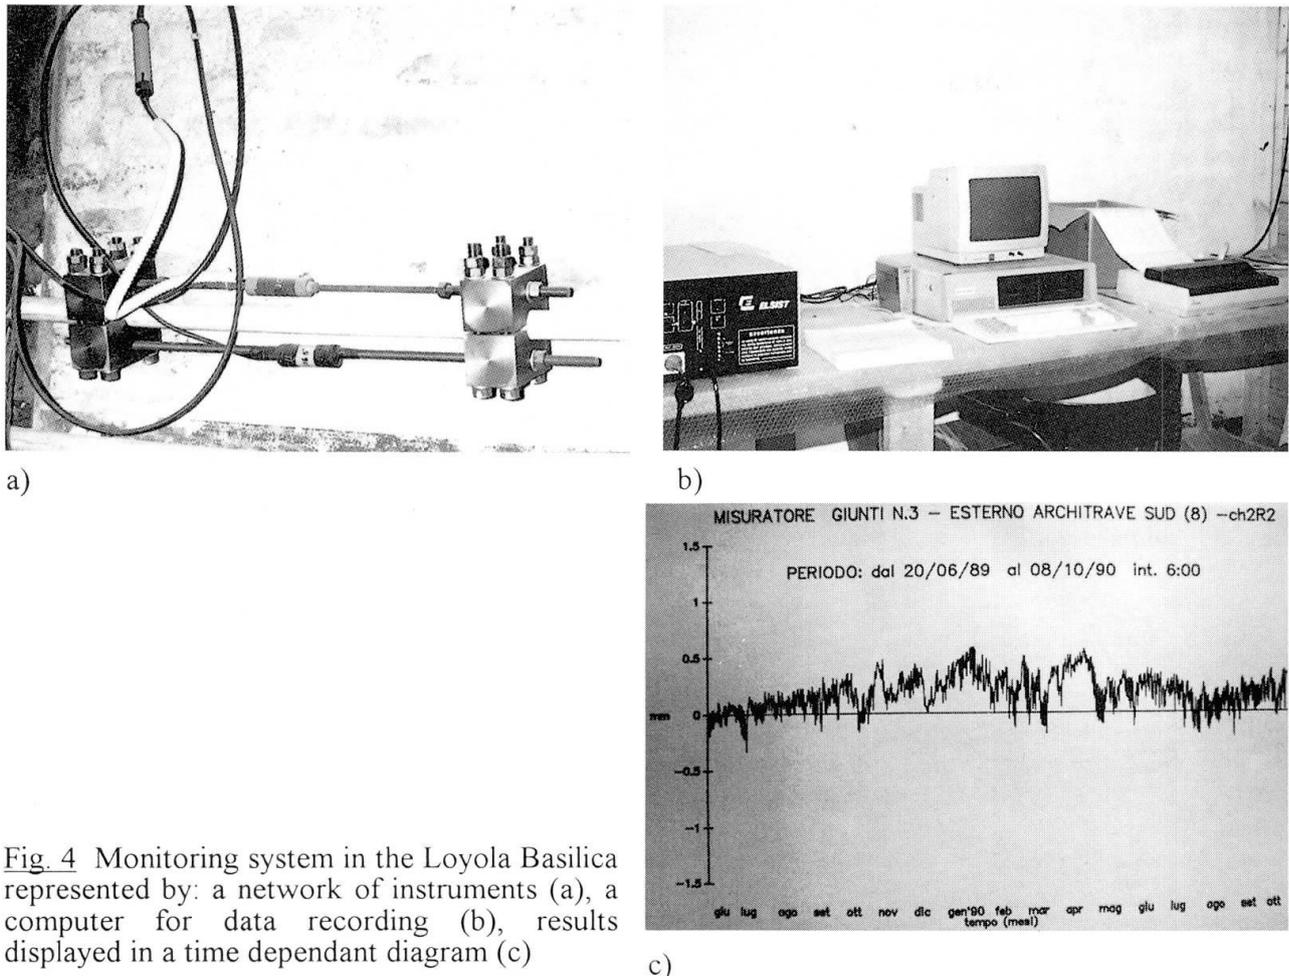
Fig. 4 Monitoring system in the Loyola Basilica represented by: a network of instruments (a), a computer for data recording (b), results displayed in a time dependant diagram (c)

a) Observation of the reality. This process, which we may call the "empirical-qualitative method", lies in the survey of the monument as it stands today, through the observation of the quality of the materials, the crack and failure patterns, the foundation system, the ground morphology, etc.; this knowledge can be supported by chemical and mechanical tests and by data recorded on a monitoring system in order to highlight the evolution of various phenomena (figure 4).

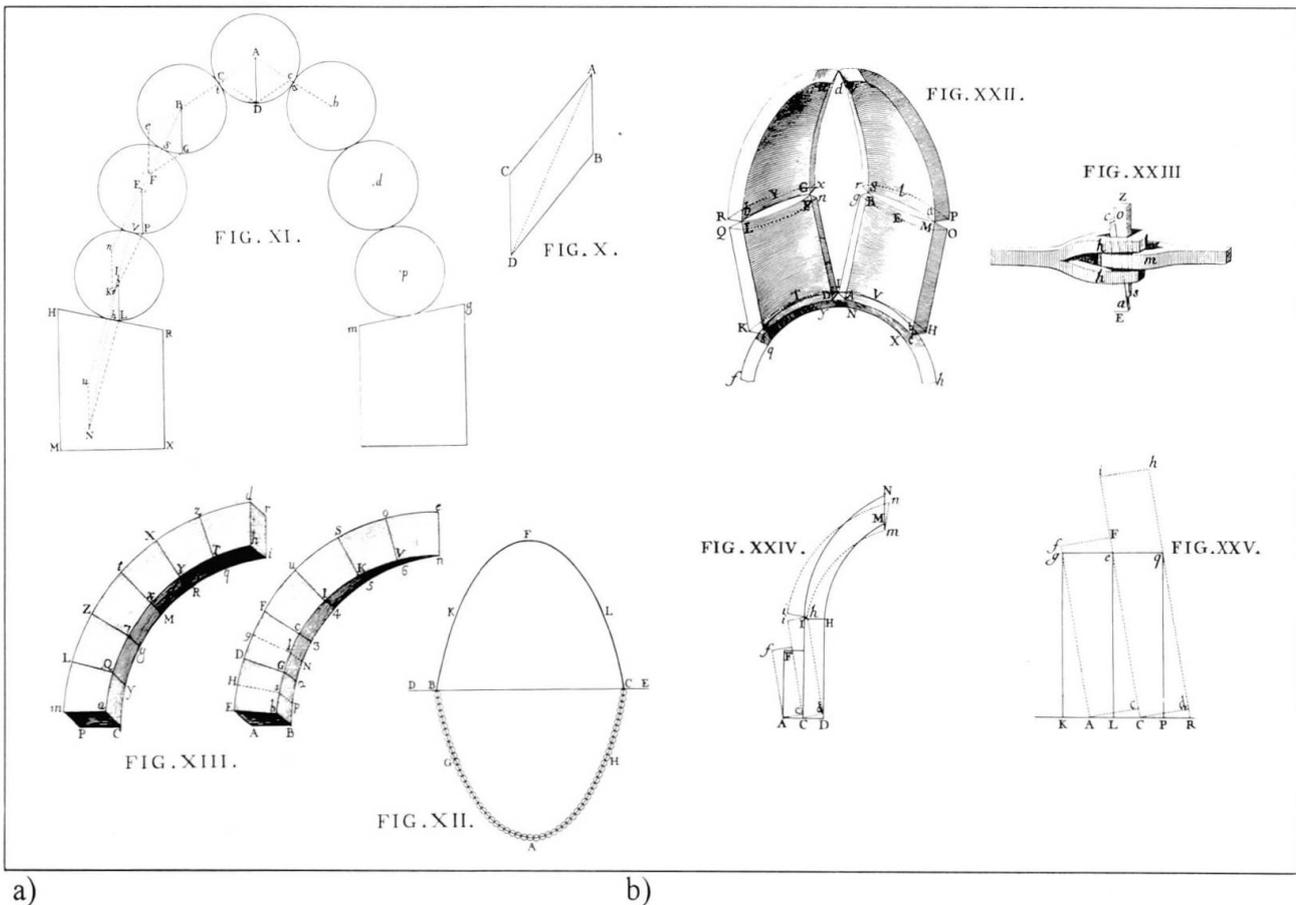
Fig. 5 Structural analysis of St. Peter's dome from Poleni's "Historical Records of the Great Dome of the Temple" - Vatican 1748: a) theory of the curve of thrust, b) application of the principle of virtual work

This attitude tends to eliminate any argument between the supporters of the "theoretical" and "empirical" approaches that has continued throughout the centuries. One of the first disputes of this kind took place in 1742 when Pope Benedict XIV asked the opinion of "three Neopolitan Mathematicians" on the damages found of the dome of St. Peter's. The method they followed, that in a certain way sanctioned the official entry of science and mathematics into a field previously dominated by practice and experience, was extremely interesting: instead of using polygons of forces, they applied a primitive principle of virtual work to the dome, reduced to a rough mechanism, the cracks being likened to joints or hinges (figure 5). The results showed that the existing conditions did not ensure equilibrium and immediately became points of discussions; critics from among the

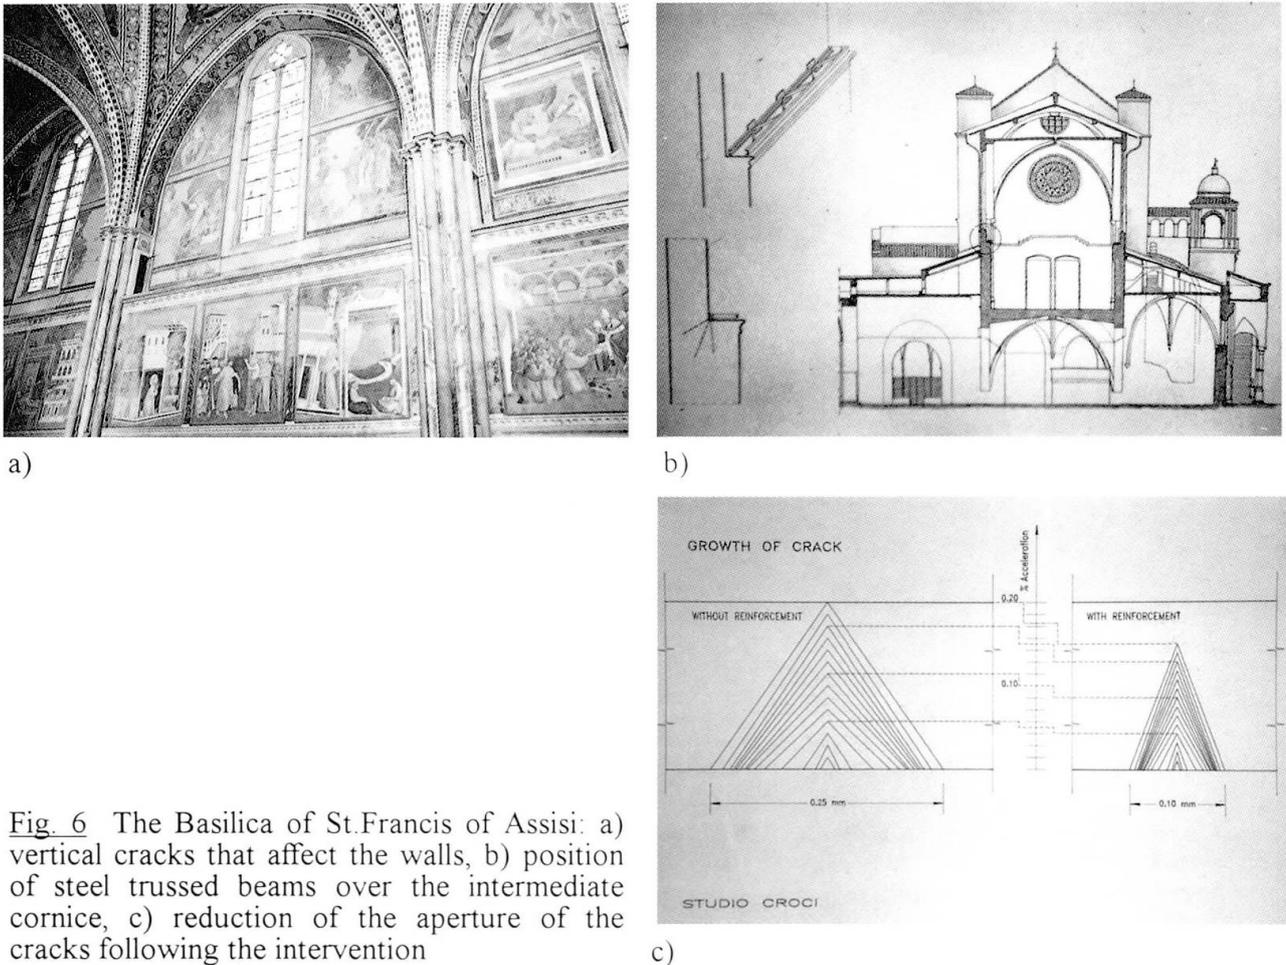
Fig. 6 The Basilica of St. Francis of Assisi: a) vertical cracks that affect the walls, b) position of steel trussed beams over the intermediate cornice, c) reduction of the aperture of the cracks following the intervention

for the possibility of their removal. In principle this philosophy is correct, taking account of the fact that judgements are not always sufficiently reliable and it therefore seems useful to allow for the possibility of applying better techniques and materials that will become available. This kind of philosophy has been proposed in the restoration of the basilica of St. Francis in Assisi, where it was revealed that earthquake forces, and in particular the component normal to the lateral walls, created cracks in the walls which support the Giotto frescos. Reinforcement has been designed in order to limit deformability and thus the damages that periodically affects the frescos; this reinforcement consists of a steel trussed beam placed over the cornice. The restraints between the steel beam and the walls are realized by oleodynamic devices so that relative movements are allowed under normal conditions, but the restraints become rigid, and thus effective, under dynamic actions (figure 6).

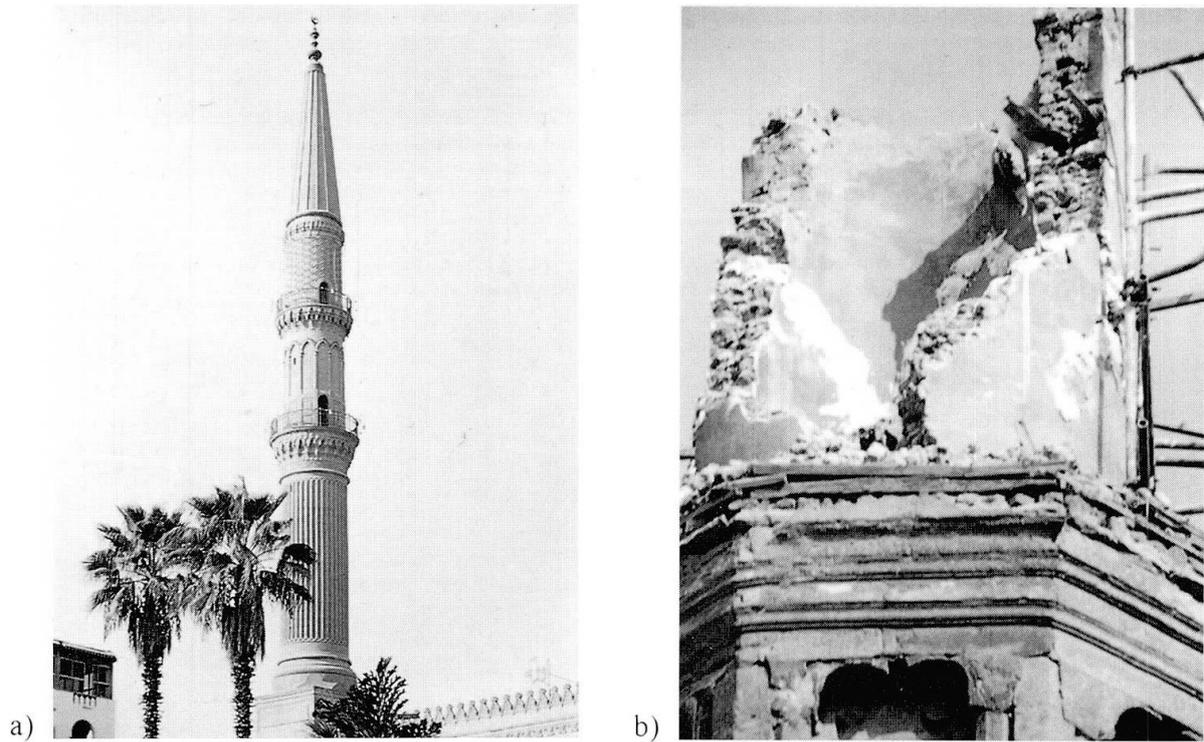
Fig. 7 Minarets in Cairo: weakness (a) and slenderness (b), often worsened by out-of-plumb

Another "reversible" intervention has been proposed for the reinforcement of some leaning minarets in Cairo, where six prestressed vertical cables will be placed along the interior perimeter, only creating small holes to cross the steps (figure 7).

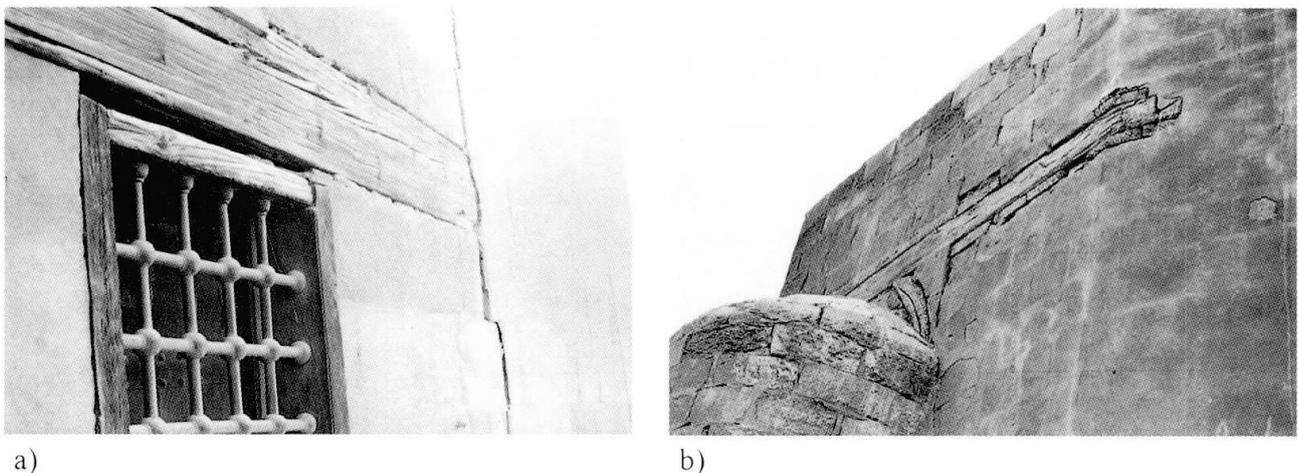
Fig. 8 Wood chains to connect the walls (a) and to counteract the thrust at the base of a dome (b)

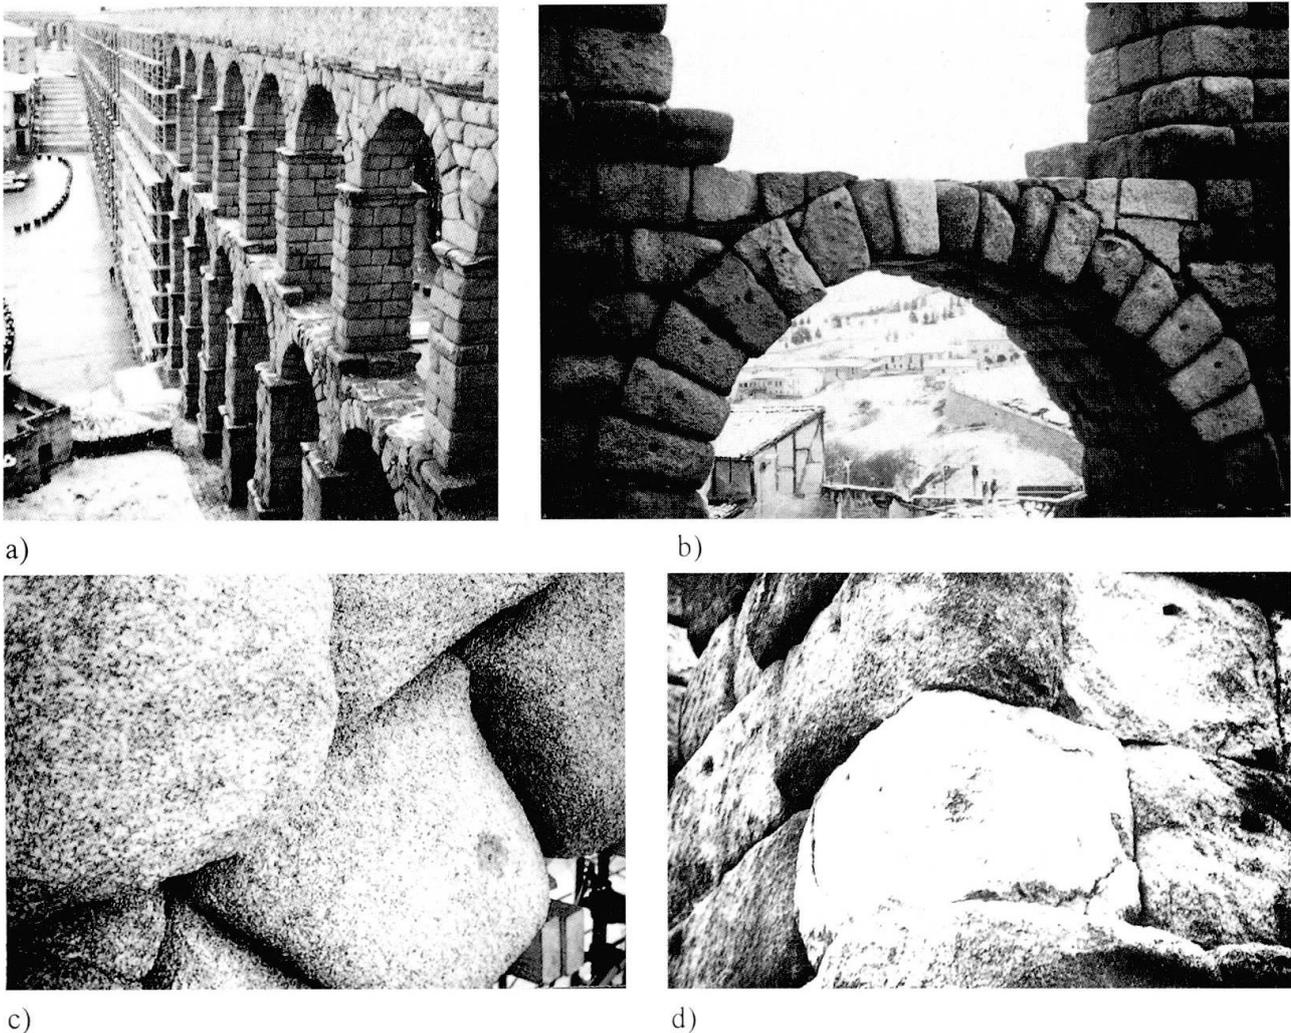
Fig 9 The Aquaduct of Segovia (a), where the perfect equilibrium of arches (b) has not been compromised by the rounding of the blocks edges by two thousand years of snow, rain and eolic action (c), but whose survival is at risk from pollution (d)

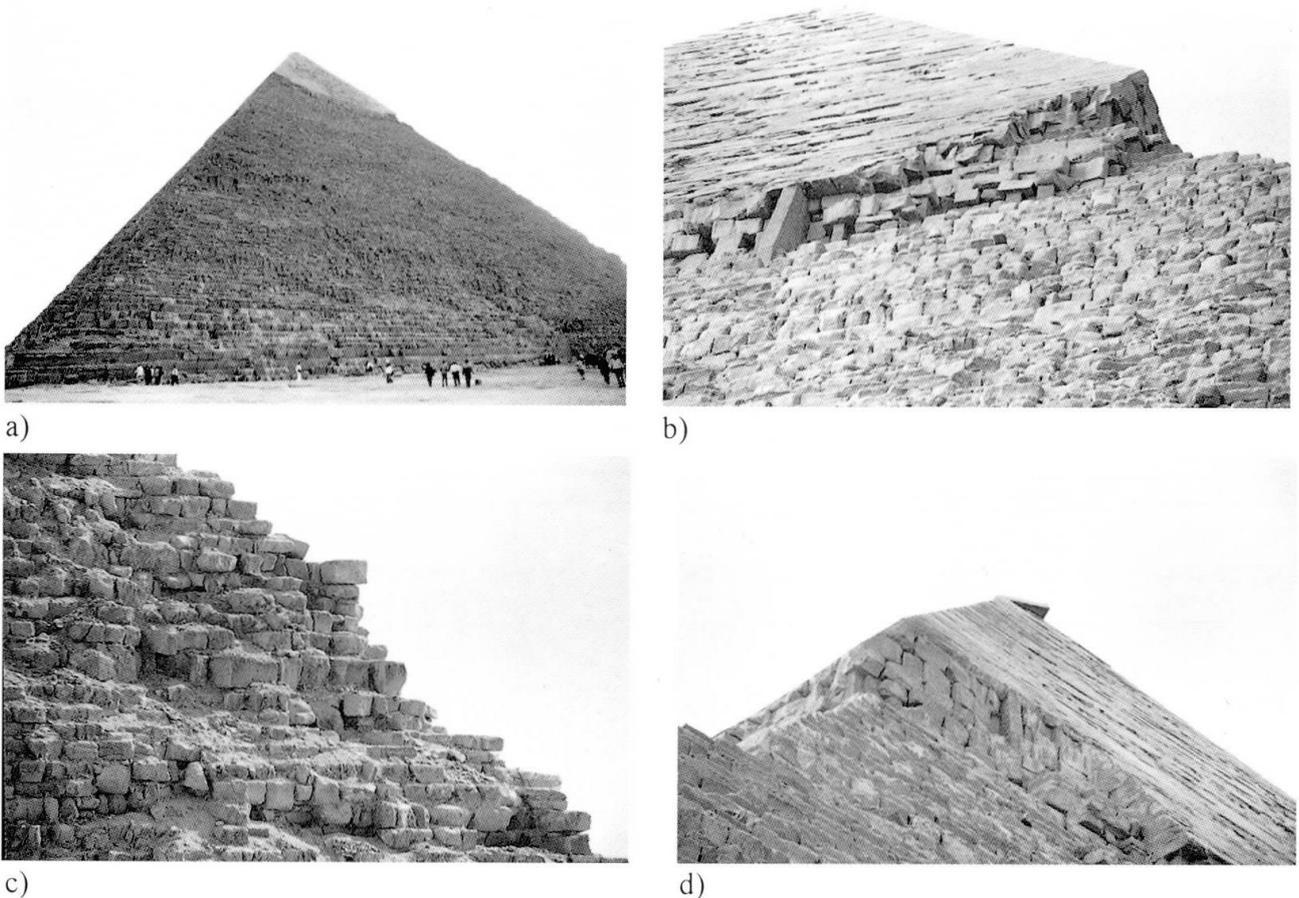
Fig. 10 The Chefred Pyramid (a) suffers from a lack of maintenance; the progressive destruction of the weak mortar and the more fragile blocks (b) has created dangerous conditions (c). The earthquakes have accentuated this situation, making some blocks fall and moving the very top (d)

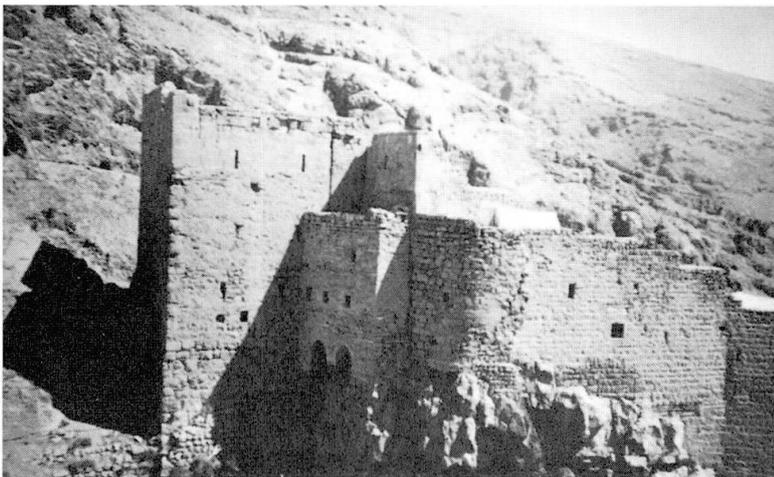
Fig. 11 Monastery of Mar Mousa in Siria: deterioration of the masonry and dangerous disintegration of the stone basement

In some situations, such as the Monastery of Mar Mousa in Syria (figure 11) deterioration is so high that it will be very difficult to reduce the risks to a level that a modern society requires using ancient technologies alone, especially regarding the precarious conditions of the foundations.

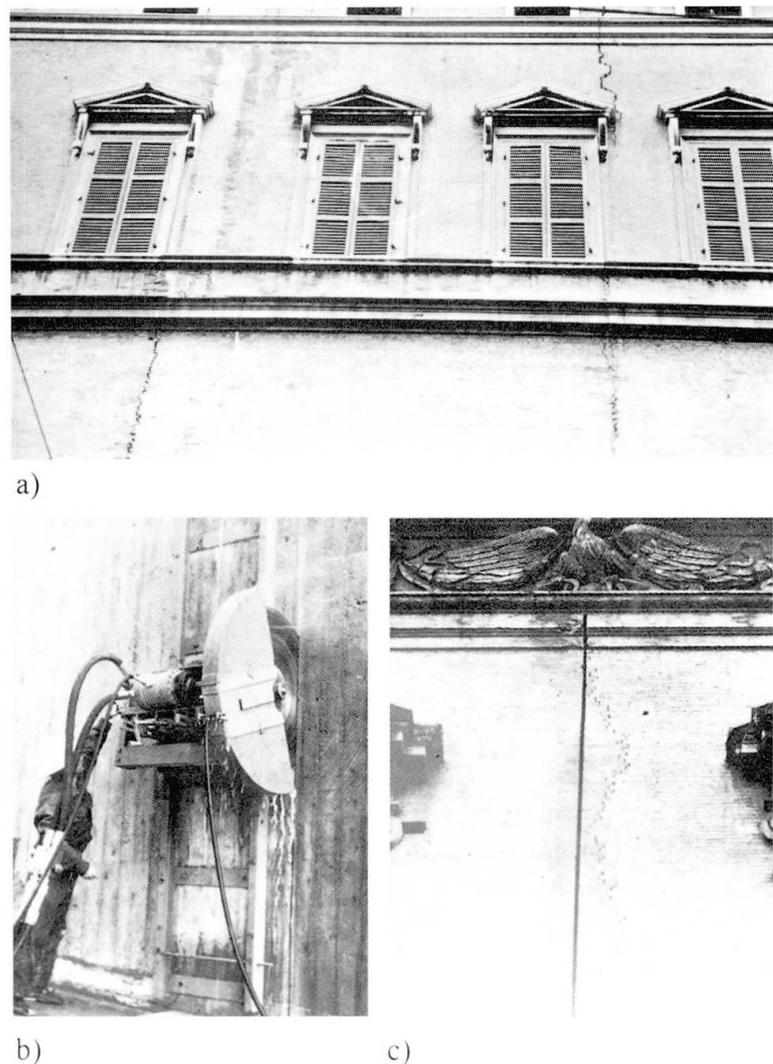
Fig. 12 The Ducal Palace of Modena: relevant cracks in the walls due to soil settlements (a), special device for cutting walls (b) and the realization of joints (c)

The Ducal Palace of Modena (figure 12) was affected by significant subsidence phenomena. Fifteen years ago the problem was solved by making vertical cuts in the Palace following the main cracks in the walls, the movement joints that have been thus created allow the building to follow the soil settlements without further relevant stresses or cracking to the structure. The result has been completely satisfactory.

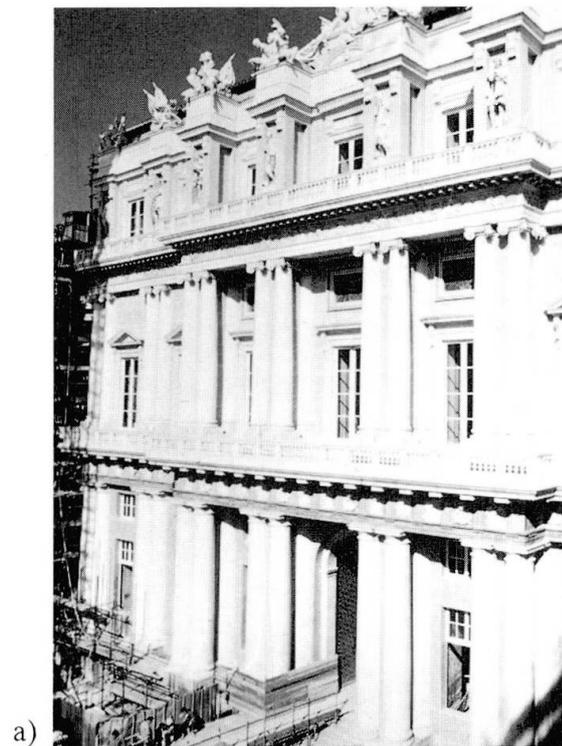
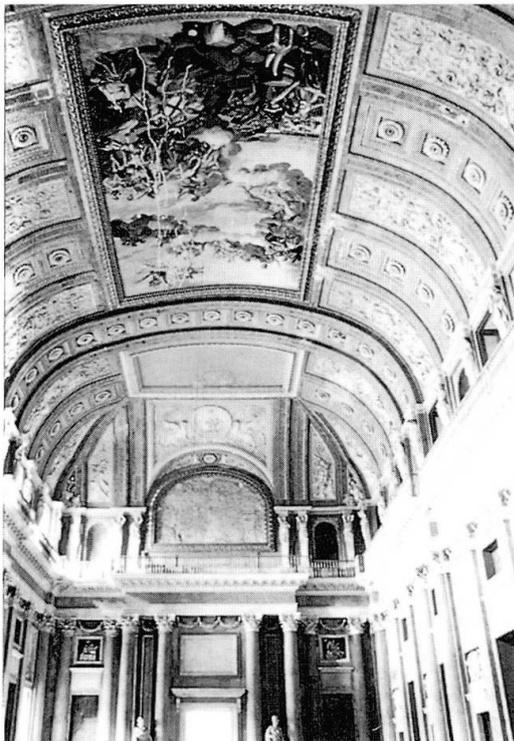
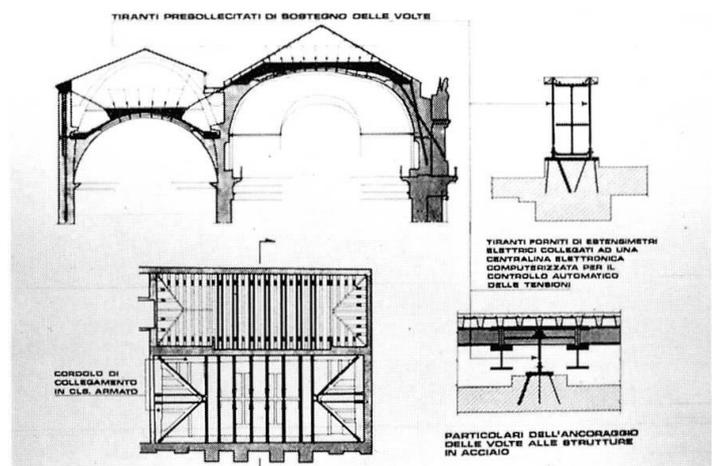
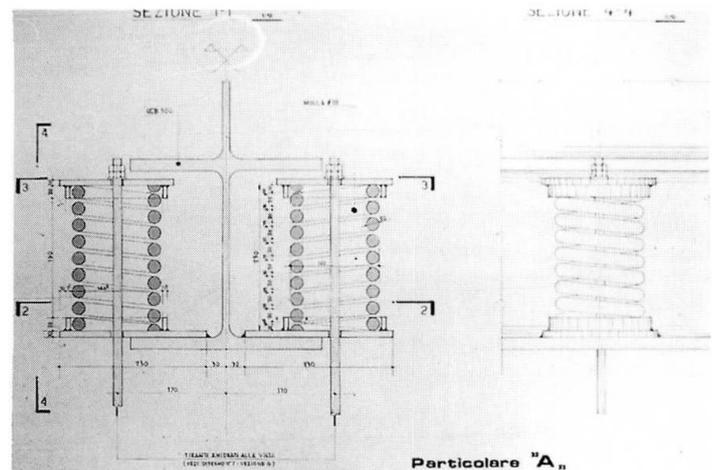
Fig. 13 The Ducal Palace of Genoa: the outward deformation of the façade (a) created by a loss in the curvature of the vault (b); the intervention (c) realized the connection between the opposite walls and support by means of springs (d) to the vault

The Ducal Palace of Genoa (figure 13) suffered from foundation deformations that affected the main façade creating a loss of curvature in the main vault of the salon; the problem required the creation of an efficient connection between the opposite façades and the assurance of the stability of the vault. This was resolved by the placing of a steel arched beam, placed between the vault and the roof. This arched beam works simultaneously as a tie between the walls (for this reason an appropriate stiffness is required) and as a support for the vault by means of small connecting rods. A monitoring system, installed for a year, checked the intervention and particularly the stresses in the connecting rods; the results showed important thermal effects which lead to the replacement of the rods with springs, in order to maintain a constant supporting force. The monitoring system has been thus not only a way of control, but also a support for the final design.

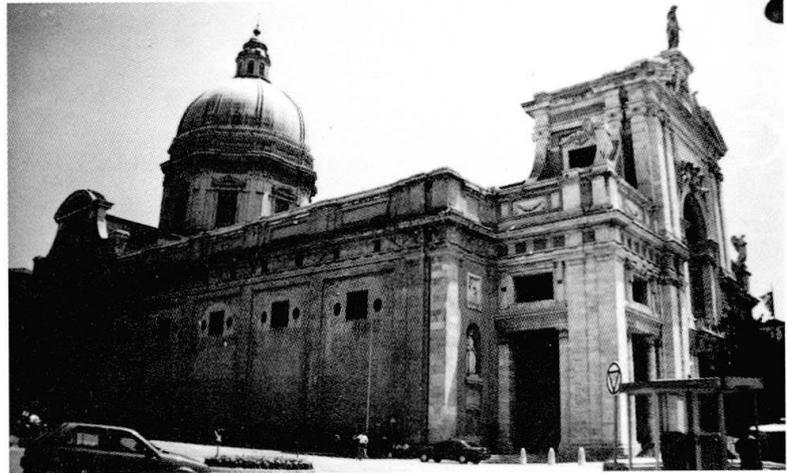
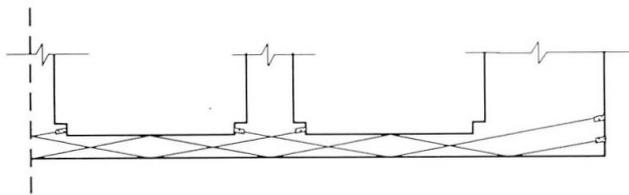
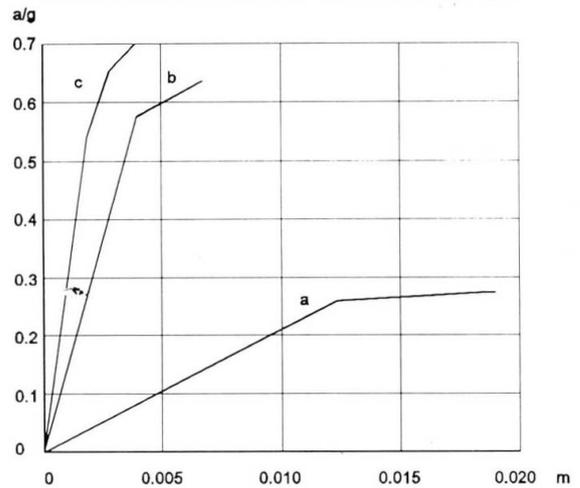
Fig. 14 St. Mary of the Angels in Assisi was affected by seismic cracks (a) and has been reinforced with synthetic fibre (b); the diagrams show the improvement in the seismic resistance capacity calculated by non-linear analysis (c)

POSITIONING IN PLAN OF POST-TENSIONED CABLES AND ANCHORS

DIAGRAM ACCELERATION - DISPLACEMENTS

a: model without intervention
 b: model with intervention without adherence
 c: model with intervention with adherence

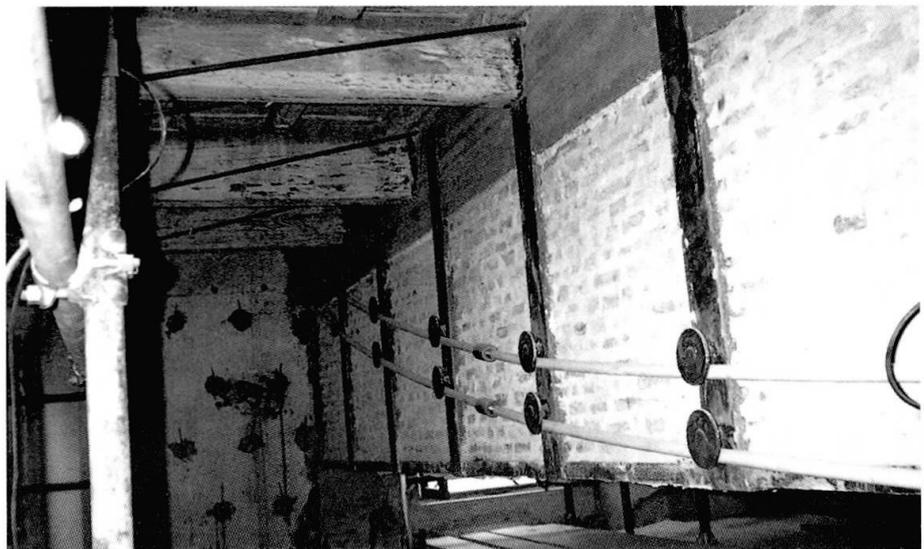
Fig. 15 Palazzo Altemps: prestressed cables to reinforce the remaining upper part of a demolished wall, working now as a "beam", to allow support for the floors above

Prestressed steel cables offer a wide range of applications: in Palazzo Altamps, in order to rid the main ancient saloon of subsequently constructed internal walls whilst supporting the floors that bear onto them, prestressed cables were used to reinforce the upper part of the walls that now work as beams (figure 15).

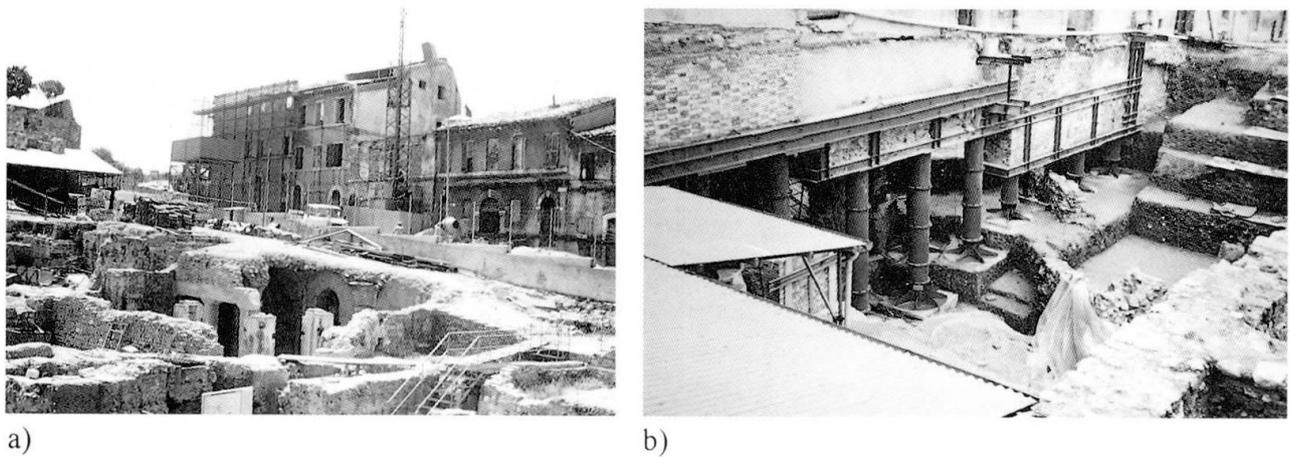
Fig. 16 The Amphitheatre of Ancona with houses built above (a) and excavation works under the foundations (b)

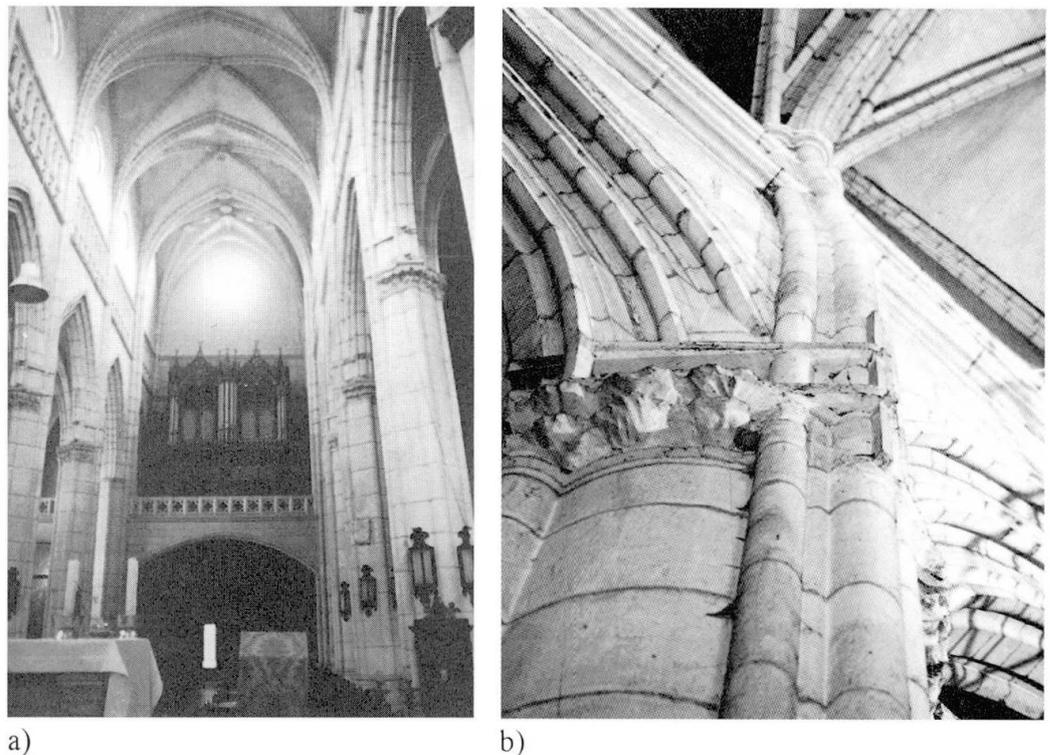
Fig. 17 The Cathedral of Vitoria in Spain (a) and the huge deformations of the columns (b)

We want to mention, finally, that new technology can be very useful when the recovery of a deformation or out-of-plumb is required. A system of jacks connected with a monitoring system, is currently being used while work is in progress on the foundations of the St. Michael Palace in Rome. A similar system is used to control the archeological excavation works beneath the foundations of small houses built centuries ago over the roman amphitheatre of Ancona (figure 16): a serie of provisional steel elements created under the foundations, step by step, allow the progression of the excavation before choosing the final solution. In the Cathedral of Vitoria in Spain (figure 17)

provisional steel elements connected to a monitoring system are going to be used to recover the huge deformations created by ancient soil settlements.

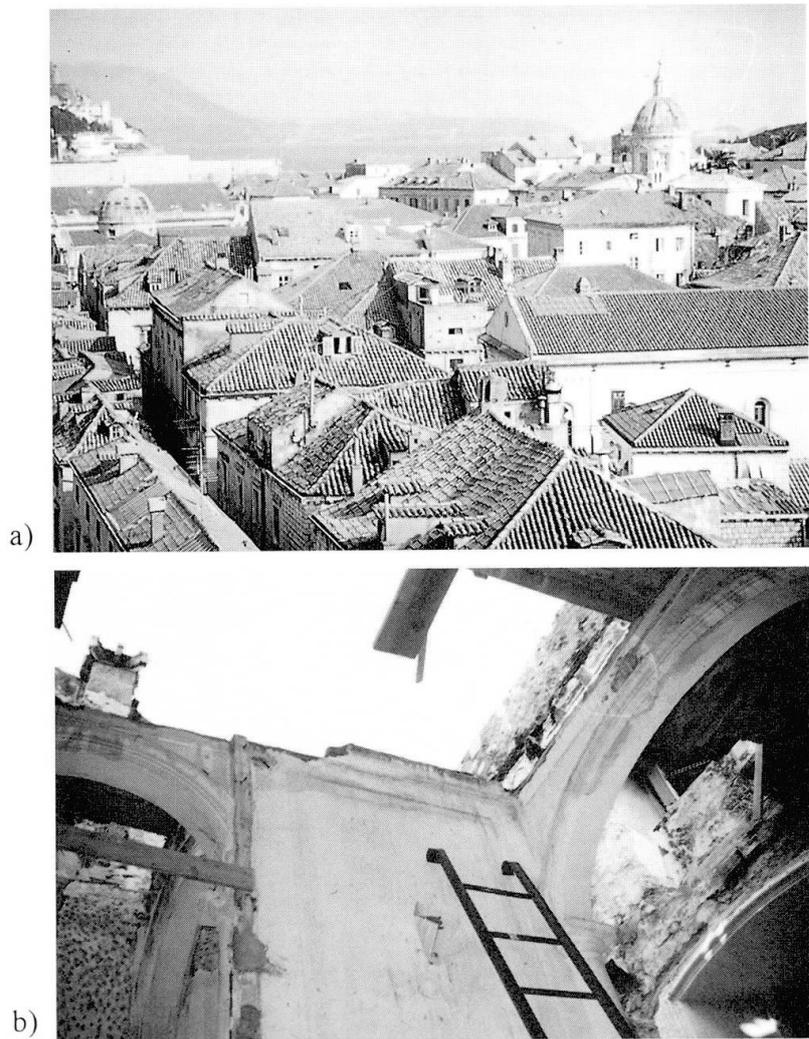
Fig. 18 A view of Dubrovnik (a) and the damages after the bombing in December 1991 (b)

It is unquestionable that a code for investigations, analysis, projects, works, controls, etc.. would not just be useful but is absolutely necessary. The lack of guidance allows us to propose solutions that are often based on arbitrary decisions without proof of the benefits or preliminary experimentation to discover the possible side effects. Besides which, as quality control is not always requested, there is no certitude that the expected results will be attained. The lack of a specific code is also the cause of misunderstanding and leads to the inappropriate use of other codes that are aimed for different purposes. The seismic codes created for new constructions or for the repair of seismic damages in ordinary buildings for example cannot be used, either for the characteristics of the actions (the behaviour of a monument under seismic loading is very particular) or for the techniques often proposed (extensive use of reinforced concrete,...). This problem occurred in Dubrovnik where, after the bombing of December 1991, we began to study various buildings with the view to designing restoration interventions (figure 18); as Dubrovnik is in a zone of strong seismic action, and we must

follow the Croatian Seismic code, we will be obliged to introduce reinforcement heavier than that required for the repair: therefore the code risks being as damaging as the bombs, creating alterations that may compromise the historical value which has been preserved for centuries.

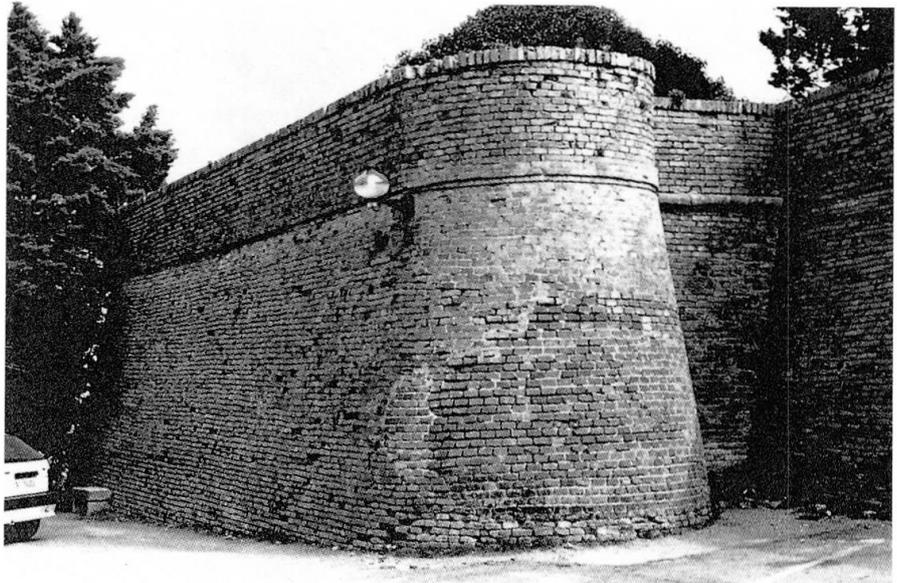
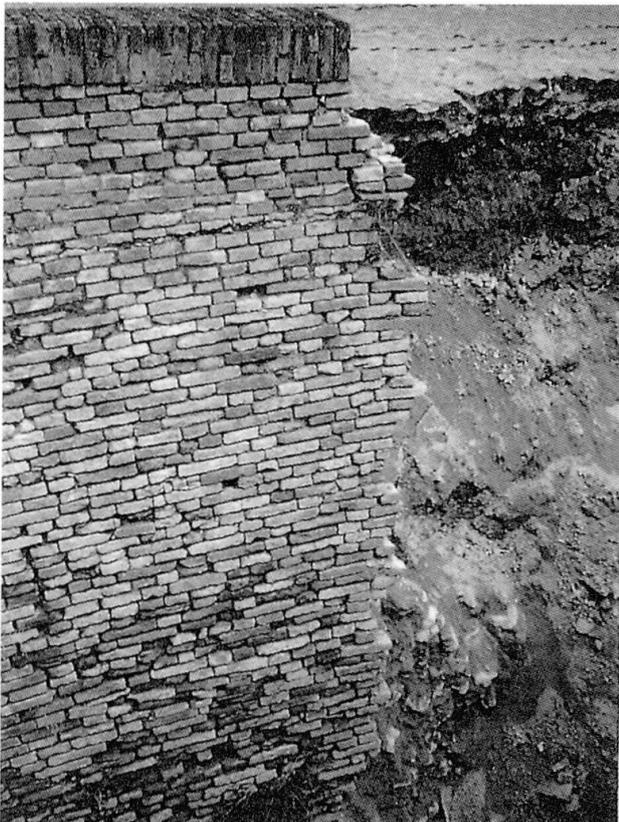
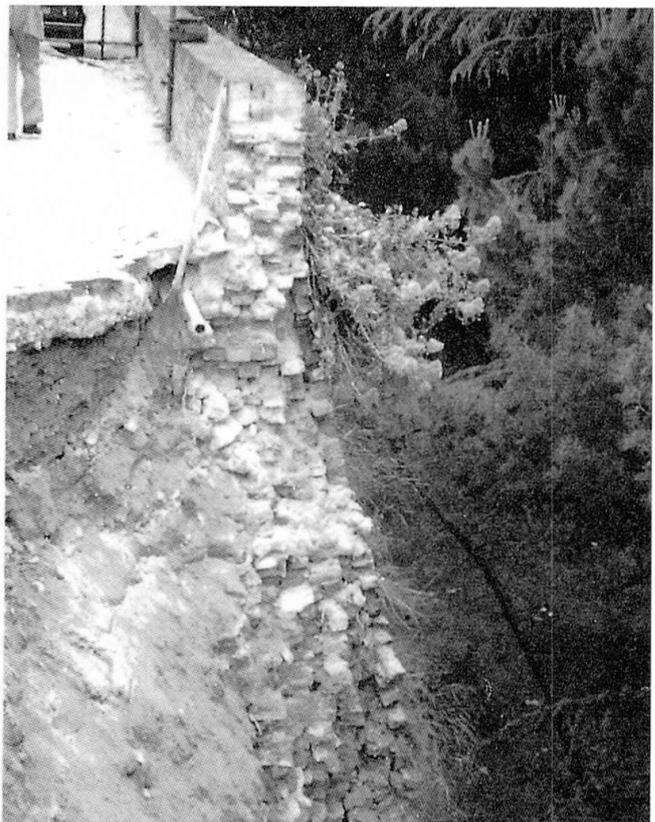
Fig. 19 A view of the Urbino walls (a), a collapsed zone where it is possible to see the poor condition of the masonry (b, c)

A similar problem is posed in the restoration of the historical walls of Urbino (figure 19), largely damaged and with a part that has recently collapsed. Calculations following the usual Code on the retaining walls show that the earth pressures are higher than the Urbino walls are capable of supporting; the designers and administrators have been left with a difficult choice, between accepting lower safety levels, thereby breaking the law or carrying out interventions that will presumably be stronger than necessary thus substantially modifying the original conception
