Artikel: Structural assessment of Leaning Tower of Pisa

Autor: Macchi, Giorgio / Ruggeri, Giovanni / Eusebio, Marina

Structural Assessment of the Leaning Tower of Pisa

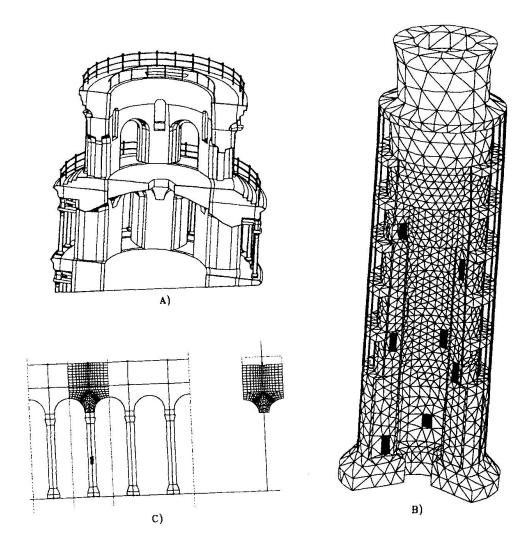
Fig.7 - Modelling of the Tower: numerical model (A), F.E.M. (B), substructuring of the colonnade system (C)

model of the Tower (Fig.7A), and then a Finite Element mesh (Fig.7B) of tetrahedral 10 nodes element (simulating the Tower and a block of linear elastic soil), for a total of 67000 degrees of freedom.

The model takes into account all the relevant openings and stairs, and 7 different densities for parts of the structure (from 18.2 to 2.7 KN/m³). A reduced level of refinement of the mesh in the upper part allowed a considerable reduction of the complexity of the model; in the most critical zones (at South, for the lowest 4 sections) the refinement has been improved by increasing the order of polynomial shape function [6]. Nevertheless, the complexity would be excessive if the colonnade would be modelled in detail; therefore (Fig.7C) the elements of the external colonnade (columns and arches) are simulated by trusses of equivalent axial stiffness.

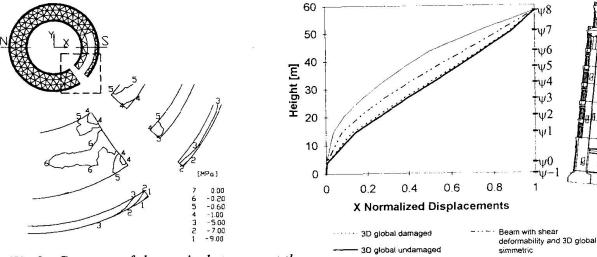
Fig.8 - Contours of the vertical stresses at the first loggia

the position of the zones of maximum stress (in Fig.8 the vertical stress contours show that the
critical section at the first loggia is not in the plane of maximum lean, but at SW, at the edge of
the door);

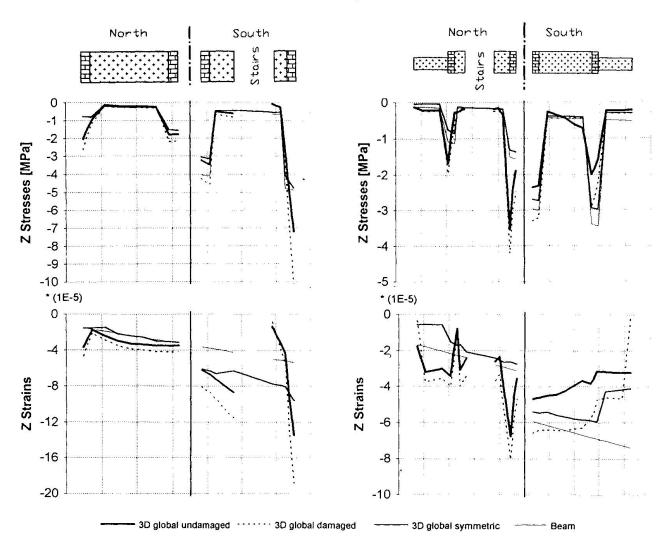
Fig. 10 - Stresses and strains at the first loggia: comparison among different models

Fig.11 - Stresses and strains at the second loggia: comparison among different models

Figures 10 and 11 compare the strain and stress distribution across the Tower, in the plane of maximum lean, at the first loggia $\psi 1$ and a second loggia $\psi 2$; the former has the stair at South, the latter at North. In both cases the stress distribution is far from the linear distribution of the plane section hypothesis ("beam" approach), and high vertical stress concentrations appear at the edges of the helicoidal stair opening. The "3D damaged" shows the higher stresses due to the absence of the columns.

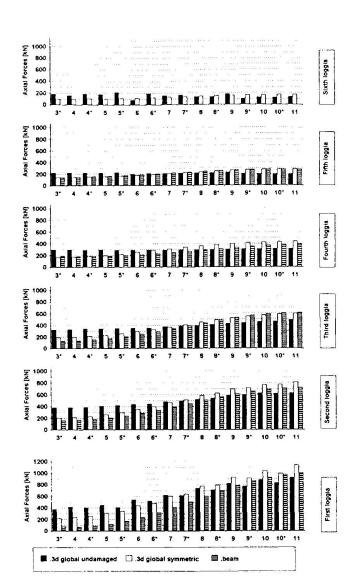
Fig. 12 - Axial forces in the colonnade:

Finally, Fig.12 compares the load in each column, at the different levels, according to the different assumptions; column 3* is at the Northern edge, column 11 at the Southern one.

- the loads on the columns are much more uniform than expected by the simplified methods of analysis;
- the columns at North are more efficient than foreseen by "beam";
- the helicoidal stairs have influence on the column load.

comparison among different models
