Zeitschrift: IABSE reports = Rapports AIPC = IVBH Berichte
Band: 70 (1993)

Artikel: Structural assessment of Leaning Tower of Pisa
Autor: Macchi, Giorgio / Ruggeri, Giovanni / Eusebio, Marina
DOI: <https://doi.org/10.5169/seals-53323>

Structural Assessment of the Leaning Tower of Pisa

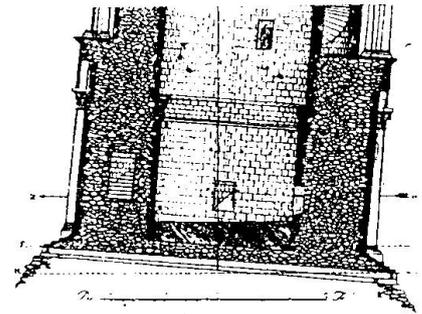
Fig.1 - Internal structure of the Tower

The cylindrical wall of the Tower is not homogeneous; between two marble linings of not constant thickness (between 250 and 400 mm) the core of the wall is made of rubble stones bonded with lime mortar (Fig.1).

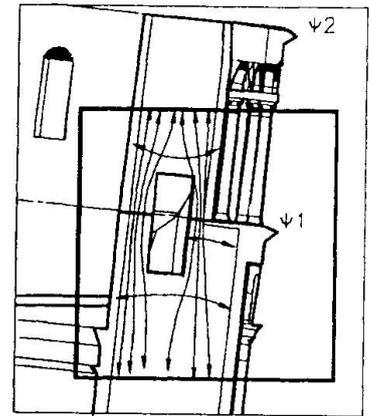
Fig.2 - Critical zone of the Tower at the first loggia

The danger is particularly high at the level of the first *loggia*, where the section of the wall is substantially reduced by the helicoidal stairs and by local cavities. Moreover, the very stiff marble facing is pressing the underlying rubble masonry with a very high compressive stress (Fig.2). In the same zone, 2 long vertical cracks have been recently found on the external facing; they may be a sign of splitting under vertical compression. Finally, the presence of radial tensile stresses caused several circumferential cracks in the ceiling and on the steps of the stairs.

However, the main concern is due to the high pressure that the external marble facing applies on the underlying masonry, through a marble slab only 160 mm thick (Fig.2). Therefore, a more detailed study of the state of stress in that region has been carried out by Plane Strain Finite Element analysis (Fig.5).

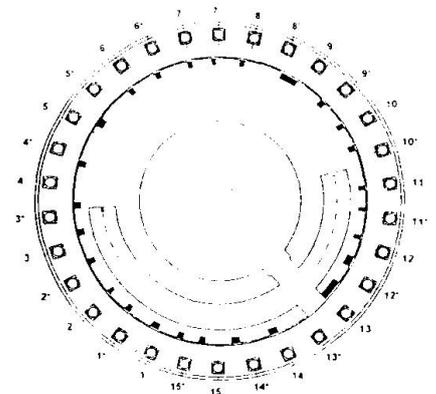
Fig.3 - Buche pontaié (recesses) at the first loggia

However, a very important local deficiency as been well documented and was taken into account: a presence of 27 large recesses (the mean size was approximately 360x230x200 mm), the *buche pontaiè*, left at the level of the first loggia during construction, for the accommodation of the scaffolding (Fig.3). Such recesses reduce by 18% the resisting horizontal section of the marble facing, and increase by 13% the edge stresses under permanent load.

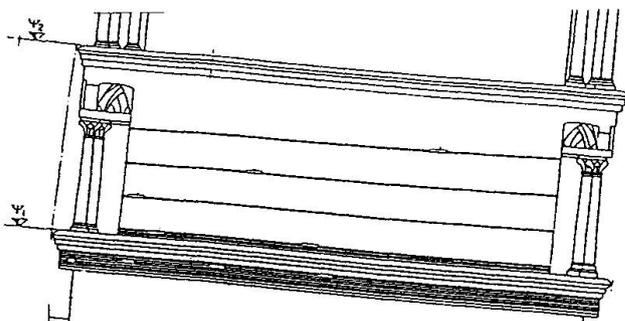
Fig.6 - Circumferential temporary prestress

In order to provide an increased margin of safety of the elevation of the Tower during the envisaged intervention on the foundations, a temporary and reversible circumferential prestress of the critical zone has been studied in 1991 by Macchi and Leonhardt, and implemented by VSL/Preco in 1992 (Fig.6).

A circumferential prestress of 2100 KN is applied by 18 0.6" unbonded strands, specially anchored. The intervention creates a slight state of multiaxial compression, and so slightly increases the strength to vertical compression of the infill and of the facing; it counteracts and it provides also a passive strength preventing external local spalling or dilatation in critical zones.

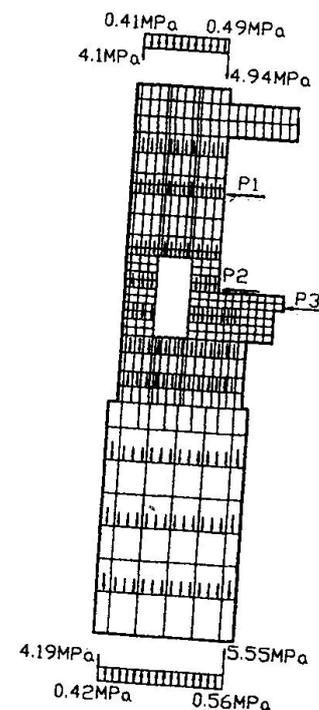
Fig.5 - Local bidimensional F.E. approach at the first loggia

Where the marble facing is pressing on the pavement of the loggia a vertical stress of 5.9 MPa was found, and under it, in the infill masonry, 3.0 MPa, value which is approaching the estimated strength. Radial tensions up to 0.3 MPa were found on the steps and roof of the helicoidal stairs, and may explain the existing circular cracks.

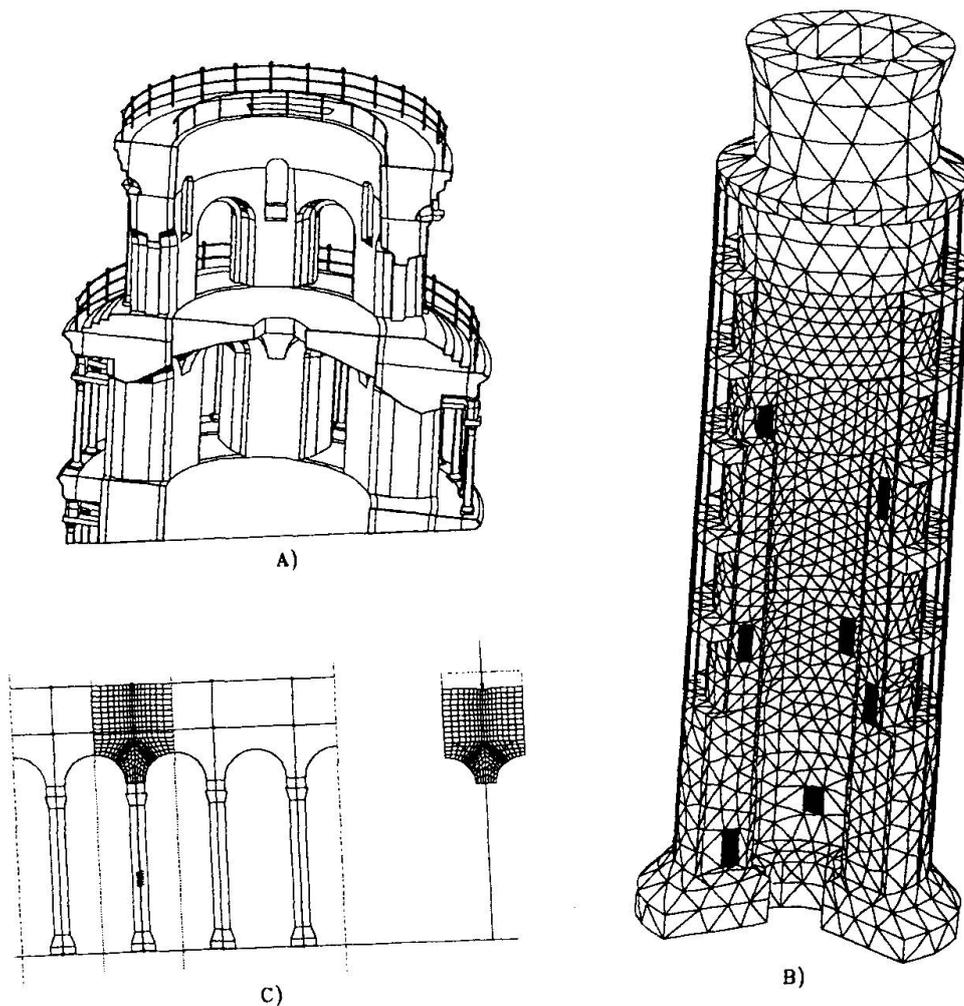
Fig.7 - Modelling of the Tower: numerical model (A), F.E.M. (B), substructuring of the colonnade system (C)

model of the Tower (Fig.7A), and then a Finite Element mesh (Fig.7B) of tetrahedral 10 nodes element (simulating the Tower and a block of linear elastic soil), for a total of 67000 degrees of freedom.

The model takes into account all the relevant openings and stairs, and 7 different densities for parts of the structure (from 18.2 to 2.7 KN/m³). A reduced level of refinement of the mesh in the upper part allowed a considerable reduction of the complexity of the model; in the most critical zones (at South, for the lowest 4 sections) the refinement has been improved by increasing the order of polynomial shape function [6]. Nevertheless, the complexity would be excessive if the colonnade would be modelled in detail; therefore (Fig.7C) the elements of the external colonnade (columns and arches) are simulated by trusses of equivalent axial stiffness.

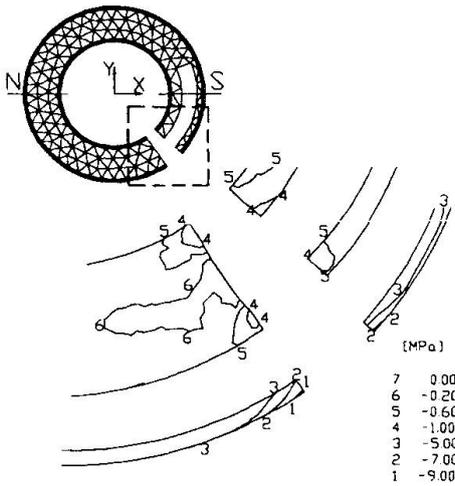
Fig.8 - Contours of the vertical stresses at the first loggia

- the position of the zones of maximum stress (in Fig.8 the vertical stress contours show that the critical section at the first loggia is not in the plane of maximum lean, but at SW, at the edge of the door);

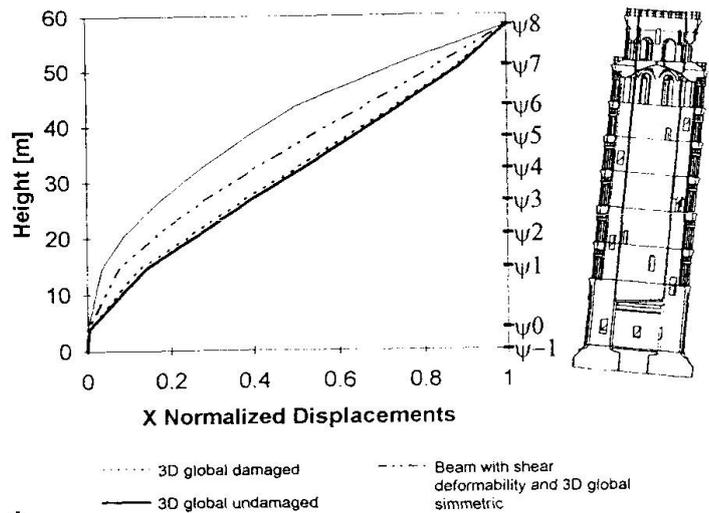
Fig.9 - Normalized horizontal displacements of the center line under permanent load

The inadequacy of the simple beam model is shown in Fig.9, where the deflection shapes are compared (under permanent load only): it gives flexural deflections only, when the "3D globals" act at the top as shear cantilevers, and show a peculiar contraflexure; intermediate is the behaviour of the simplified "3D symmetric", whose solid walls are less sensitive to shear; the latter may be well simulated by the beam with correction for shear deformability. The deflections are normalized to 1; in fact, "3D damaged" gives higher deflections than "3D undamaged".

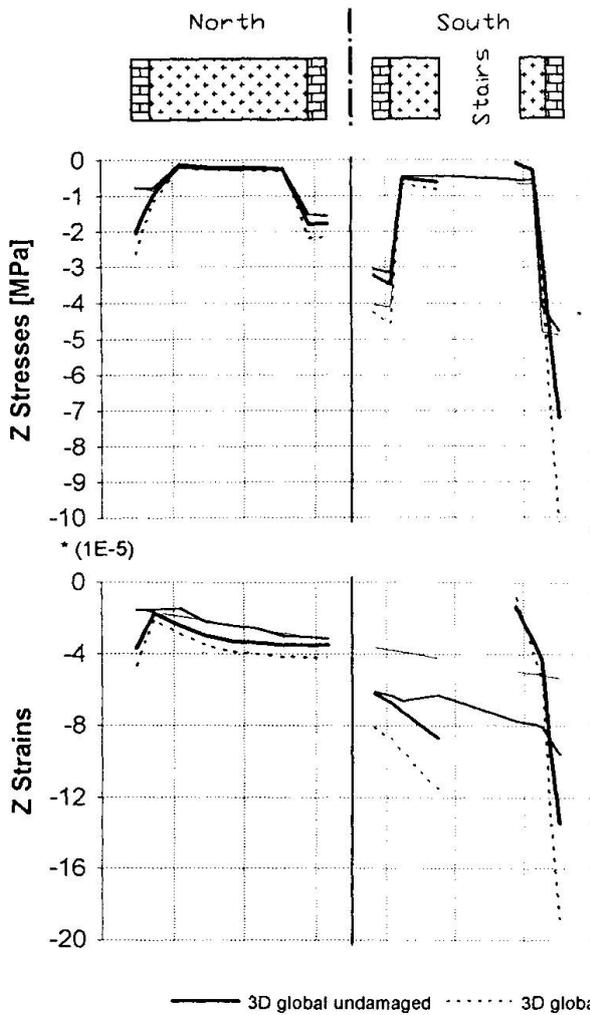
Fig.10 - Stresses and strains at the first loggia: comparison among different models

Figures 10 and 11 compare the strain and stress distribution across the Tower, in the plane of maximum lean, at the first loggia ψ_1 and a second loggia ψ_2 ; the former has the stair at South, the latter at North. In both cases the stress distribution is far from the linear distribution of the plane section hypothesis ("beam" approach), and high vertical stress concentrations appear at the edges of the helicoidal stair opening. The "3D damaged" shows the higher stresses due to the absence of the columns.

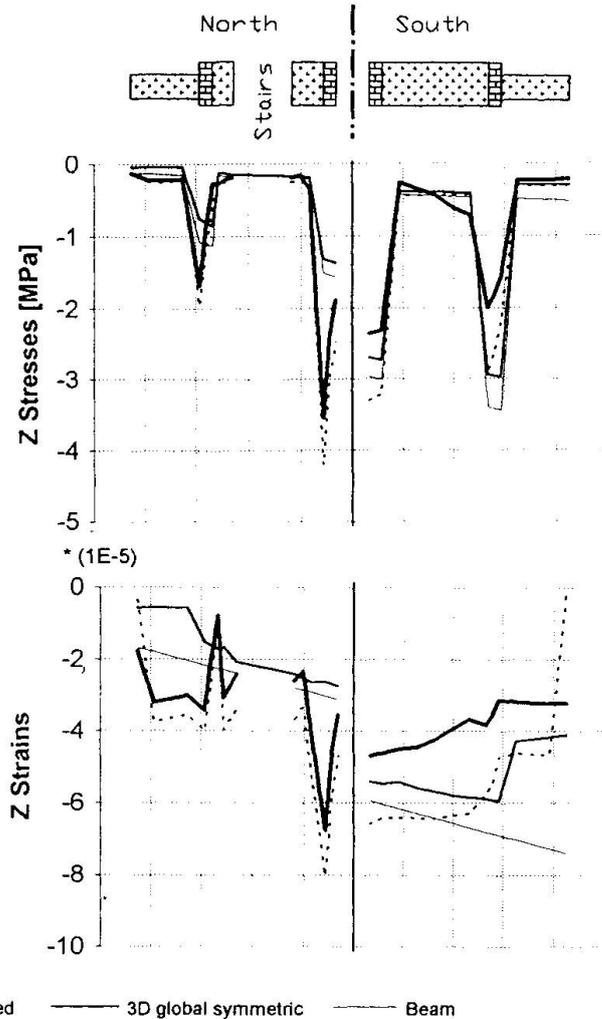
Fig.11 - Stresses and strains at the second loggia: comparison among different models

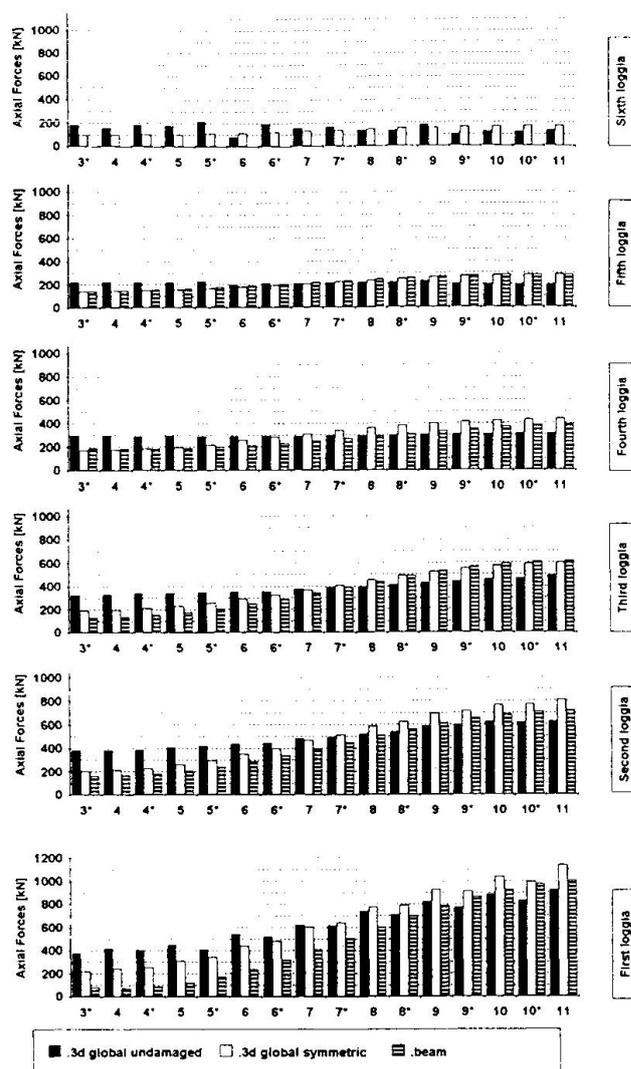
Fig.12 - Axial forces in the colonnade: comparison among different models

Finally, Fig.12 compares the load in each column, at the different levels, according to the different assumptions; column 3* is at the Northern edge, column 11 at the Southern one.

- the loads on the columns are much more uniform than expected by the simplified methods of analysis;
- the columns at North are more efficient than foreseen by "beam";
- the helicoidal stairs have influence on the column load.
