Artikel: Damage and repair of St. Charles Basilica in Rome

Damage and Repair of the St. Charles Basilica in Rome

The paper reports on studies of damage and solutions proposed for the restoration of the dome of the St. Charles Basilica in Rome. The study is based on the results of an indepth program of investigation on the soil conditions, the building materials and the analysis of the behaviour during this period. The data has been recorded by a computer connected to a monitoring system. The assessment of the safety levels was performed with the support of mathematical models, by studying historical information and a permanent analysis and comparison of theoretical results with reality.

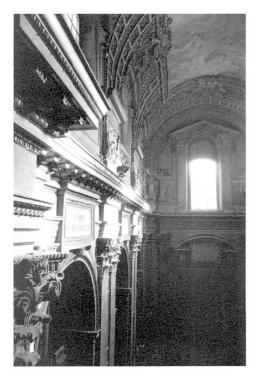
Fig.2

At the death of Onorio the project continued under the guidance of his son, Mario Longhi, with successive interuptions due to lack of funding, the most important being the interuption which occurred from 1625 to 1642, during which the central vault was absent; this probably lead to large deformations of the columns in the central nave that are now out of plumb by about 10cm (fig. 2).

Longitudinal cracks are present along the lateral nave in the keys of the vaults, these are associated with a pronounced deformation of the columns along the central nave and a macroscopic deformation of the cornice (fig. 2).

The study of the soil - structure interaction also justified the lateral deformation of the columns in the nave and the curvature of the cornice, probably produced during construction due to the delay in the construction of the central nave which left the thrust from the vaults of the lateral naves unresisted for decades.

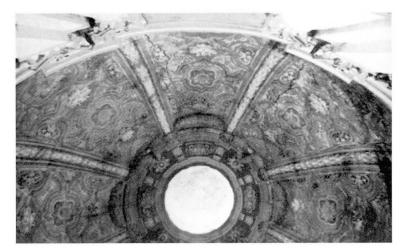
Fig. 4

The church has suffered from large scale cracking present in the dome, the vaults of the lateral naves and the vaults of the preambulatory general they are diagonal symmetrical about the longitudinal axis of the church), some cracks are also present in the walls, the crypt, the paving and in the floor above. The cracks in the dome are rather serious, being of the amplitude of a few centimeters (fig. 4); they follow the meridian curves and are concentrated around the ribs. where architectural requirement of emphasing the ribs lead to a reduction of the dome section immediately next

to them, they continue along the drum and also affect the fan arches connected to the drum.

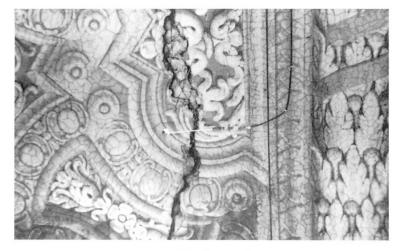
Fig. 5

An important part of this investigation was the monitoring system set up to automatically survey the opening and closing of the cracks over time, in relation to the variation of temperature and other phenomena (fig. 5).

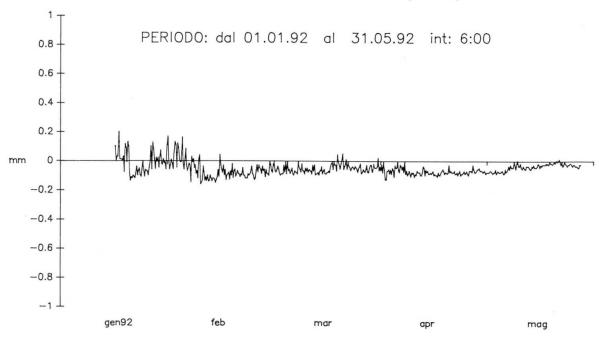
Fig. 6

During the control period, which took place, with interuptions, for over three years, no sign of evolutionary phenomena linked to the cracking was observed; however the longitudinal cracks showed a high sensibility to both the daily and seasonal temperature cycles, probably caused by the fact that these cracks represent a hinge which

runs along the centre of the basilica and along which the thermal deformations take place (fig. 6).

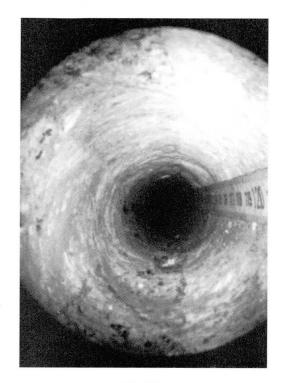
Fig. 7

- traditional geognostic tests and inspection of the soil strata and foundations with a miniture telecamera;
- observation of the composition and condition of the masonry by means of an endoscope placed in small drilled holes, the presence of deep cracks or cavities could also be ascertained (fig. 7);
- sonic tests to determine the homogeneity and compaction of the masonry;
- in-situ flat-jack and pull-out tests, to determine both the strength and the existing stress levels of the masonry to a reasonable approximation (fig. 8);
- measurement of the verticality of the columns in the nave.

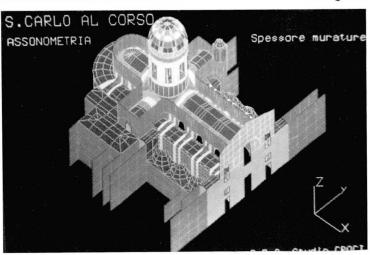
Fig. 9

series of checks, and were carried out by means of different finite element mathematical models of the structure; the global model took into account the real three-dimensional distribution of the mass and rigidity of the basilica and of the adjacent buildings, closely connected to the walls of the lateral chapel (fig. 9).

Three different analyses were calculated by means of these models: the first considering the dead load only, the second taking account of seismic actions coresponding to the earthquake of 1703, the third considering the effects of temperature. In particular, the models took account

of the entire form of the dome disregarding the presence of cracks in order to discover what caused them. Regarding the central part of the basilica, the levels of tensile stress in the parallels of the dome were analized to find the correlation between them and the existing cracks. The maximum values obtained were:

- for dead load: 0.7t/m²
- dead load + seismic load: 0.8t/m²
- dead load + seasonal variation in temperature (summer to winter) + seismic action: 1.1t/m².

The maximum tension was verified as being adjacent to the ribs of the dome, due to the reduction of the section at this point, corresponding perfectly to the existing crack pattern; however

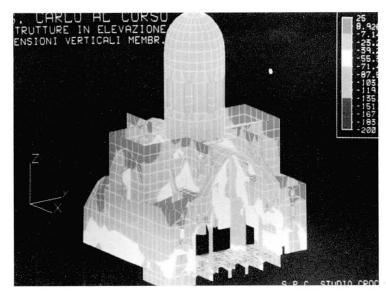
Fig. 10

It thus appeared necessary to investigate other possible phenomena, and in particular the role of soil movements; a finite element model was then used to specifically study the interaction between structure and soil, and to evaluate the influence of soil movements on the formation of the cracks (fig. 10). This model took into account the mechanical characteristics of the soil gleaned from the series of tests carried out.

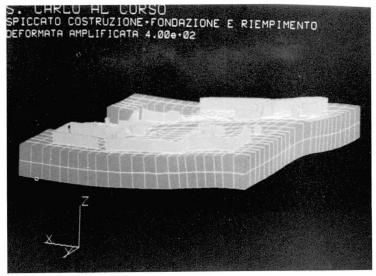
Fig. 11

The analysis of the deformations caused by loads transmitted to the soil from the structure (fig. 11), showed a large settlement in the area of the crypt

and apse with respect to the lateral nave. The deformations of the transepts, with respect to the central part of the basilica, produce a rotation around the outer columns of the dome (fig. 12), and additional stresses in the rings of the drum and the dome itself.

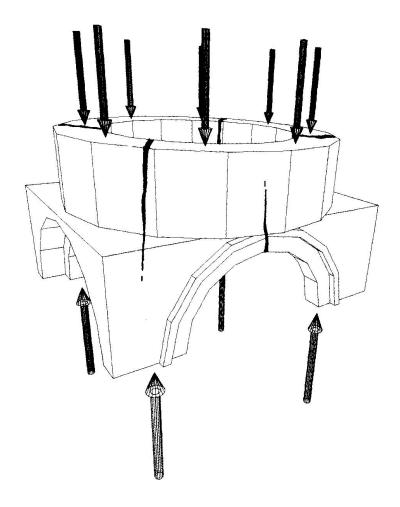
Fig. 13

As the drum is affected by four windows, which, for architectural motives of symmetry, occupy the principal axes of the basilica, the load of the dome is transmitted in the lower arches with an eccentricity in relation to the columns; this leads to a further increase in stress that is suoerimposed onto those generatedby load, temperature and seismic actions, overcoming the strength of the material thereby causing the distribution of cracks visible today (fig. 13).

Thus having understood the origin of the cracks in the dome and the drum a new model has been made to verify the present safety level. The results show important bending moments in the "arches" created along the meridians by the cracks themselves (fig. 13). In order to eliminate this unfavourable situation a system of hoops, using metal cables placed at different levels on the outer surface of the dome, was proposed; the cables are not visible as they are placed beneath the lead sheeting which will be replaced and re-anchored.

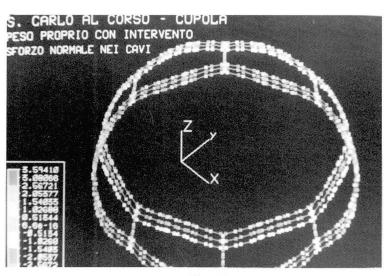
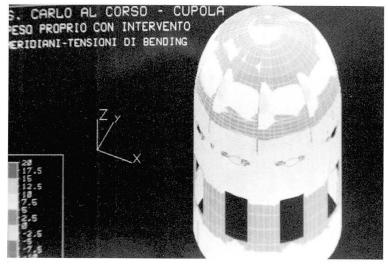
To find the most appropriate positioning of the hoops, which consist of three separate pairs of cables, to determine the level of prestressing required in order to minimize the bending stresses in the meridians that developed as a result of the cracking and to assume appropriate safety levels, a final mathematical model was created (figg. 14 and 15).

The hooping cables, made of high strength stainless steel, (the type normally used for sailing boats) are lightly prestressed, in order to provide immediatly the optimum radial action and reestabilish a bidimensional "meridians-parallels" membrane behaviour. This solution incorporates economy, ease of construction, favourable structural behaviour anddurability.

This type of intervention is really a modern version of an ancient method for reinforcing domes, that used to involve chains built around the base of the dome. It is reversible and does not alter the architectural aspect of the dome, from the structural point of view moreover, notwithstanding the modest stresses directly applied to the masonry as shown by the mathematical model, it guarantees the survival of the monument even in the evet of future earthquakes.
