Artikel: Damage and repair of St. Charles Basilica in Rome
Autor: Zurli, Francesco / Viola, Raffaele M.
DOI: <https://doi.org/10.5169/seals-53325>

Damage and Repair of the St. Charles Basilica in Rome

Francesco ZURLI

Raffaele M. VIOLA

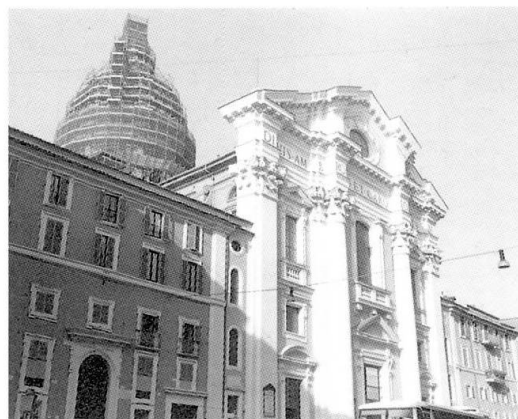
Fig. 1

The construction of the church began in 1612, after Pope Paul V canonised St. Charles Borromeo. It was finished in 1684 with the completion of the façade (fig. 1).

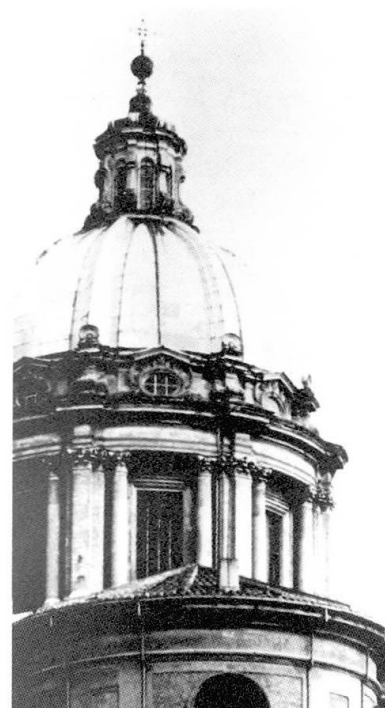
Fig. 3

The drum and dome were built in 1668 and 1669 under the direction of Pietro Berrettini (known as "il Cortona") (fig. 3). By the time Rome was affected by the strong earthquake, which caused damage and failures in the Colosseum, in 1703, the building was completed.

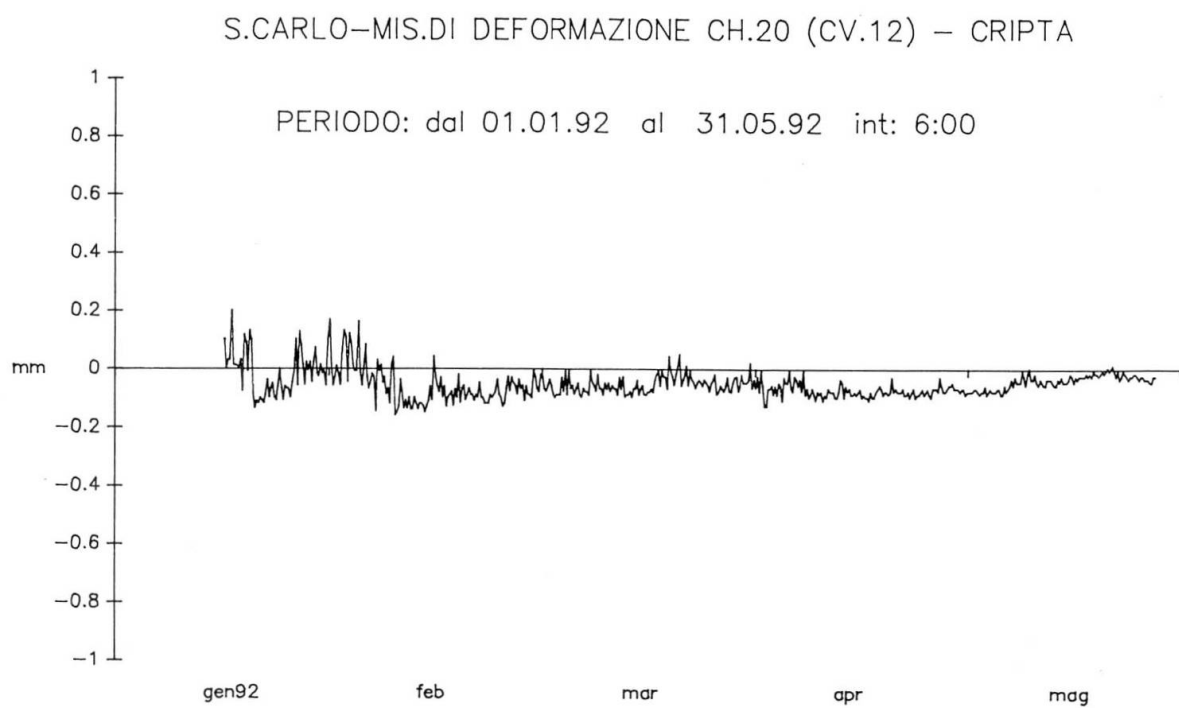
Fig. 6

During the control period, which took place, with interruptions, for over three years, no sign of evolutionary phenomena linked to the cracking was observed; however the longitudinal cracks showed a high sensibility to both the daily and seasonal temperature cycles, probably caused by the fact that these cracks represent a hinge which

runs along the centre of the basilica and along which the thermal deformations take place (fig. 6).
