Zeitschrift: IABSE reports = Rapports AIPC = IVBH Berichte
Band: 70 (1993)

Artikel: Damage and repair of St. Charles Basilica in Rome
Autor: Zurli, Francesco / Viola, Raffaele M.
DOI: <https://doi.org/10.5169/seals-53325>

Damage and Repair of the St. Charles Basilica in Rome

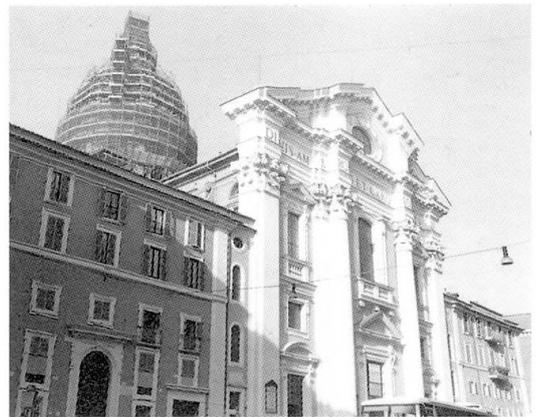
Fig. 1

The construction of the church began in 1612, after Pope Paul V canonised St. Charles Borromeo. It was finished in 1684 with the completion of the façade (fig. 1).

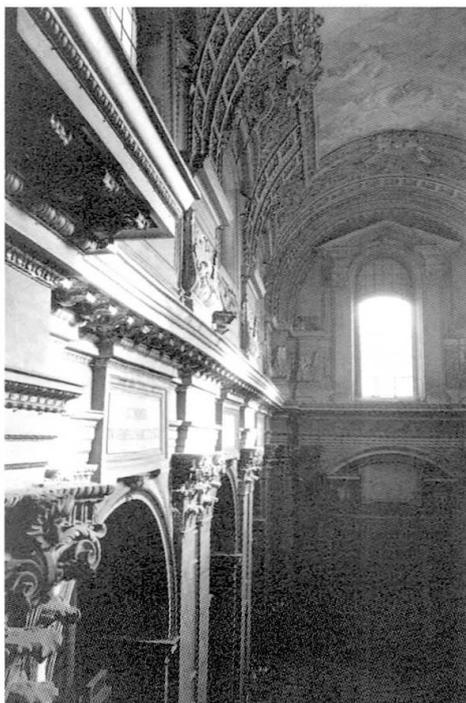
Fig. 2

At the death of Onorio the project continued under the guidance of his son, Mario Longhi, with successive interruptions due to lack of funding, the most important being the interruption which occurred from 1625 to 1642, during which the central vault was absent; this probably led to large deformations of the columns in the central nave that are now out of plumb by about 10cm (fig. 2).

Longitudinal cracks are present along the lateral nave in the keys of the vaults, these are associated with a pronounced deformation of the columns along the central nave and a macroscopic deformation of the cornice (fig. 2).

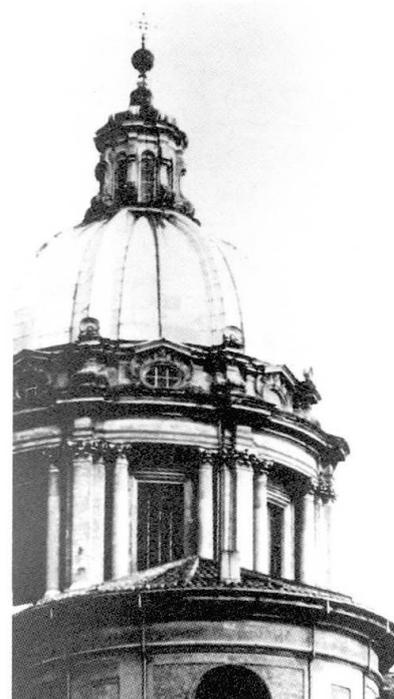
Fig. 3

The drum and dome were built in 1668 and 1669 under the direction of Pietro Berrettini (known as "il Cortona") (fig. 3). By the time Rome was affected by the strong earthquake, which caused damage and failures in the Colosseum, in 1703, the building was completed.

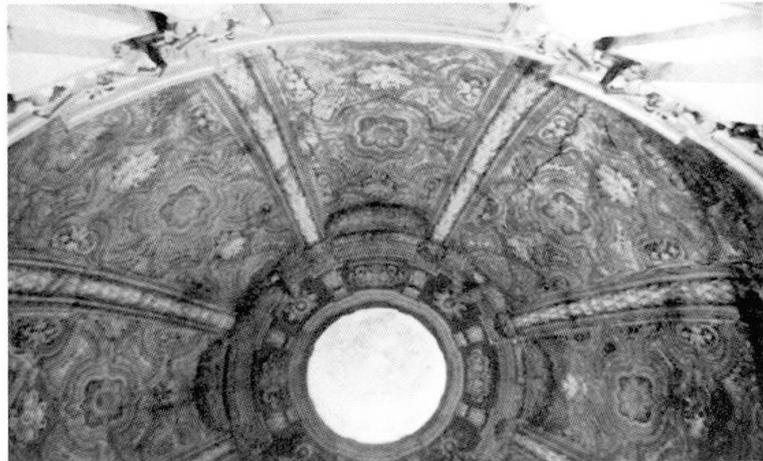
Fig. 4

The church has suffered from large scale cracking present in the dome, the vaults of the lateral naves and the vaults of the preambulatory (in general they are diagonal and symmetrical about the longitudinal axis of the church), some cracks are also present in the walls, the crypt, the paving and in the floor above. The cracks in the dome are rather serious, being of the amplitude of a few centimeters (fig. 4); they follow the meridian curves and are concentrated around the ribs, where the architectural requirement of emphasizing the ribs lead to a reduction of the dome section immediately next to them, they continue along the drum and also affect the fan arches connected to the drum.

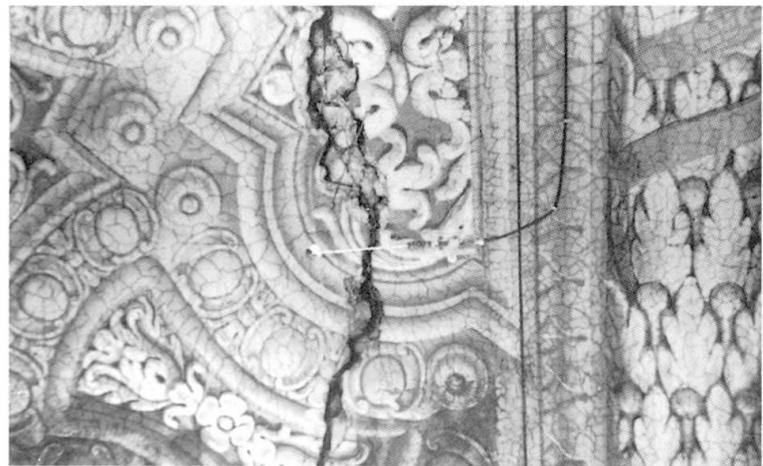
Fig. 5

An important part of this investigation was the monitoring system set up to automatically survey the opening and closing of the cracks over time, in relation to the variation of temperature and other phenomena (fig. 5).

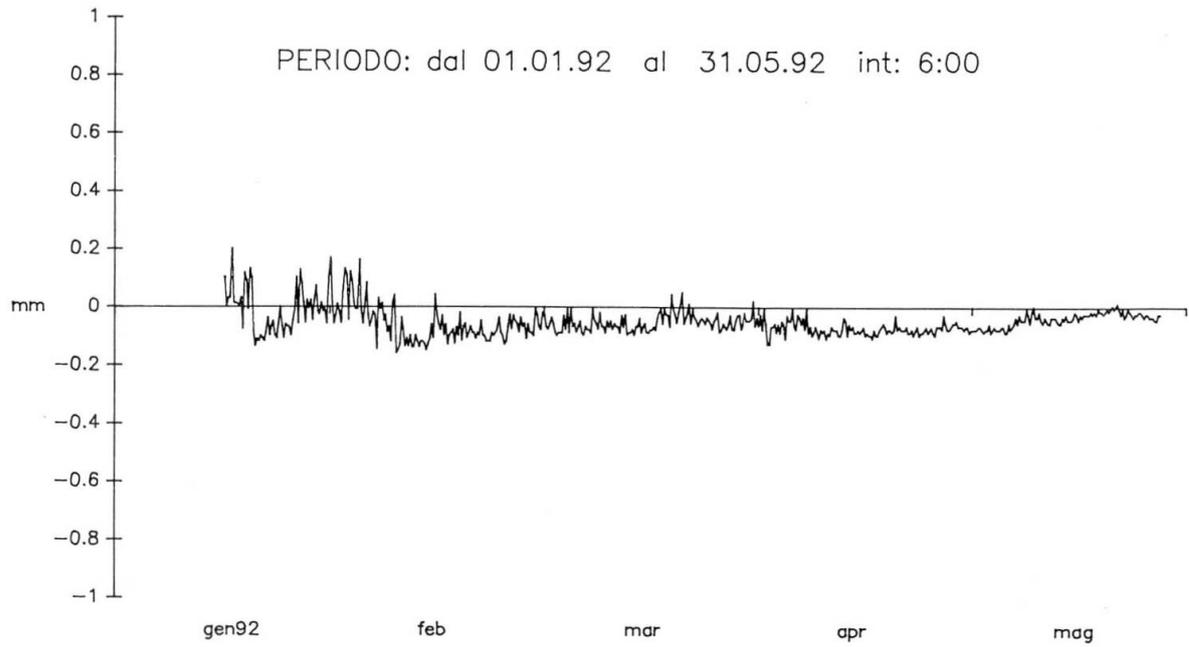
Fig. 6

During the control period, which took place, with interruptions, for over three years, no sign of evolutionary phenomena linked to the cracking was observed; however the longitudinal cracks showed a high sensibility to both the daily and seasonal temperature cycles, probably caused by the fact that these cracks represent a hinge which

runs along the centre of the basilica and along which the thermal deformations take place (fig. 6).

S.CARLO-MIS.DI DEFORMAZIONE CH.20 (CV.12) – CRIPTA

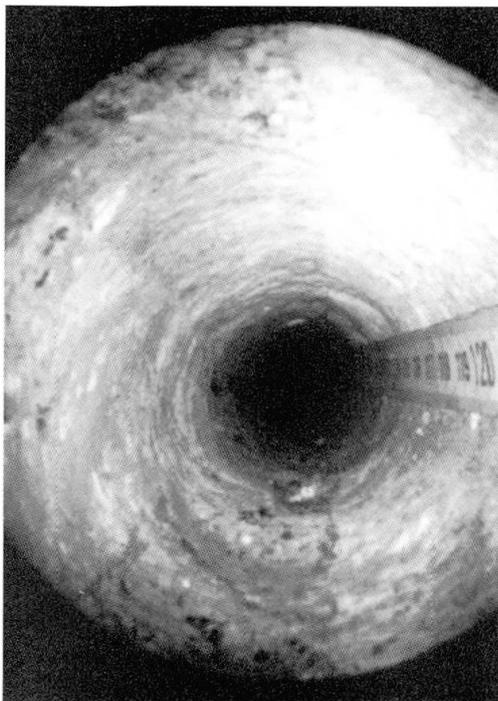
Fig. 7

- traditional geognostic tests and inspection of the soil strata and foundations with a miniature telecamera;
- observation of the composition and condition of the masonry by means of an endoscope placed in small drilled holes, the presence of deep cracks or cavities could also be ascertained (fig. 7);
- sonic tests to determine the homogeneity and compaction of the masonry;
- in-situ flat-jack and pull-out tests, to determine both the strength and the existing stress levels of the masonry to a reasonable approximation (fig. 8);
- measurement of the verticality of the columns in the nave.

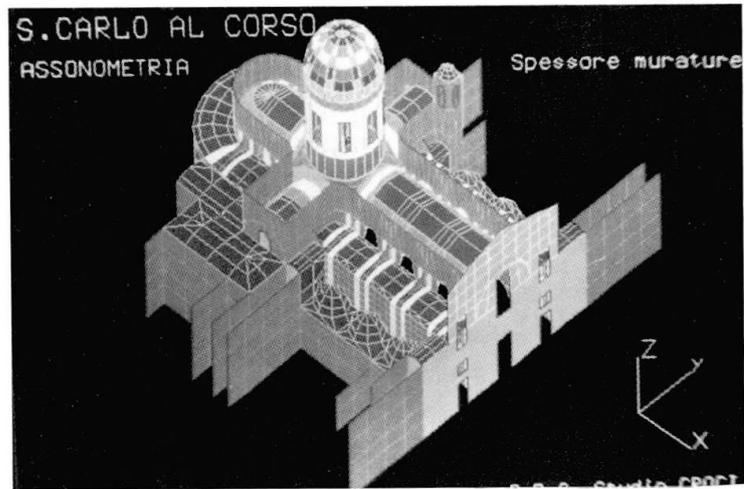
Fig. 9

The theoretical analyses of the behaviour of the monument used the information obtained during the series of checks, and were carried out by means of different finite element mathematical models of the structure; the global model took into account the real three-dimensional distribution of the mass and rigidity of the basilica and of the adjacent buildings, closely connected to the walls of the lateral chapel (fig. 9).

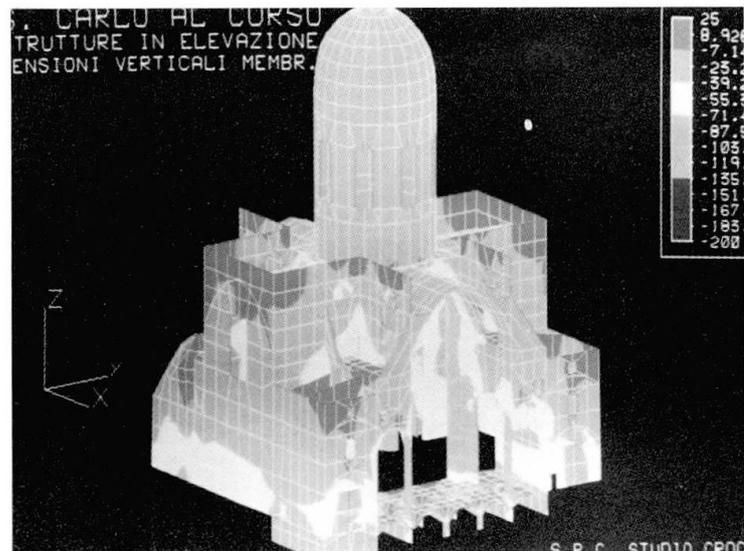
Fig. 10

It thus appeared necessary to investigate other possible phenomena, and in particular the role of soil movements; a finite element model was then used to specifically study the interaction between structure and soil, and to evaluate the influence of soil movements on the formation of the cracks (fig. 10). This model took into account the mechanical characteristics of the soil gleaned from the series of tests carried out.

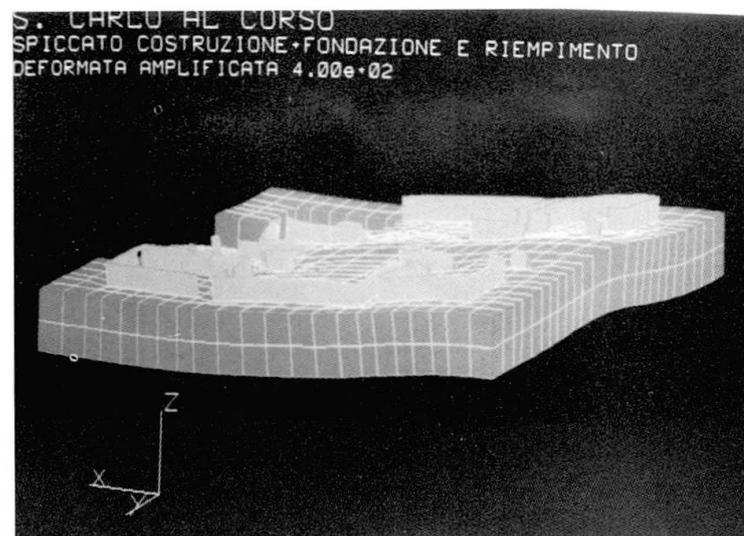
Fig. 11

The analysis of the deformations caused by loads transmitted to the soil from the structure (fig. 11), showed a large settlement in the area of the crypt

and apse with respect to the lateral nave. The deformations of the transepts, with respect to the central part of the basilica, produce a rotation around the outer columns of the dome (fig. 12), and additional stresses in the rings of the drum and the dome itself.

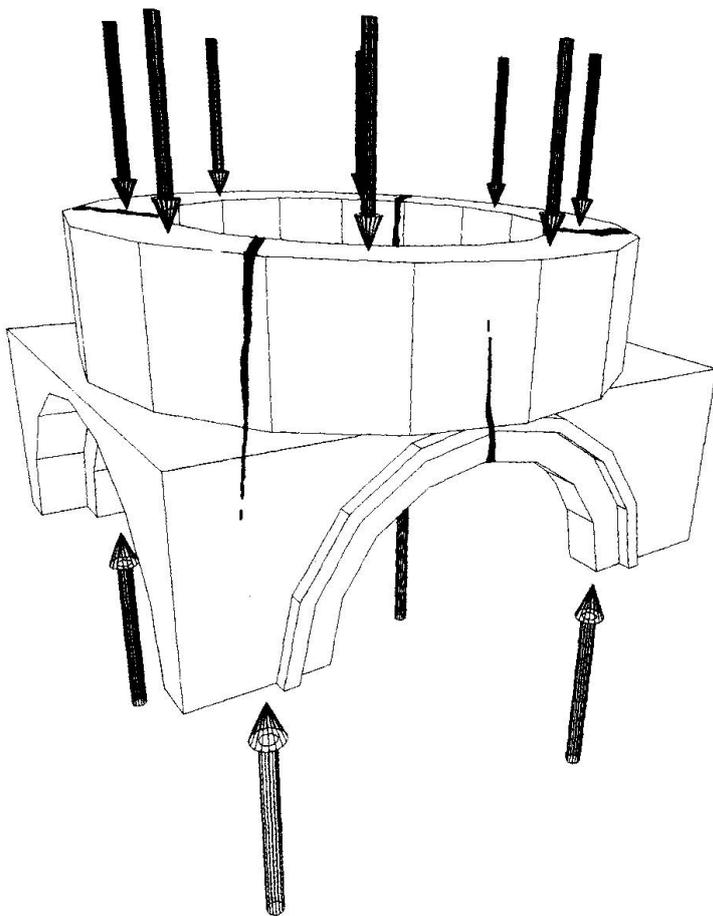
Fig. 13

As the drum is affected by four windows, which, for architectural motives of symmetry, occupy the principal axes of the basilica, the load of the dome is transmitted in the lower arches with an eccentricity in relation to the columns; this leads to a further increase in stress that is superimposed onto those generated by load, temperature and seismic actions, overcoming the strength of the material thereby causing the distribution of cracks visible today (fig. 13).

Thus having understood the origin of the cracks in the dome and the drum a new model has been made to verify the present safety level. The results show important bending moments in the "arches" created along the meridians by the cracks themselves (fig. 13). In order to eliminate this unfavourable situation a system of hoops, using metal cables placed at different levels on the outer surface of the dome, was proposed; the cables are not visible as they are placed beneath the lead sheeting which will be replaced and re-anchored.

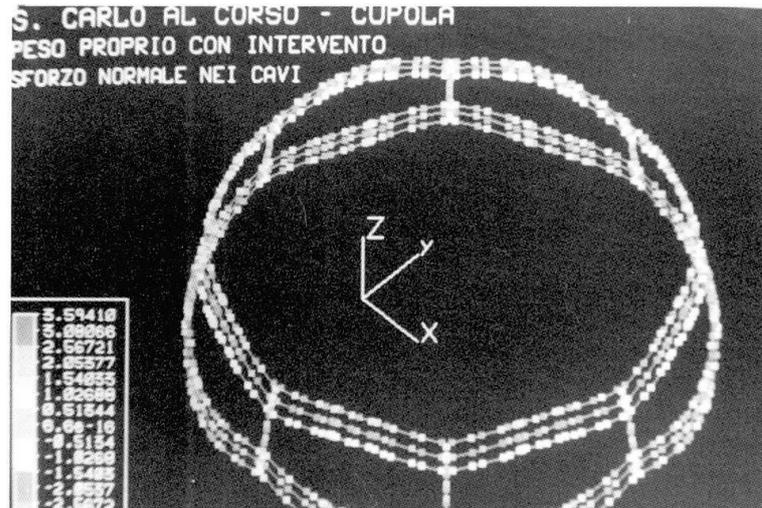
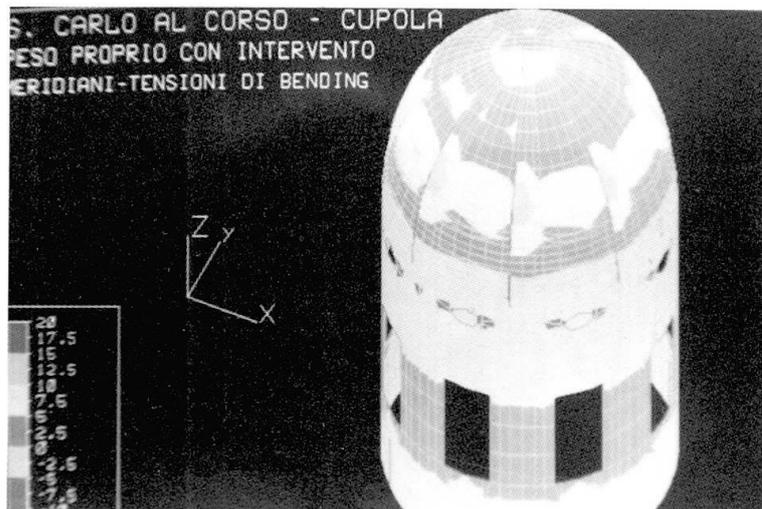
Fig. 14

To find the most appropriate positioning of the hoops, which consist of three separate pairs of cables, to determine the level of prestressing required in order to minimize the bending stresses in the meridians that developed as a result of the cracking and to assume appropriate safety levels, a final mathematical model was created (fig. 14 and 15).

The hooping cables, made of high strength stainless steel, (the type normally used for sailing boats) are lightly prestressed, in order to provide immediately the optimum radial action and reestablish a bidimensional "meridians-parallels" membrane behaviour. This solution incorporates economy, ease of construction, favourable structural behaviour and durability.

This type of intervention is really a modern version of an ancient method for reinforcing domes, that used to involve chains built around the base of the dome. It is reversible and does not alter the architectural aspect of the dome; from the structural point of view moreover, notwithstanding the modest stresses directly applied to the masonry as shown by the mathematical model, it guarantees the survival of the monument even in the event of future earthquakes.
