Artikel: Damage and repair of St. Charles Basilica in Rome
Autor: Zurli, Francesco / Viola, Raffaele M.
DOI: <https://doi.org/10.5169/seals-53325>

Damage and Repair of the St. Charles Basilica in Rome

The paper reports on studies of damage and solutions proposed for the restoration of the dome of the St. Charles Basilica in Rome. The study is based on the results of an in-depth program of investigation on the soil conditions, the building materials and the analysis of the behaviour during this period. The data has been recorded by a computer connected to a monitoring system. The assessment of the safety levels was performed with the support of mathematical models, by studying historical information and a permanent analysis and comparison of theoretical results with reality.

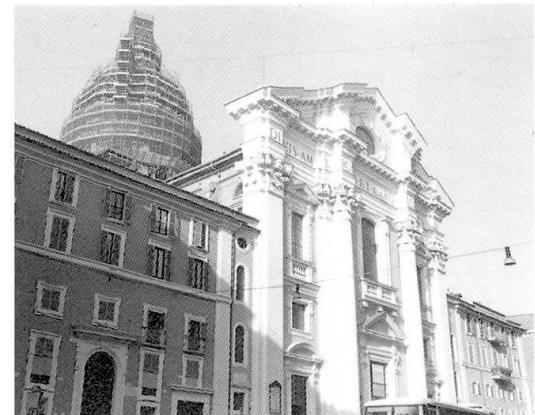
Fig. 1

The construction of the church began in 1612, after Pope Paul V canonised St. Charles Borromeo. It was finished in 1684 with the completion of the façade (fig. 1).

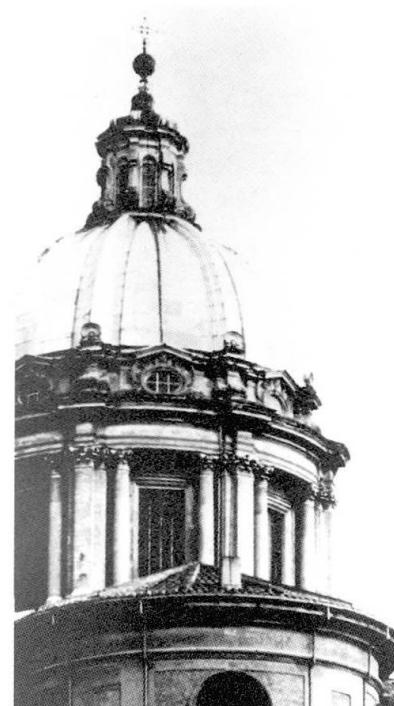
Fig. 3

The drum and dome were built in 1668 and 1669 under the direction of Pietro Berrettini (known as "il Cortona") (fig. 3). By the time Rome was affected by the strong earthquake, which caused damage and failures in the Colosseum, in 1703, the building was completed.

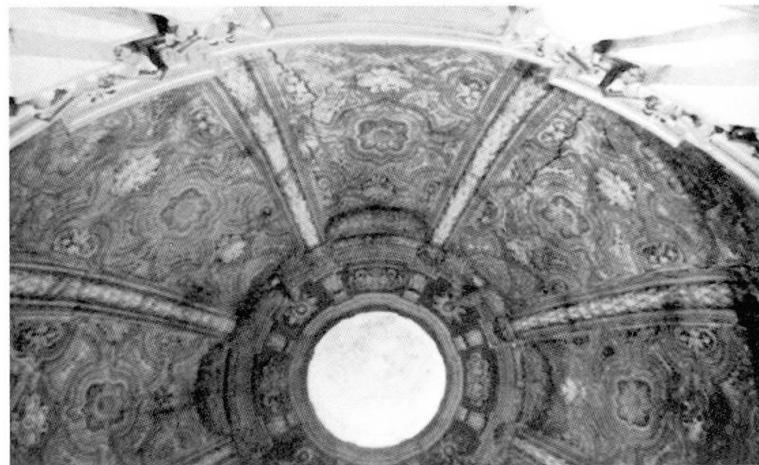
Fig. 4

The church has suffered from large scale cracking present in the dome, the vaults of the lateral naves and the vaults of the preambulatory (in general they are diagonal and symmetrical about the longitudinal axis of the church), some cracks are also present in the walls, the crypt, the paving and in the floor above. The cracks in the dome are rather serious, being of the amplitude of a few centimeters (fig. 4); they follow the meridian curves and are concentrated around the ribs, where the architectural requirement of emphasizing the ribs lead to a reduction of the dome section immediately next

to them, they continue along the drum and also affect the fan arches connected to the drum.

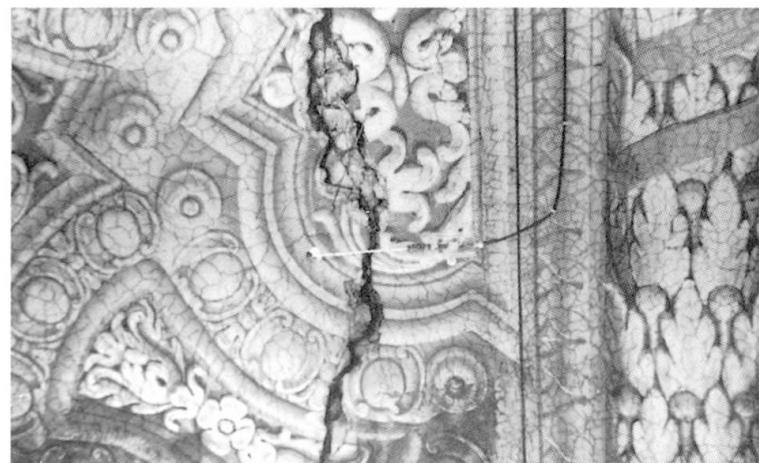
Fig. 5

An important part of this investigation was the monitoring system set up to automatically survey the opening and closing of the cracks over time, in relation to the variation of temperature and other phenomena (fig. 5).
