**Zeitschrift:** IABSE reports = Rapports AIPC = IVBH Berichte  
**Band:** 70 (1993)

**Artikel:** Recent developments in the safety assessment of the Colloseum  
**Autor:** Croci, Giorgio / D'Ayala, Dina  
**DOI:** <https://doi.org/10.5169/seals-53326>

## Recent Developments in the Safety Assessment of the Colosseum

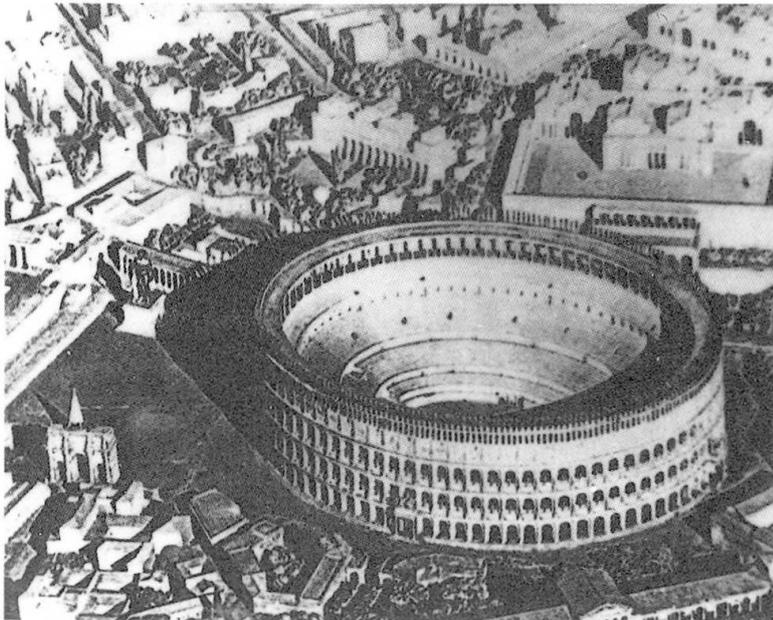
fig. 1 - Model from the plastic of "Roma at the time of the Empire"

The construction of the Colosseum probably began in 72 a.D. and lasted almost ten years, the monument being dedicated under Titus reign in the 80 a. D.(fig. 1). One of the hypotheses that explains the rather fast realization of the monument is that the building-site was probably organised in four portions divided along the principal axes of symmetry of the plan. The connections between these portions can then be regarded as the weak points in the masonry. A second reason of amorphism is the building site, previously partially filled by the lake of the Domus Aurea, created by an alteration of the original hydrography settlement. The topography and the few available non-destructive drillings, it can be seen how the slopes on the two sides of the major axis have different gradients and soils: the mechanical behaviour of the ground beneath the structure is therefore not homogeneous and the foundation system presents variable depth and lay-out.

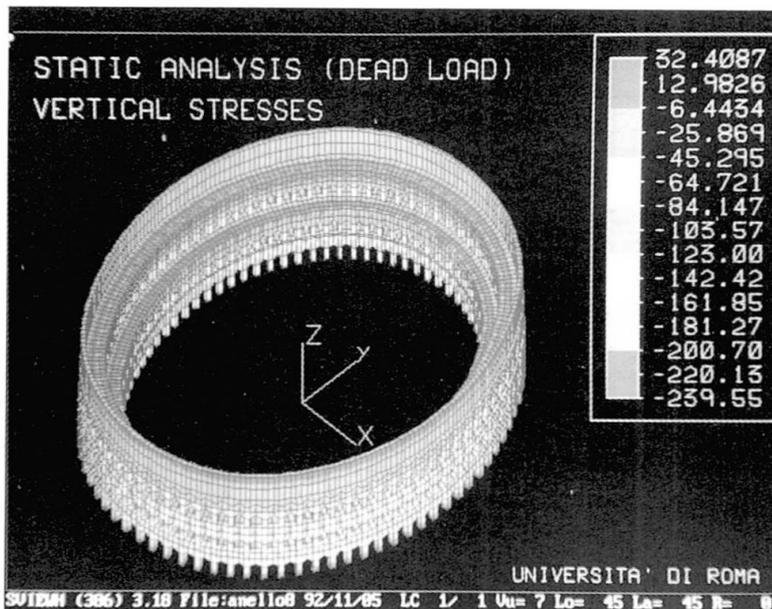
fig. 2 - Analytical model for the original configuration

The first analytical model is a test of the structural original capacity of the monument under the dead load action. The f. e. model realised with 8 node-brick-elements, which best simulate the shear behaviour of the stone blocks, covers the three annular bands connected by the annular vaults, while the inner radial brick-masonry walls are neglected due to the high number of d.o.f involved. Under static conditions (fig. 2) the bearing capacity basically relies on the pillars whose average stresses vary from 23 KN/m<sup>2</sup>, at the base of the first order, to 10 KN/m<sup>2</sup> at the base of the third order. A slightly flexural effect is also present due to the global circumferential shape that does not completely absorb the thrust of the annular barrel vaults, causing a stress increment of 15% at the second order in the pillars close to the major axis of symmetry, where the radial component of the arches' thrust is maximum. The stress in arches and vaults is at least two order of magnitude lower than that in the columns and it can therefore be said that the monument is overdimensioned for static loading, even if we refer to the crowd load during the "spectacula", the failure stress of the travertine material being 500 KN/m<sup>2</sup>, while the masonry limit stress, due to the roughness of the contact surfaces and the weakening due to the dressing of the stone, is definitely lower.

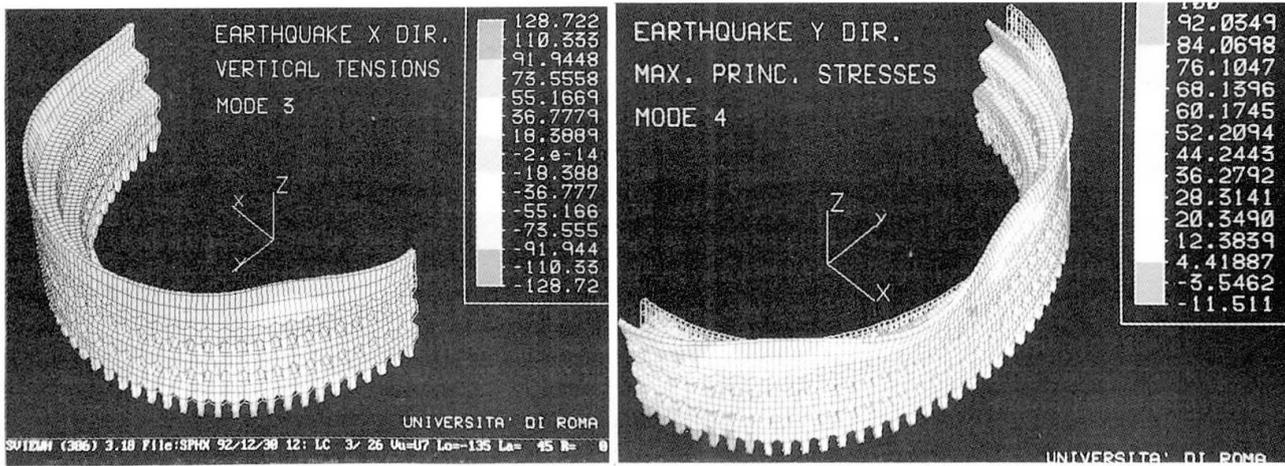
fig. 3 - 4 Response spectrum dynamic analysis for the original shape

The cylindrical vertical surfaces (fig. 3-4) exerted a fundamental bidimensional behaviour which, as long as the friction limit is not overcome, lead to relatively low bending moments in the pillars: the maximum reaches 13.0 KN/m<sup>2</sup> that added to the dead load stress gives a top value of 36 KN/m<sup>2</sup> while the cross section is wholly compressed. On the other hand, in the upper part, due to the low vertical stress level and the lack of radial constraint, active in the lower part by means of the annular vaults, the friction limit is extensively overcome: tensile circumferential stresses ( $\sigma_a$ ) reach up to 4.53 KN/m<sup>2</sup>, while the corresponding vertical stress ( $\sigma_v$ ) is 6.6 KN/m<sup>2</sup> with a ratio 0.68 that is over the value of the dynamic friction coefficient  $\mu = 0.433$ , corresponding to the fact that the most severe damage occurred here.

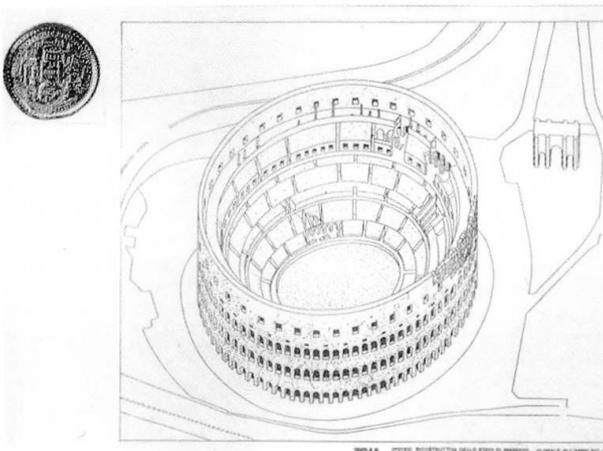
fig 5 Hypothetical state of conservation after year 801

The next destructive earthquake recorded is in the year 801; it arrived after a period of almost 300 years during which, the monument was not only disused and abandoned (after 523) but also a few small earthquakes occurred, plant roots expanded existing cracks and formed new ones and finally, the structure underwent serious damage when the metal connections between blocks were removed. The earthquake probably had its epicentre in the Abbruzzese Appennino and caused damages up to the IX M. S. grade in the roman area. Extensive notes of the damages in the Colosseum are not available but it can be inferred that what was left of the cyclopic order at the attic level fell into the cavea causing huge damages in the inclined barrel-vaults of the arena, and other less striking structural cracks. It is likely that on this occasion the first important breach in the annular walls opened (fig. 5): if the location is deduced from later iconography (there being no remaining contemporary iconography), we can say that it occurred in the quarter overlooking the Constantinian Arch, this being common to all the available views. Whether it has occurred at a point closest to the major or minor axis of symmetry can not be positively said, but our results indicate the portion close to the major curvature as the one with highest radial tensile stresses in the annular vaults (up to 3.25 KN/m<sup>2</sup> versus 2.66 KN/m<sup>2</sup> along the minor axis) and highest annular stresses in the attic wall, 5.6 KN/m<sup>2</sup> with a vertical compressive stress of 5.2 KN/m<sup>2</sup>, that clearly exceed the frictional resistance. Once the sliding occurs there is a corresponding increase in the circumferential length at the upper level leading to out of plumb and thus to relevant eccentricity of the normal force in the first order pillars, consequent reduction of the effective section, and finally an increase of stress level, which initiate instability.

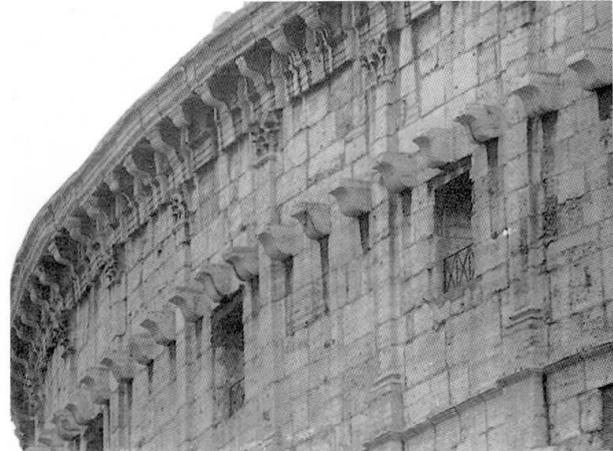
fig.6 Synusoidal deformation of the parapet.

In 1703 another destructive earthquake occurred, again with its origin in the appenine region and the same energy characteristic as the one that occurred in 1349. Nevertheless damages were much less extensive, only the ruin of an arch having been recorded. To understand the behaviour of the structure in this configuration, a new model has been prepared under the hypothesis that the most vulnerable part, the outer annular wall, had highly inefficient radial constraints. Results show a wave deformation of the attic level (fig. 9) both in the horizontal and vertical planes, and high vertical stresses in the pillars at the free edge of the surface, affected by an outward flexural action around the radial axis. The maximum flexural stress,  $\sigma_v = 34.27 \text{ KN/m}^2$ , cannot be equilibrated by the dead-load stress. The annular horizontal stresses in the attic reach a maximum in the area of the minor axis ( $\sigma_a = 12.1 \text{ KN/m}^2$ ). As it can be seen the zones more stressed are the zones that a century later were affected by the large restoration works of Stern, Valadier, Salvi, and today the deformation provoked by the seismic action is still visible in part of the attic level (fig. 6).

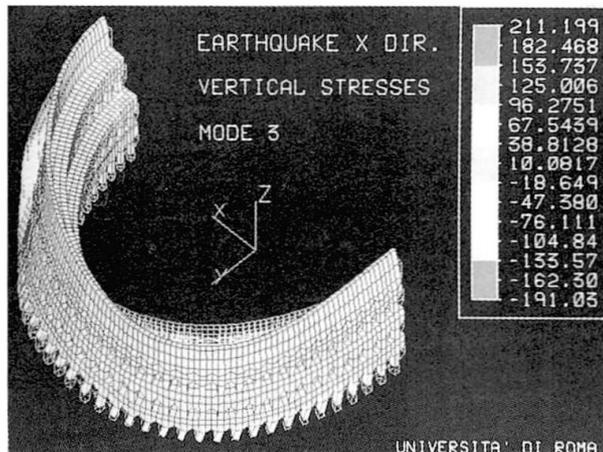
fig. 7 Spectrum response dynamic analysis simulating differentiated foundations

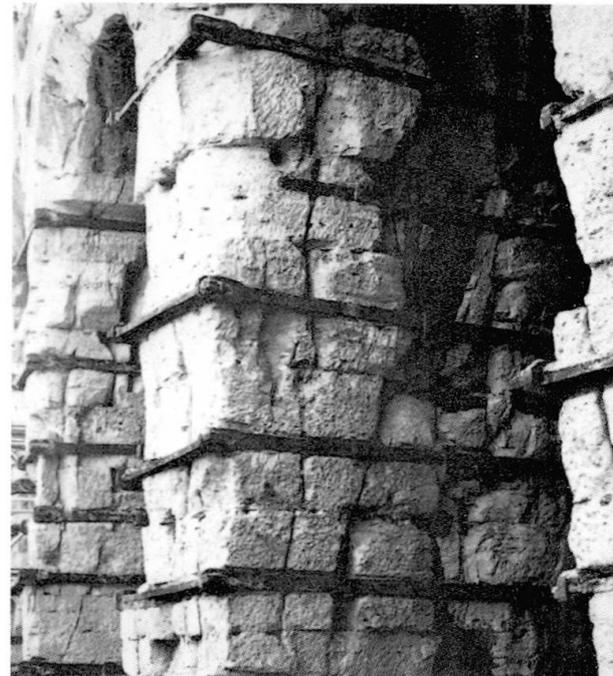
fig.8 State of the pillars on the Stern abutment side in 1979.

After this earthquake the Colosseum was abandoned apart for its use as a quarry for travertine blocks and loose bricks for use in furnaces. During the next three centuries, all sources agree in stating that most of the material that was taken for other building sites, apart from a few recorded exceptions, was not removed from the structure itself but from a large mound of rubble called "Coxa Colisei". Also in this period (beginning of the XVI century) the ruin of a wide portion of the inner ring on the Celio side around the minor axis is recorded. Other "spontaneous" failures took place in 1646 and 1689. These events, called "spontaneous" because they cannot be directly related with any seismic action, can be explained as consequences of the mechanism described above: the high compressive stress level, created cracks and microcracks sensitive to thermo-hygrometric conditions, provoking an increment of internal stress in the outer layers of the blocks, thus facilitating spalling. A deterioration process was therefore initiated, leading to a critical situation decades or centuries after the original action. This phenomenon, leading to near collapse, was observed by us in 1979, when following the removal of cladding blocks, a limit state situation was evident (fig. 8)

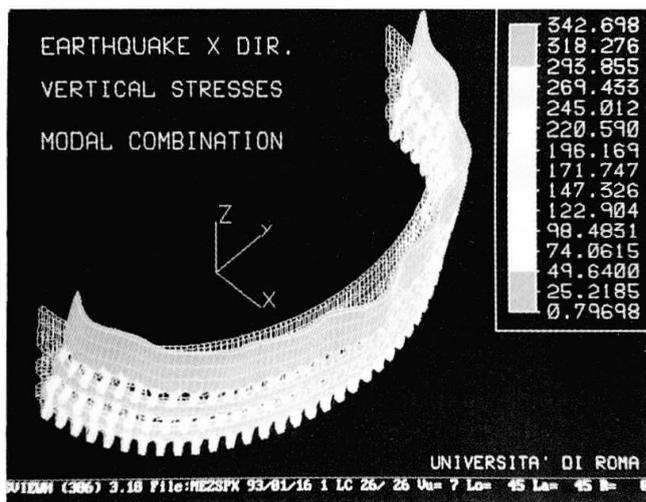
fig. 9 Analytical model in the 1703 configuration

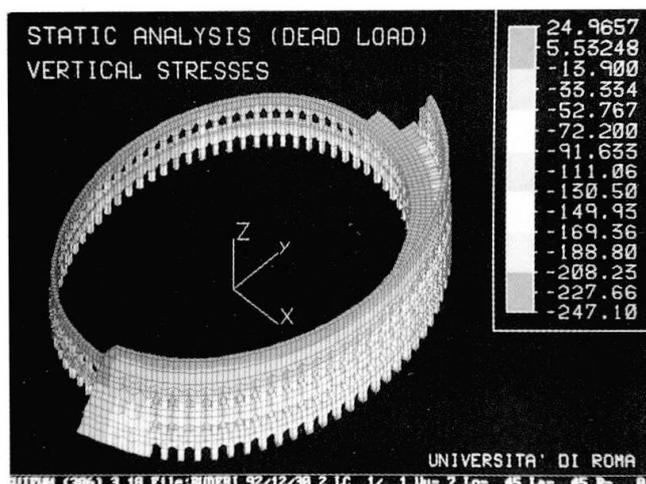
fig. 10 - Analytical model of the today configuration

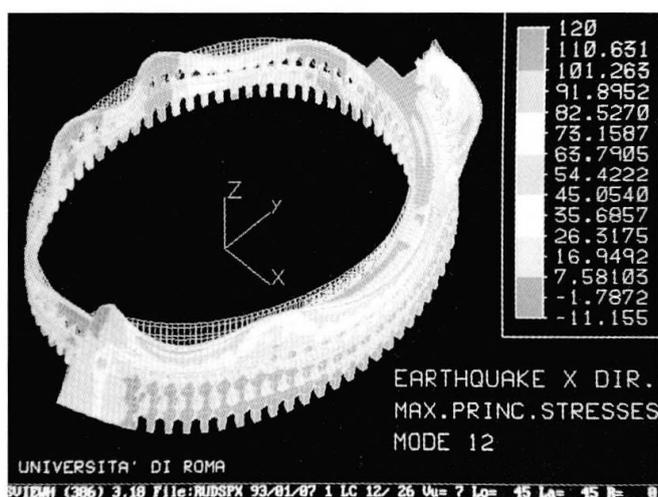
fig. 11 - Analytical model of the today configuration. Spectrum response dynamic analysis.

These XVIII century restorations were all related to static stability, with no concern for dynamic actions. In fact, analysing their behaviour as part of the global structure under seismic actions, the abutments appear to be rather dangerous due to the difference in strength with regard to the original material, while also involving excitement of large masses. The worst result stems from actions orthogonally oriented to them; in the model analysed, connections in the radial direction are assumed to be active: the static situation is already quite different from the original one (fig. 10), the present configuration implying higher flexural stresses in the pillars of all orders (maximum eccentricity being up to 5 times higher than the original value); the seismic action, on a structure with fundamental natural frequencies 2 times smaller than the original one, greatly amplifies this phenomenon especially for the pillars of the third order where the stiffening contribution of the abutments is less and the connection with the inner rings are only partially realised (fig. 11). For those pillars flexural stresses produced by the earthquake are of the same order of magnitude as the static ones, therefore causing partialization of the cross sections ( $\sigma_v$  reaches 22 KN/m<sup>2</sup> versus -14.4 KN/m<sup>2</sup> of the dead load case). The attic portion has very low natural frequency these being caused by the low stiffness in the annular direction; stresses are of the same level as before but greater deformation and further sliding should be expected.
