Artikel: Mechanical characteristics of ancient Roman masonry
Autor: Ignatakis, Christos / Stavrakakis, E. / Penelis, George
DOI: <https://doi.org/10.5169/seals-53327>

Mechanical Characteristics of Ancient Roman Masonry

The procedure for the analytical evaluation of the mechanical characteristics of Roman masonry and the strength of the bearing structure of the Rotunda of Thessaloniki is presented. The mechanical properties and failure envelope of ancient Roman masonry were predicted using a specific finite element program for the non-linear analysis of masonry micromodels. Using the predicted properties of masonry, the structural system of the monument was analysed and proved to be cracked meridionally under dead loads. Finally the ultimate seismic capacity of the supporting piers has been calculated.

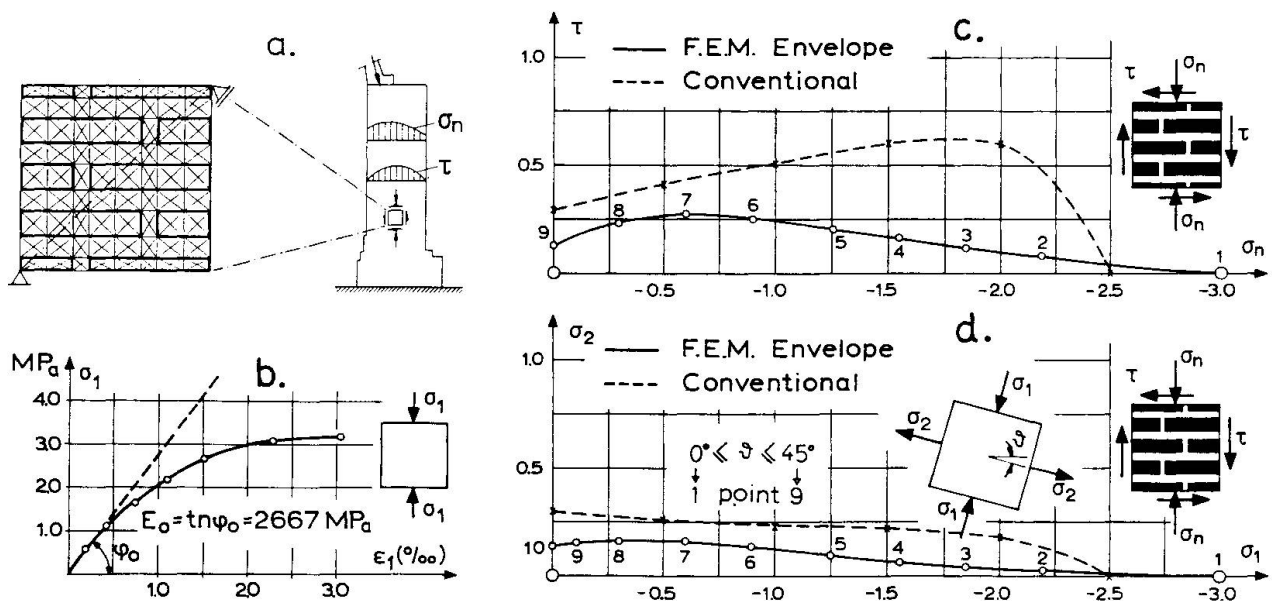
Fig.2 Analytical evaluation of masonry properties: a. Masonry micromodel, b. Stress-strain curve ($\sigma_n - \epsilon_n$), c. Failure envelope (σ_n, τ), d. Failure envelope (σ_1, σ_2)

Rotunda, under dead and radial seismic loading, consists mainly of normal stresses σ_n perpendicular to the bed joints and shear stresses τ in meridional level (Fig. 2a). The stress state (σ_n, τ) is equivalent to the principal stress state $(\sigma_1 < 0, \sigma_2 > 0)$ mentioned above.

In order to determine the mechanical characteristics of Roman masonry, the micromodel shown in Fig. 2a was analysed under various normal stresses σ_n increasing gradually to a defined value, followed by shear stresses τ increasing gradually until failure.

- Compressive strength perpendicular to bed joints: $f_{wc}^n=3.11\text{MPa}$
- Modulus of elasticity perpendicular to bed joints (initial value): $E_{wo}^n=2667\text{MPa}$
- Normal stress-strain curve ($\sigma_n-\epsilon_n$): See Fig. 2b
- Shear modulus (initial value): $G_{wo}^n=1090\text{MPa}$
- Strength under pure shear loading: $f_{wso}^n=0.133\text{MPa}$
- Shear stress-strain curve ($\tau-\gamma$): Almost straight line.

In order to define the failure envelope shown in Fig. 2c, seven failure points (σ_n, τ_u) were determined for various predefined values of σ_n (points 2, 3...8). It can be seen that the shear strength of masonry shows a serious reduction when the normal stress σ_n exceeds the 50% of the compressive strength of masonry. The corresponding failure envelope in principal stresses at the $(-, +)$ region ($\sigma_1 < 0, \sigma_2 > 0$) is shown in Fig. 2d. Finally in order to bound this curve at the tensile axis, the masonry micromodel was analysed for tenth time under uniaxial tensile loading ($\sigma_1=0, \sigma_2$) parallel to the bed joints until failure ($f_{wt}^p=0.135\text{MPa}$, see Fig. 2d, point 10). The initial value of elasticity modulus under this loading found to be $E_{wo}^p=5555\text{MPa}$ which is more than double in comparison with E_{wo}^n . The anisotropic character of the masonry is obvious.

In Fig. 2c and 2d, are also shown in dashed line the corresponding failure envelopes of a "concrete like" material having a compressive strength equal to the masonry. These curves had been used as failure criteria at the strengthening project of Rotunda in the 1980. The compressive strength of masonry had been calculated according to the following formula:
