Artikel: Diagnosis and strengthening of the Brunelleschi Dome

Autor: Chiarugi, A. / Fanelli, M. / Giuseppetti, G.

Diagnosis and Strengthening of the Brunelleschi Dome

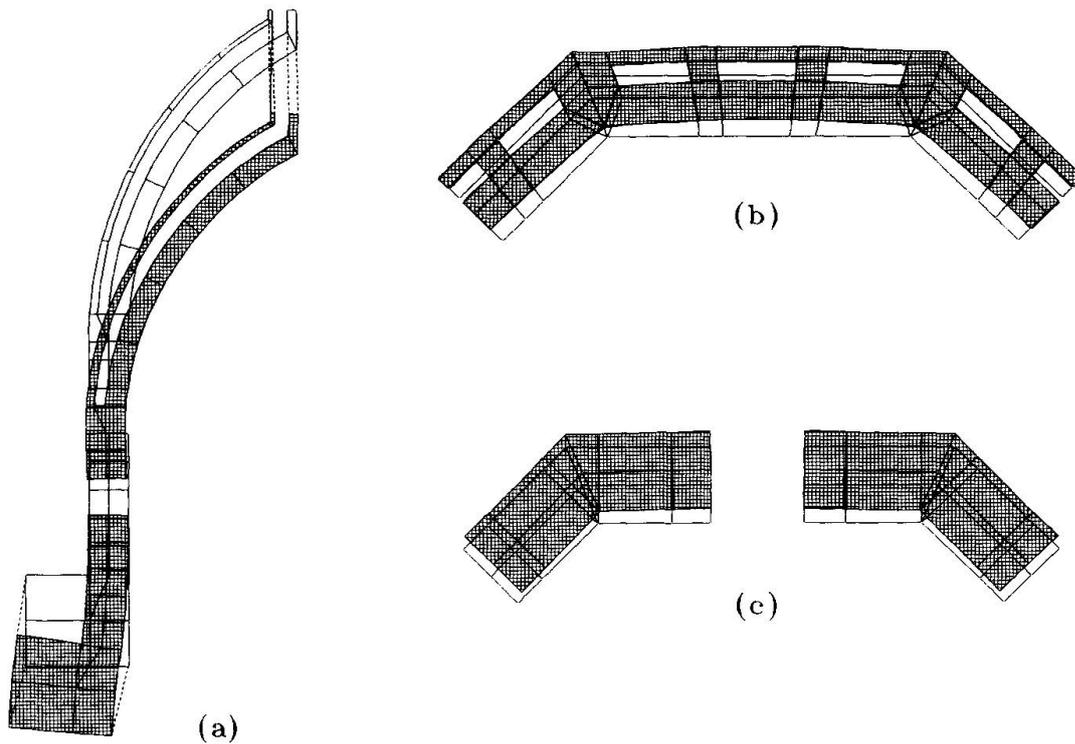
Fig. 3 "First virtual model" undamaged structure:

- (a) deformed line of vertical section in centerline on even-numbered panel;
- (b) deformed line of section 3-3 at 66 m level;
- (c) deformed line of horizontal section on circular centerline window (note ovalization of opening on even-numbered panel);
- (d) stress distribution σ horizontal on intrados face (note tension increase around the circular windows of even numbered panel and above the keystone of arch). Tension zone shaded.

In the process of mechanical identification of the structure a first virtual numerical model was built up, formed only by the following members: pylons, drum, dome. In this virtual F.E. model, 15 and 20 nodes isoparametric elements were used, with the same linear elastic constitutive law-throughout the structure. The first numerical analysis concerned the original (undamaged) virtual model under gravitational loads (deadweight).

A perusal of results clearly shows that the "parallels" just above the circular windows on the even-numbered panels undergo high levels of tensile stresses. Horizontal tensile stresses are found also in the drum, above the keystone of arches on the odd-numbered sides (see fig. 3 a, b, c, d).

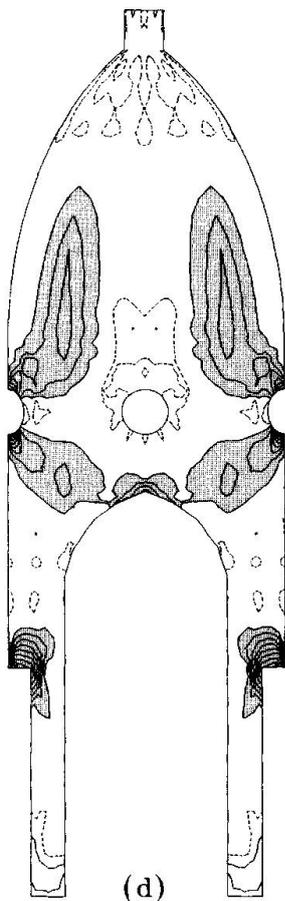
- "First virtual model" characteristic:
 - n° nodes 3286
 - n° elements 569
- Elements characteristic:
 - isoparametric hexahedrons with 20 nodes
 - isoparametric pentahedrons with 15 nodes
- Material characteristic:

modulus of elasticity:	50000 kg/cm ²
Poisson's ratio :	0.1
Density :	0.0018 kg/cm ³

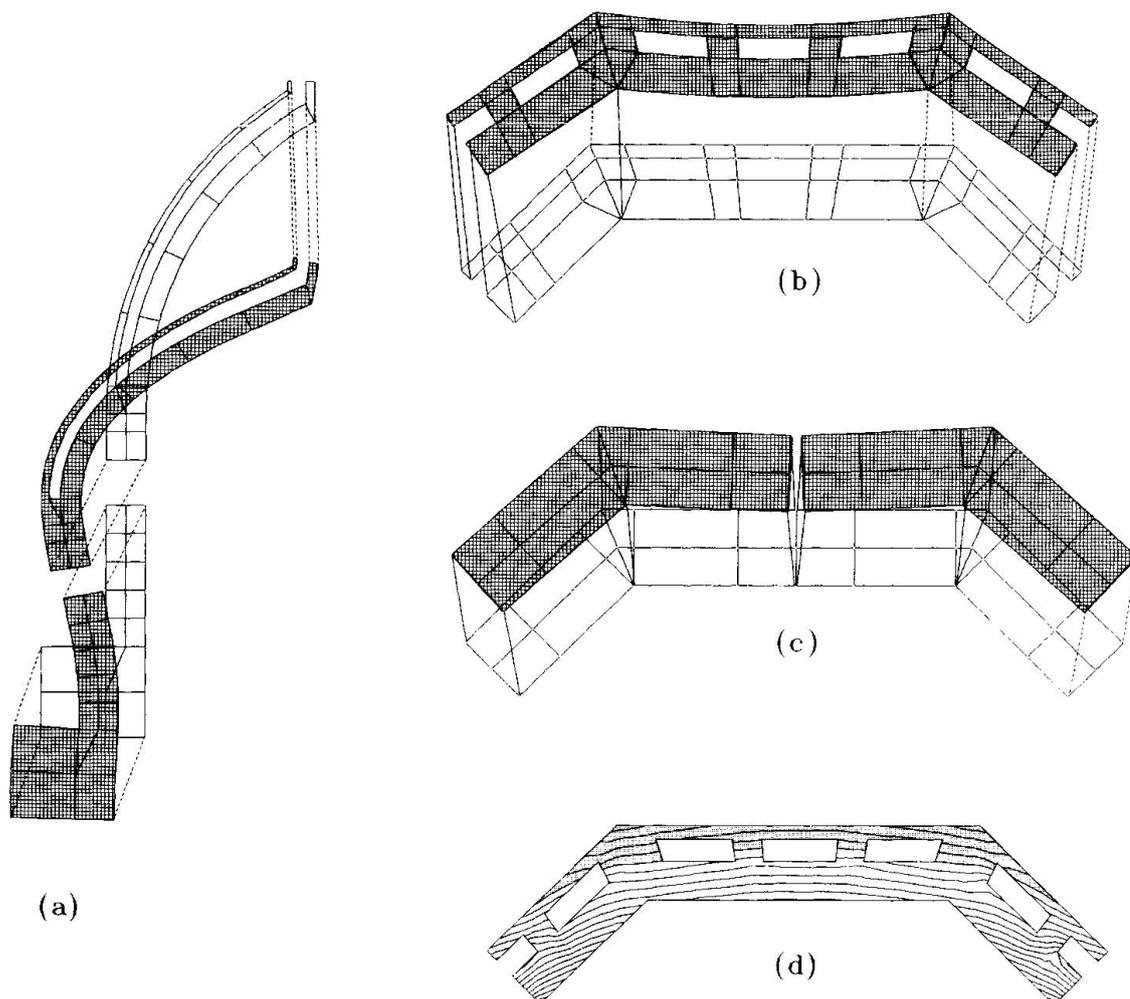
Fig. 4 "First identification model" with type A and B cracks:

- (a) deformed line of vertical section;
- (b) deformed line of section 3-3 at 66 m level
(note inflexion on the section plane);
- (c) deformed line of section under circular window
(note opening crack B);
- (d) stress distribution σ_z vertical in section 3-3
(note effects of bending with vertical tension
localized in external panels with odd numbering).
Tension zone shaded.

The results of the "continuous monitoring" yielded by the crack disposition allows to introduce cracks type A and B in the virtual model according to the dead-weight effects. Thus the first-identification model is defined.

The results of the analysis carried out on this second model confirm the indications of the crack pattern, explaining in particular the origin of the cracks "type C and D". It is observed also that the external shell on the odd-numbered sides is subjected to vertical tensile stresses, whereas the highest level of vertical compressive stresses is found in the internal corners of cracks "type A".

This distribution of vertical stresses has been confirmed experimentally through another "continuous monitoring" operation using the flat jack technique (fig. 4 a, b, c, d; fig. 5 a, b, c).

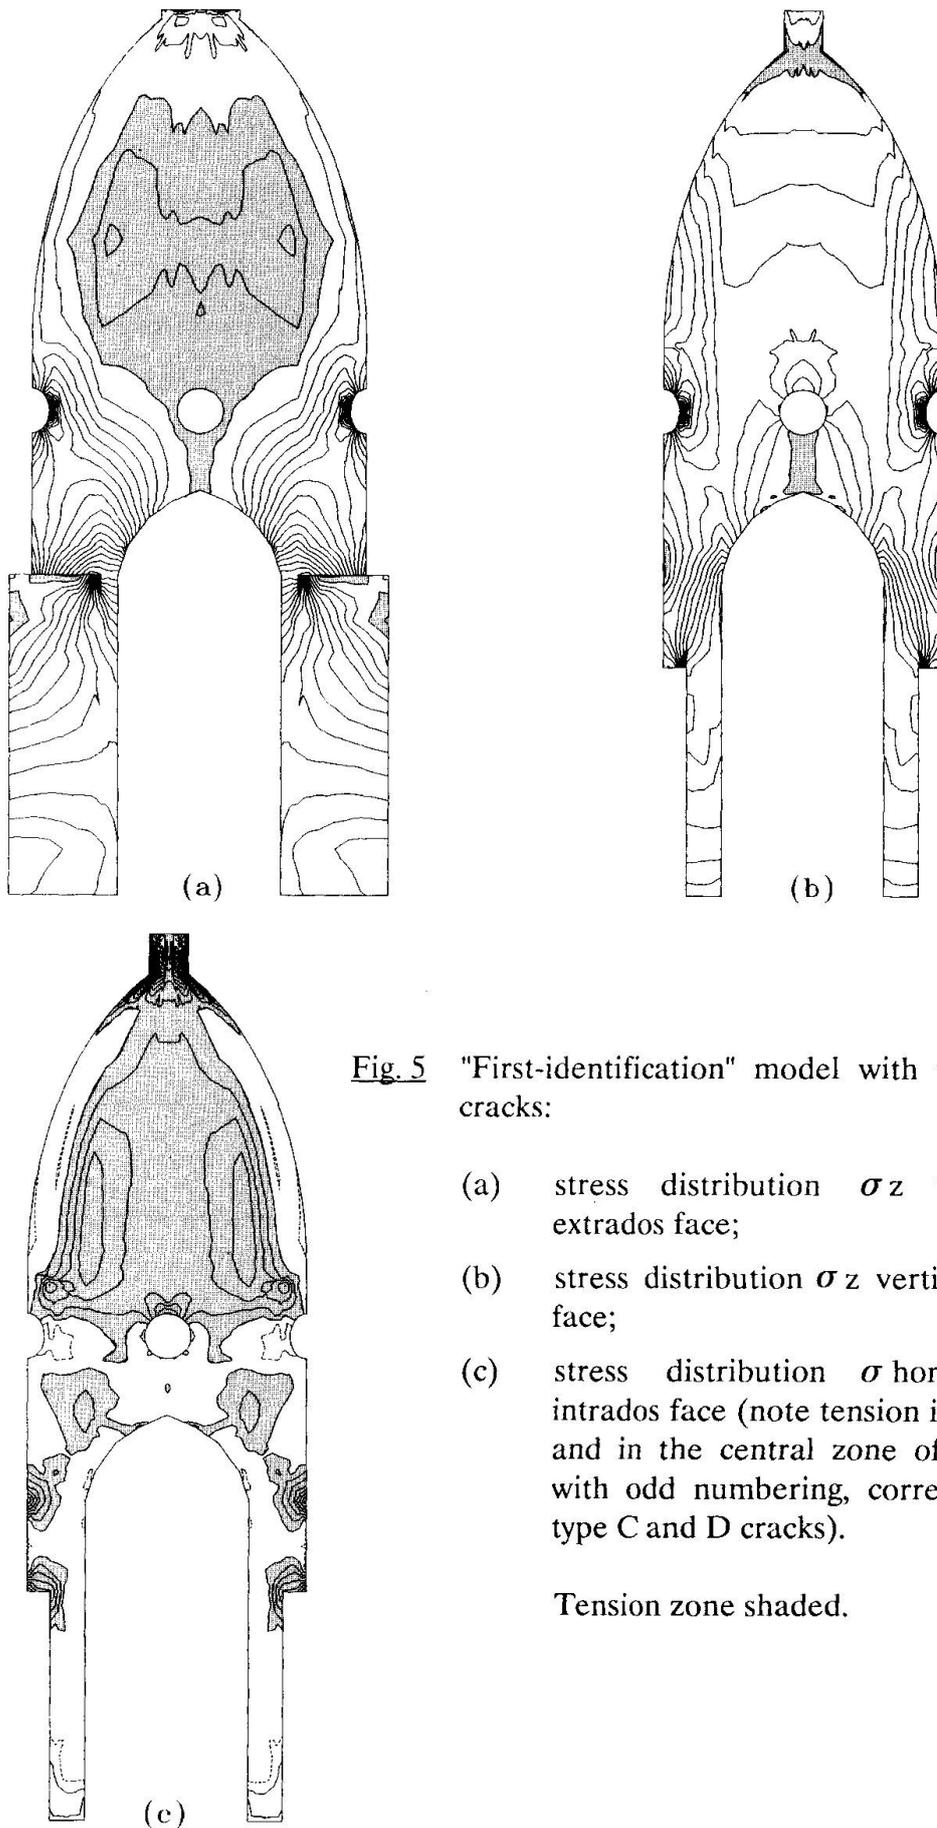
Fig. 5 "First-identification" model with type A and B cracks:

- (a) stress distribution σ_z vertical on extrados face;
- (b) stress distribution σ_z vertical intrados face;
- (c) stress distribution σ horizontal on intrados face (note tension in the corner and in the central zone of the panels with odd numbering, corresponding at type C and D cracks).

Tension zone shaded.

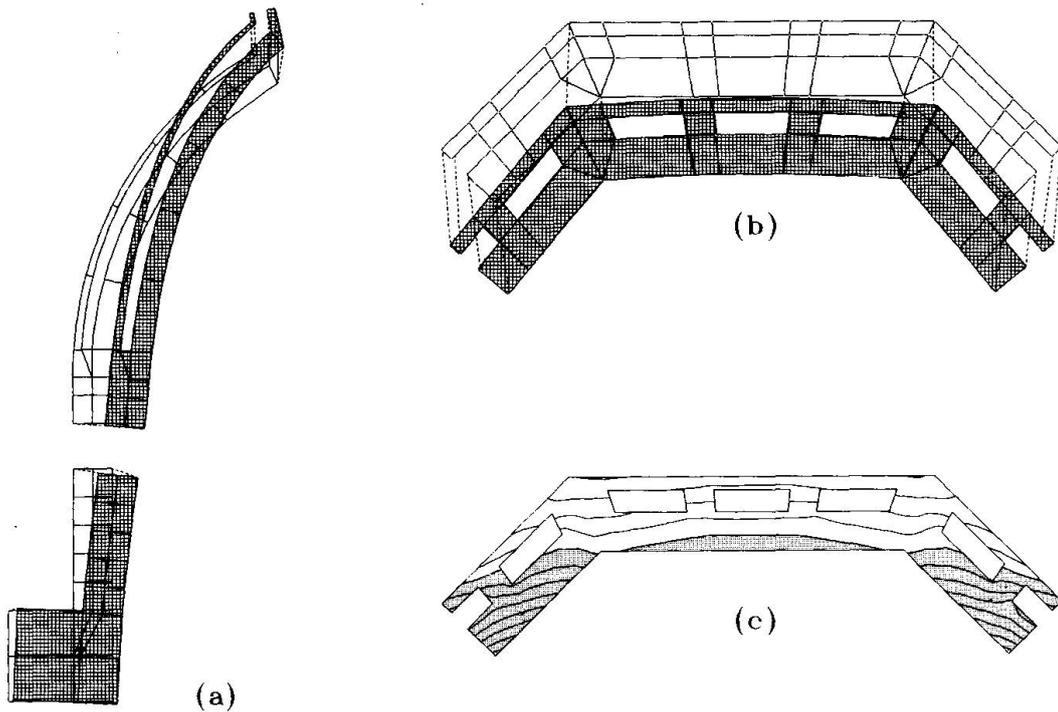
Fig. 6

"First identification model" under only strengthening effect:

- (a) deformed line of vertical section;
- (b) deformed line of section 3-3 at 66 m level;
- (c) stress distribution σ_z vertical in the section 3-3; with opposite distribution with respect to the dead-weight;
- (d) stress distribution σ_z vertical on intrados face;

Tension zone shaded.

By using the identified model one can simulate, starting from the present situation, the effects of the installation of horizontal belts.

The strengthening intervention could be effected through harmonic-steel cables placed at floor level in the first walking. The shape of these belts, pulled on at the midpoint of each side, would be octagonal; thus the interaction with the existing structure (apart from local effect) could be schematized by a system of radial forces, applied in the edges at the springing section of the dome.

Perusing the numerical simulation of this strengthening carried out on the "first-identification" model, one is surprised by the close-fitting antagonistic effect brought about by the intervention as against the dead-weight stress pattern (fig. 6 a, b, c, d).

One can remark that, according to the Betti theorem, the mutual work of the two force systems (dead-weight and prestressed belts) is obviously negative. However, one can moreover generally recognize that "almost everywhere" is negative also the local function which expressed the density of mutual work at every point of the structure.
