Zeitschrift: IABSE reports = Rapports AIPC = IVBH Berichte
Band: 70 (1993)

Artikel: Diagnosis and strengthening of the Brunelleschi Dome
Autor: Chiarugi, A. / Fanelli, M. / Giuseppetti, G.
DOI: <https://doi.org/10.5169/seals-53328>

Diagnosis and Strengthening of the Brunelleschi Dome

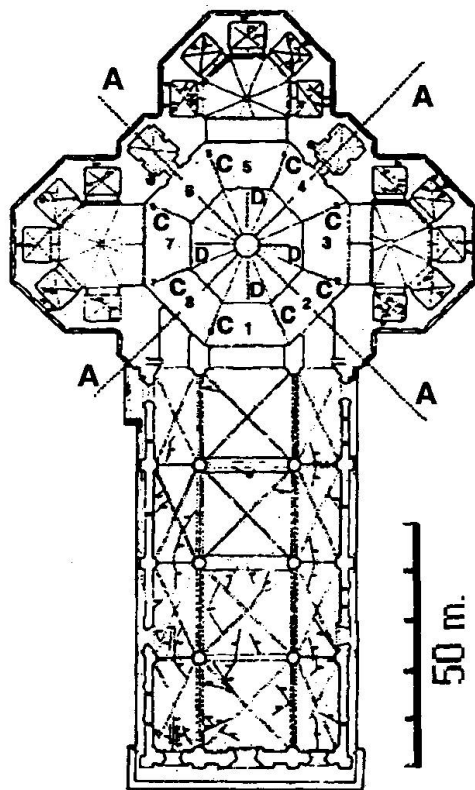
Fig. 1 Sides numbering and planar position of type "A, B, C and D" cracks.

After 1434 (the year in which Filippo Brunelleschi achieved the construction of the Dome of Santa Maria del Fiore), and after the erection of the skylight, carried out after Brunelleschi's death, no direct information is available until 1600 about mechanical problems in the Dome. Successively, several investigation campaigns are mounted concerning the cracks observed on some of the dome's panels, especially on the sides directly above the absidal pylons, and in particular in the South-East corner, panel n° 4; see figgs. 1 and 2.

- "type A" cracks, subvertical, through the whole thickness. (panels with even numbering);
- "type B" cracks, subvertical, through the whole thickness, in the panels with odd numbering;
- "type C" cracks, penetrating only to a partial depth in the thickness, in the edges between adjoining panels;

- "type D" cracks, also penetrating only to a partial depth in the thickness, along the midline of the panels with odd numbering (see figs. 1 and 2).

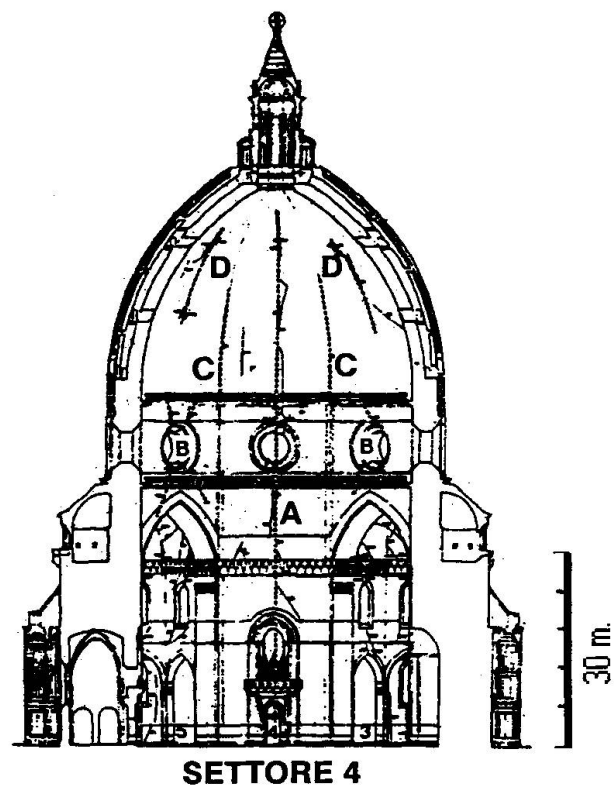
Fig. 2 Crack description summary with type "A, B, C and D" cracks.

The time evolution of cracks is known too, insofar as in 1757 only "type A" cracks were observable, and then only on sides 4 and 6, whereas nowadays cracks are observable in all four sides above the pylons.

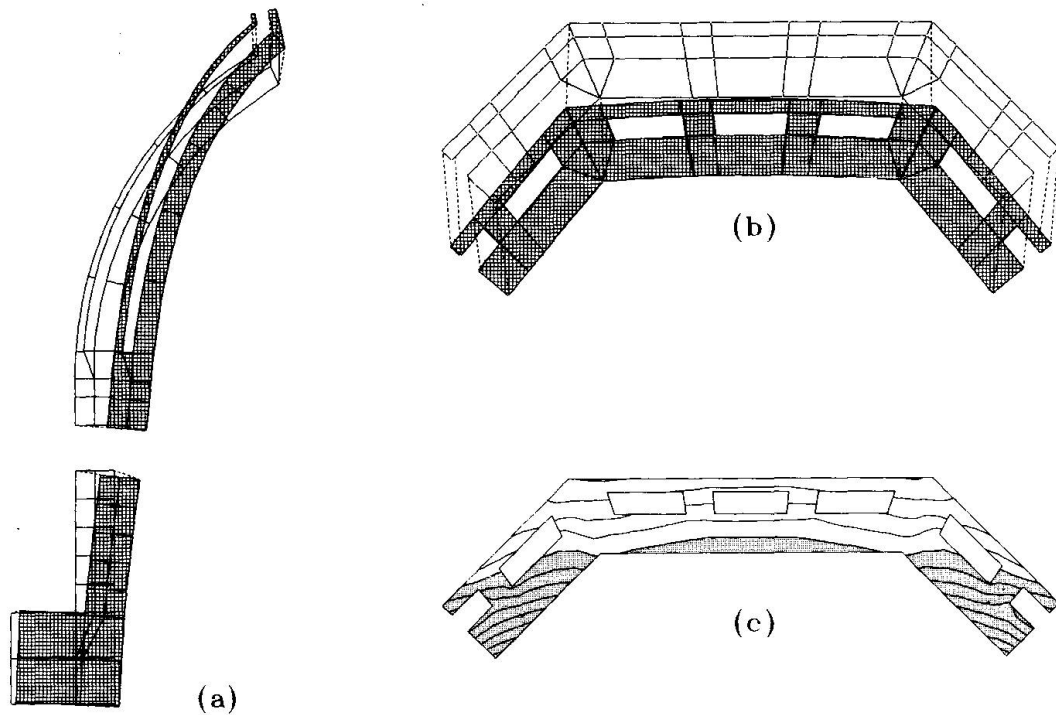
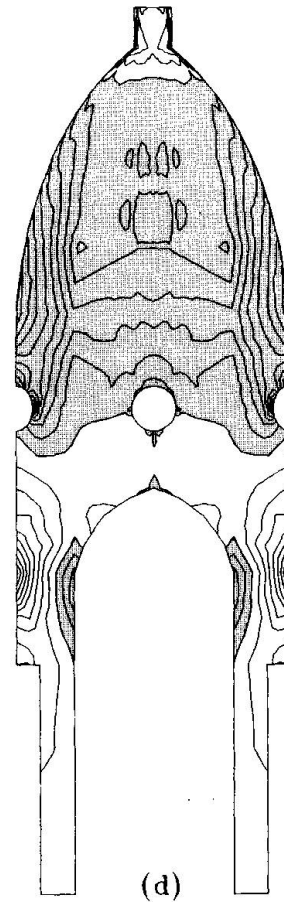
Fig. 6

"First identification model" under only strengthening effect:

- (a) deformed line of vertical section;
- (b) deformed line of section 3-3 at 66 m level;
- (c) stress distribution σ_z vertical in the section 3-3; with opponent distribution with respect to the dead-weight;
- (d) stress distribution σ_z vertical on intrados face;

Tension zone shaded.

The strengthening intervention could be effected through harmonic-steel cables placed at floor level in the first walking. The shape of these belts, pulled on at the midpoint of each side, would be octagonal; thus the interaction with the existing structure (apart from local effect) could be schematized by a system of radial forces, applied in the edges at the springing section of the dome.

Perusing the numerical simulation of this strengthening carried out on the "first-identification" model, one is surprised by the close-fitting antagonistic effect brought about by the intervention as against the dead-weight stress pattern (fig. 6 a, b, c, d).

One can remark that, according to the Betti theorem, the mutual work of the two force systems (dead-weight and prestressed belts) is obviously negative. However, one can moreover generally recognize that "almost everywhere" is negative also the local function which expressed the density of mutual work at every point of the structure.
