Zeitschrift: IABSE reports = Rapports AIPC = IVBH Berichte
Band: 70 (1993)

Artikel: Diagnosis and strengthening of the Brunelleschi Dome
Autor: Chiarugi, A. / Fanelli, M. / Giuseppetti, G.
DOI: <https://doi.org/10.5169/seals-53328>

Diagnosis and Strengthening of the Brunelleschi Dome

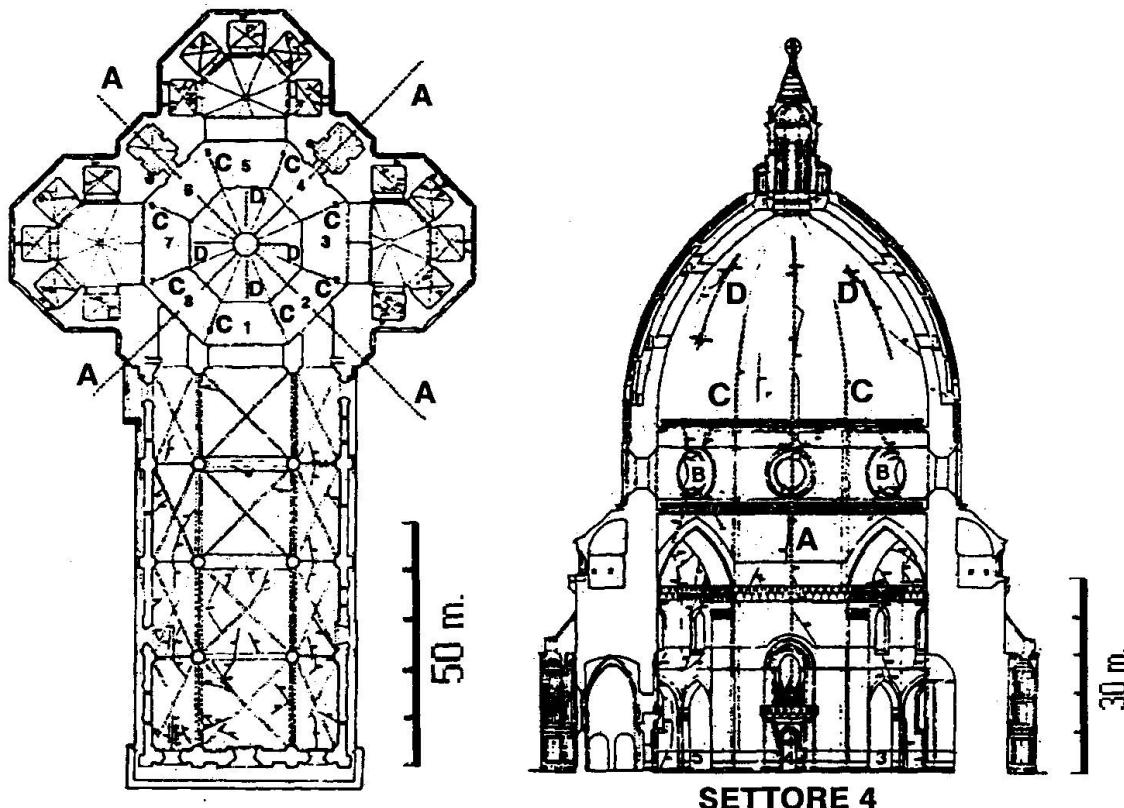
- "type A" cracks, subvertical, through the whole thickness. (panels with even numbering);
- "type B" cracks, subvertical, through the whole thickness, in the panels with odd numbering;
- "type C" cracks, penetrating only to a partial depth in the thickness, in the edges between adjoining panels;

- "type D" cracks, also penetrating only to a partial depth in the thickness, along the midline of the panels with odd numbering (see figgs. 1 and 2).

Fig. 1 Sides numbering and planar position of type "A, B, C and D" cracks.

Fig. 2 Crack description summary with type "A, B, C and D" cracks.

After 1434 (the year in which Filippo Brunelleschi achieved the construction of the Dome of Santa Maria del Fiore), and after the erection of the skylight, carried out after Brunelleschi's death, no direct information is available until 1600 about mechanical problems in the Dome. Successively, several investigation campaigns are mounted concerning the cracks observed on some of the dome's panels, especially on the sides directly above the absidal pylons, and in particular in the South-East corner, panel n° 4; see figgs. 1 and 2.

The time evolution of cracks is known too, insofar as in 1757 only "type A" cracks were observable, and then only on sides 4 and 6, whereas nowadays cracks are observable in all four sides above the pylons.

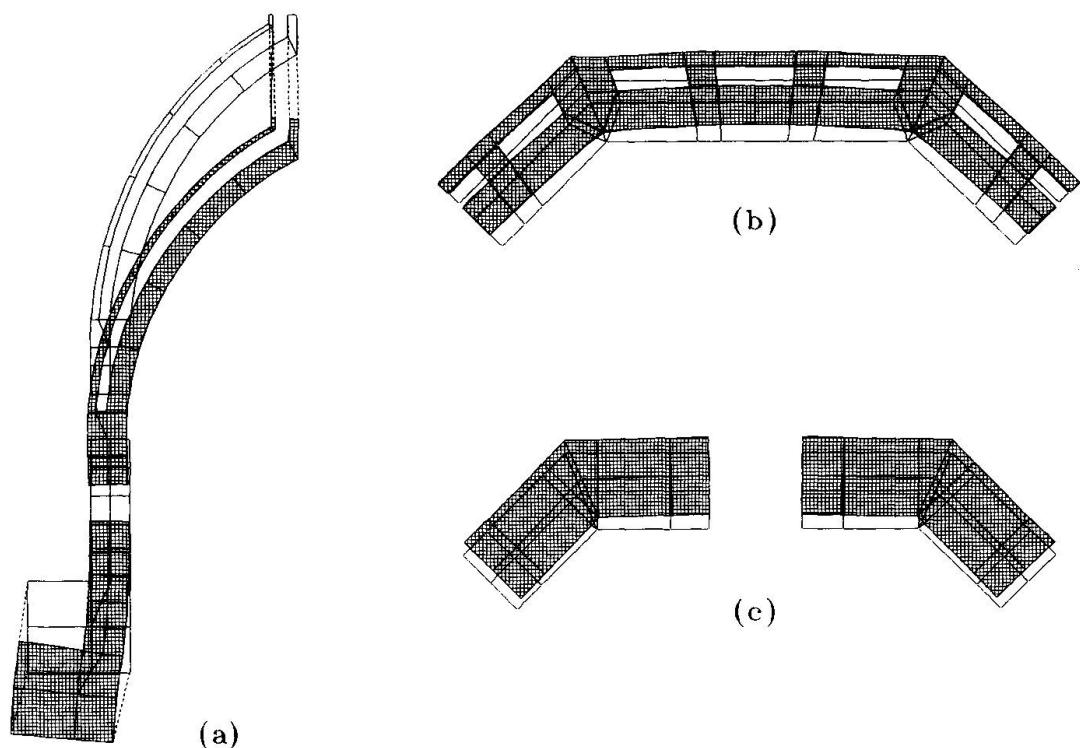
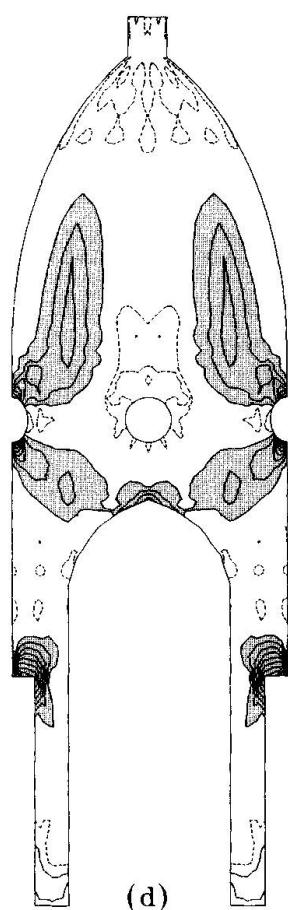
Fig. 3 "First virtual model" undamaged structure:

- (a) deformed line of vertical section in centerline on even-numbered panel;
- (b) deformed line of section 3-3 at 66 m level;
- (c) deformed line of horizontal section on circular centerline window (note ovalization of opening on even-numbered panel);
- (d) stress distribution σ horizontal on intrados face (note tension increase around the circular windows of even numbered panel and above the keystone of arch). Tension zone shaded.

- "First virtual model" characteristic:

n° nodes 3286

n° elements 569

isoparametric hexahedrons with 20 nodes

isoparametric pentahedrons with 15 nodes

modulus of elasticity: 50000 kg/cm²

Poisson's ratio : 0.1

Density : 0.0018 kg/cm³

A perusal of results clearly shows that the "parallels" just above the circular windows on the even-numbered panels undergo high levels of tensile stresses. Horizontal tensile stresses are found also in the drum, above the keystone of arches on the odd-numbered sides (see fig. 3 a, b, c, d).

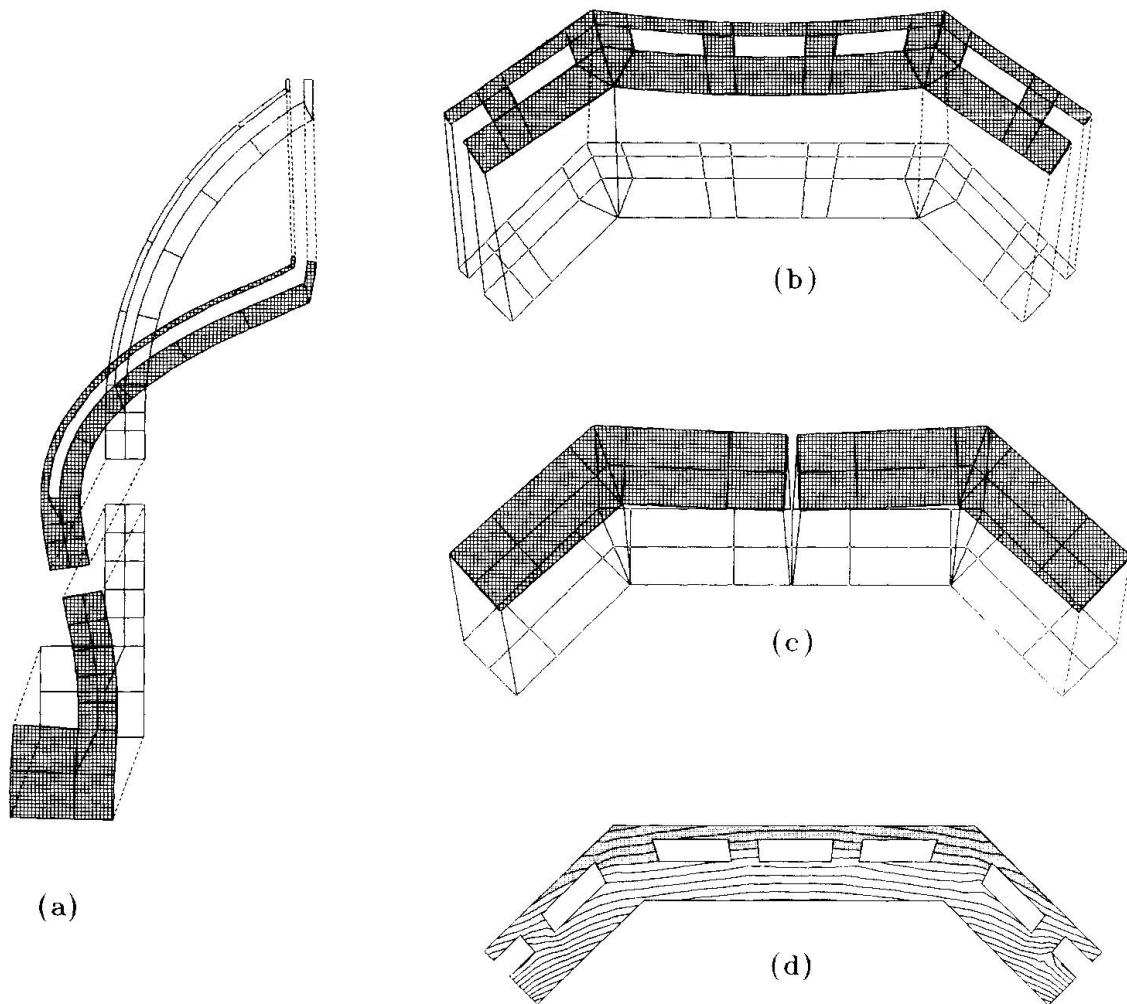
Fig. 4 "First identification model" with type A and B cracks:

- (a) deformed line of vertical section;
- (b) deformed line of section 3-3 at 66 m level
(note inflexion on the section plane);
- (c) deformed line of section under circular window
(note opening crack B);
- (d) stress distribution σ_z vertical in section 3-3
(note effects of bending with vertical tension
localized in external panels with odd numbering).
Tension zone shaded.

The results of the analysis carried out on this second model confirm the indications of the crack pattern, explaining in particular the origin of the cracks "type C and D". It is observed also that the external shell on the odd-numbered sides is subjected to vertical tensile stresses, whereas the highest level of vertical compressive stresses is found in the internal corners of cracks "type A".

This distribution of vertical stresses has been confirmed experimentally through another "continuous monitoring" operation using the flat jack technique (fig. 4 a, b, c, d; fig. 5 a, b, c).

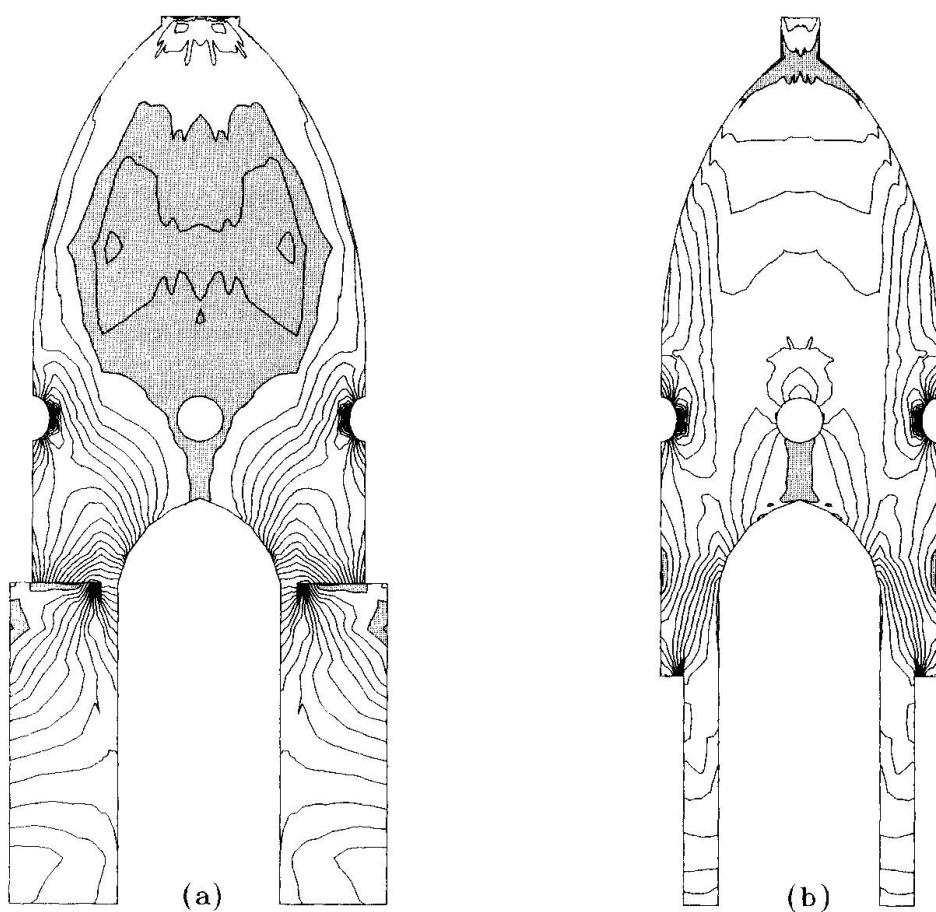
Fig. 5 "First-identification" model with type A and B cracks:

- (a) stress distribution σ_z vertical on extrados face;
- (b) stress distribution σ_z vertical intrados face;
- (c) stress distribution σ horizontal on intrados face (note tension in the corner and in the central zone of the panels with odd numbering, corresponding at type C and D cracks).

Tension zone shaded.

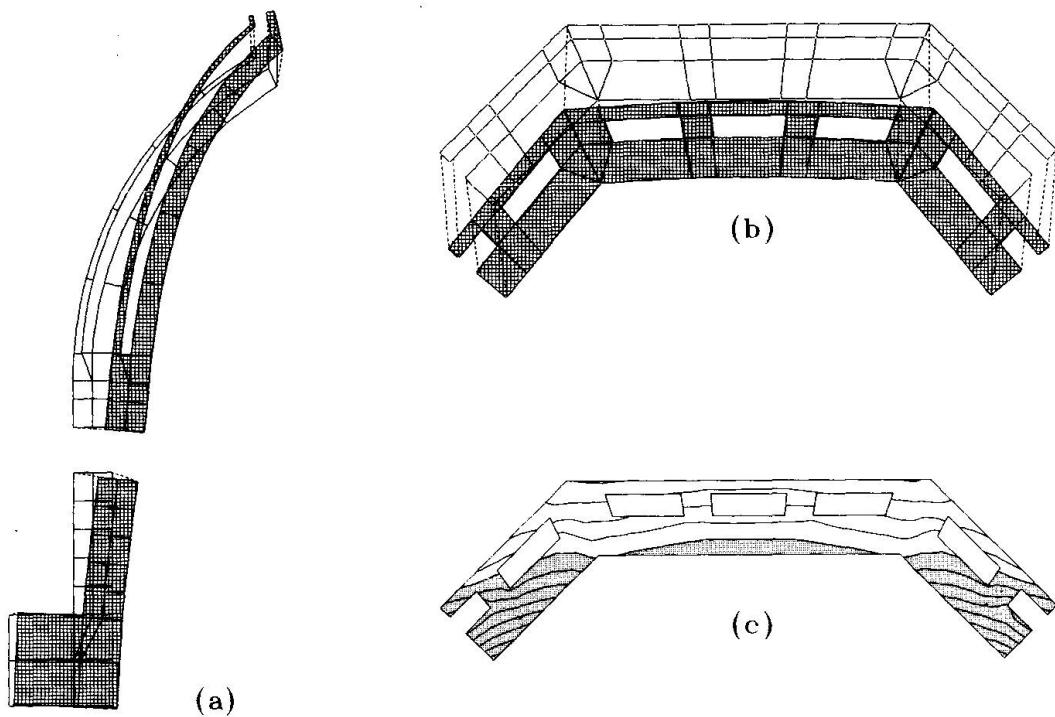
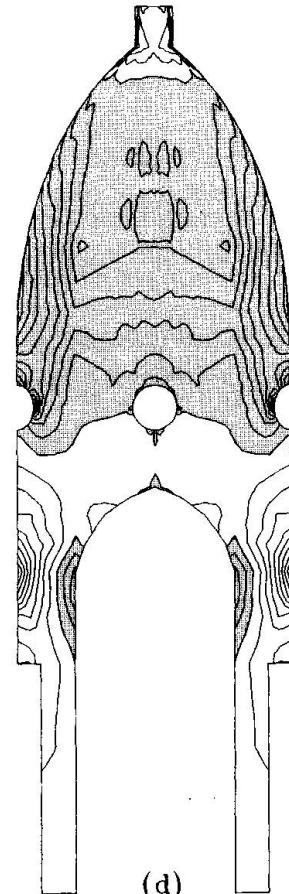
Fig. 6 "First identification model" under only strengthening effect:

- (a) deformed line of vertical section;
- (b) deformed line of section 3-3 at 66 m level;
- (c) stress distribution σ_z vertical in the section 3-3; with opponent distribution with respect to the dead-weight;
- (d) stress distribution σ_z vertical on intrados face;

Tension zone shaded.

The strengthening intervention could be effected through harmonic-steel cables placed at floor level in the first walking. The shape of these belts, pulled on at the midpoint of each side, would be octagonal; thus the interaction with the existing structure (apart from local effect) could be schematized by a system of radial forces, applied in the edges at the springing section of the dome.

Perusing the numerical simulation of this strengthening carried out on the "first-identification" model, one is surprised by the close-fitting antagonistic effect brought about by the intervention as against the dead-weight stress pattern (fig. 6 a, b, c, d).
