Artikel: Diagnosis and strengthening of the Brunelleschi Dome
Autor: Chiarugi, A. / Fanelli, M. / Giuseppetti, G.
DOI: <https://doi.org/10.5169/seals-53328>

Diagnosis and Strengthening of the Brunelleschi Dome

SUMMARY

The paper begins by reviewing the historical information about the different studies carried out in past centuries in order to follow the evolution of the dome's state of damage. The diagnostic evaluation advanced in 1695 is confirmed in the light of modern studies. An intervention hypothesis is then illustrated, which could be assumed as the starting point for a consolidation strategy of the monument.

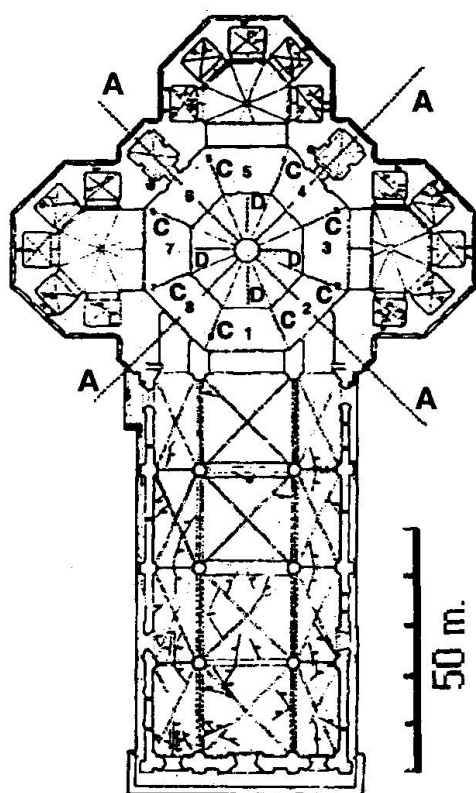
Fig. 1 Sides numbering and planar position of type "A, B, C and D" cracks.

After 1434 (the year in which Filippo Brunelleschi achieved the construction of the Dome of Santa Maria del Fiore), and after the erection of the skylight, carried out after Brunelleschi's death, no direct information is available until 1600 about mechanical problems in the Dome. Successively, several investigation campaigns are mounted concerning the cracks observed on some of the dome's panels, especially on the sides directly above the absidal pylons, and in particular in the South-East corner, panel n° 4; see figgs. 1 and 2.

- "type A" cracks, subvertical, through the whole thickness. (panels with even numbering);
- "type B" cracks, subvertical, through the whole thickness, in the panels with odd numbering;
- "type C" cracks, penetrating only to a partial depth in the thickness, in the edges between adjoining panels;

- "type D" cracks, also penetrating only to a partial depth in the thickness, along the midline of the panels with odd numbering (see figs. 1 and 2).

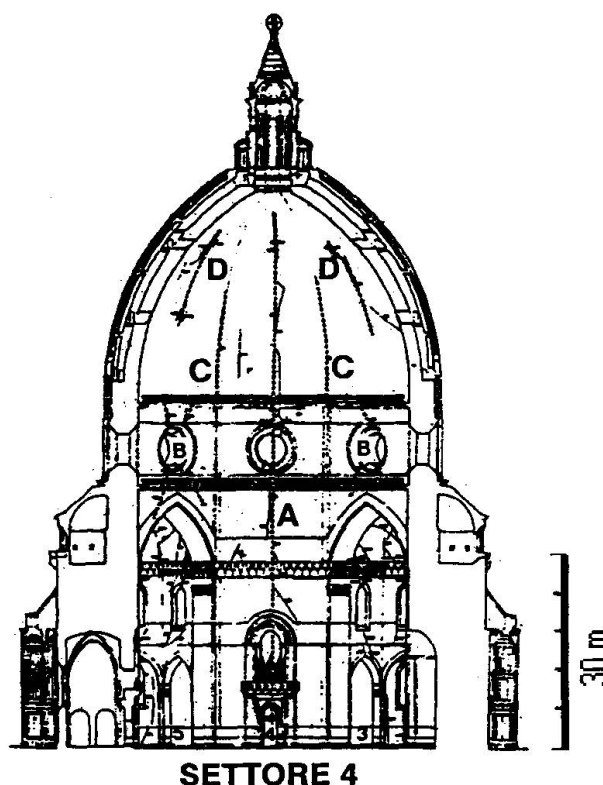
Fig. 2 Crack description summary with type "A, B, C and D" cracks.

The time evolution of cracks is known too, insofar as in 1757 only "type A" cracks were observable, and then only on sides 4 and 6, whereas nowadays cracks are observable in all four sides above the pylons.

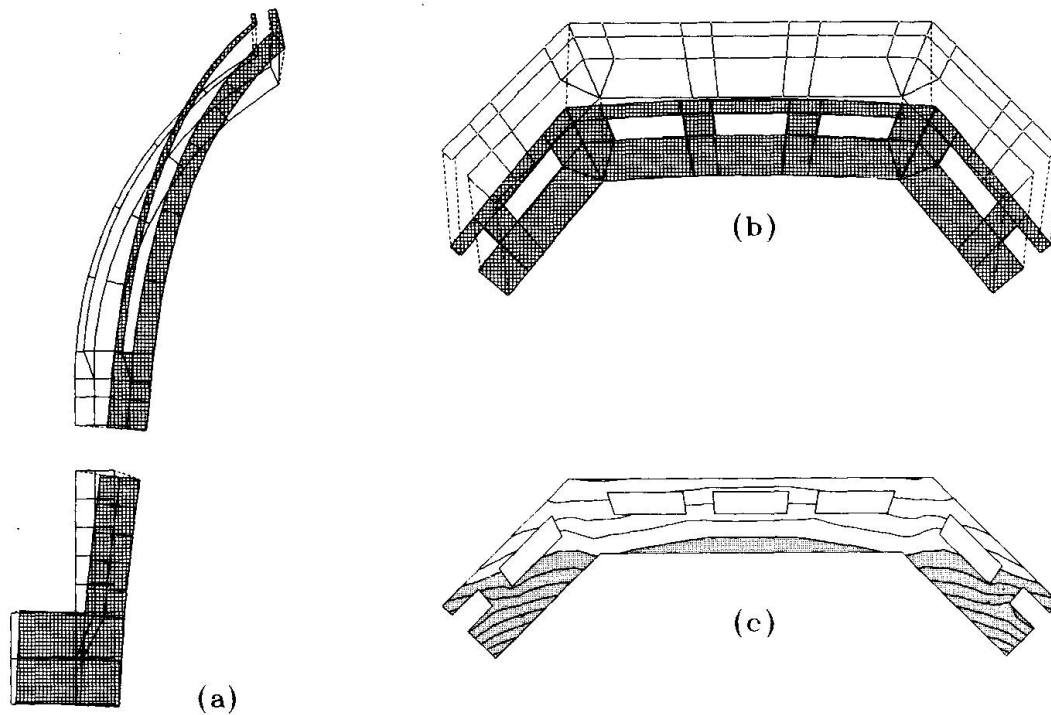
**Fig. 6**

"First identification model" under only strengthening effect:

- (a) deformed line of vertical section;
- (b) deformed line of section 3-3 at 66 m level;
- (c) stress distribution σ_z vertical in the section 3-3; with opponent distribution with respect to the dead-weight;
- (d) stress distribution σ_z vertical on intrados face;

Tension zone shaded.

The strengthening intervention could be effected through harmonic-steel cables placed at floor level in the first walking. The shape of these belts, pulled on at the midpoint of each side, would be octagonal; thus the interaction with the existing structure (apart from local effect) could be schematized by a system of radial forces, applied in the edges at the springing section of the dome.

Perusing the numerical simulation of this strengthening carried out on the "first-identification" model, one is surprised by the close-fitting antagonistic effect brought about by the intervention as against the dead-weight stress pattern (fig. 6 a, b, c, d).

One can remark that, according to the Betti theorem, the mutual work of the two force systems (dead-weight and prestressed belts) is obviously negative. However, one can moreover generally recognize that "almost everywhere" is negative also the local function which expressed the density of mutual work at every point of the structure.

It seems, thus, right to state that the intervention proposed in 1695 was a qualitatively correct therapy ensuing from a realistic evaluation of the main damaging factor.
