**Zeitschrift:** IABSE reports = Rapports AIPC = IVBH Berichte  
**Band:** 70 (1993)

**Artikel:** Wind induced stresses in the spire of Brussels Town Hall Tower  
**Autor:** Espion, B. / Elinck, S. / Halleux, P.  
**DOI:** <https://doi.org/10.5169/seals-53329>

## Wind Induced Stresses in the Spire of Brussels Town Hall Tower

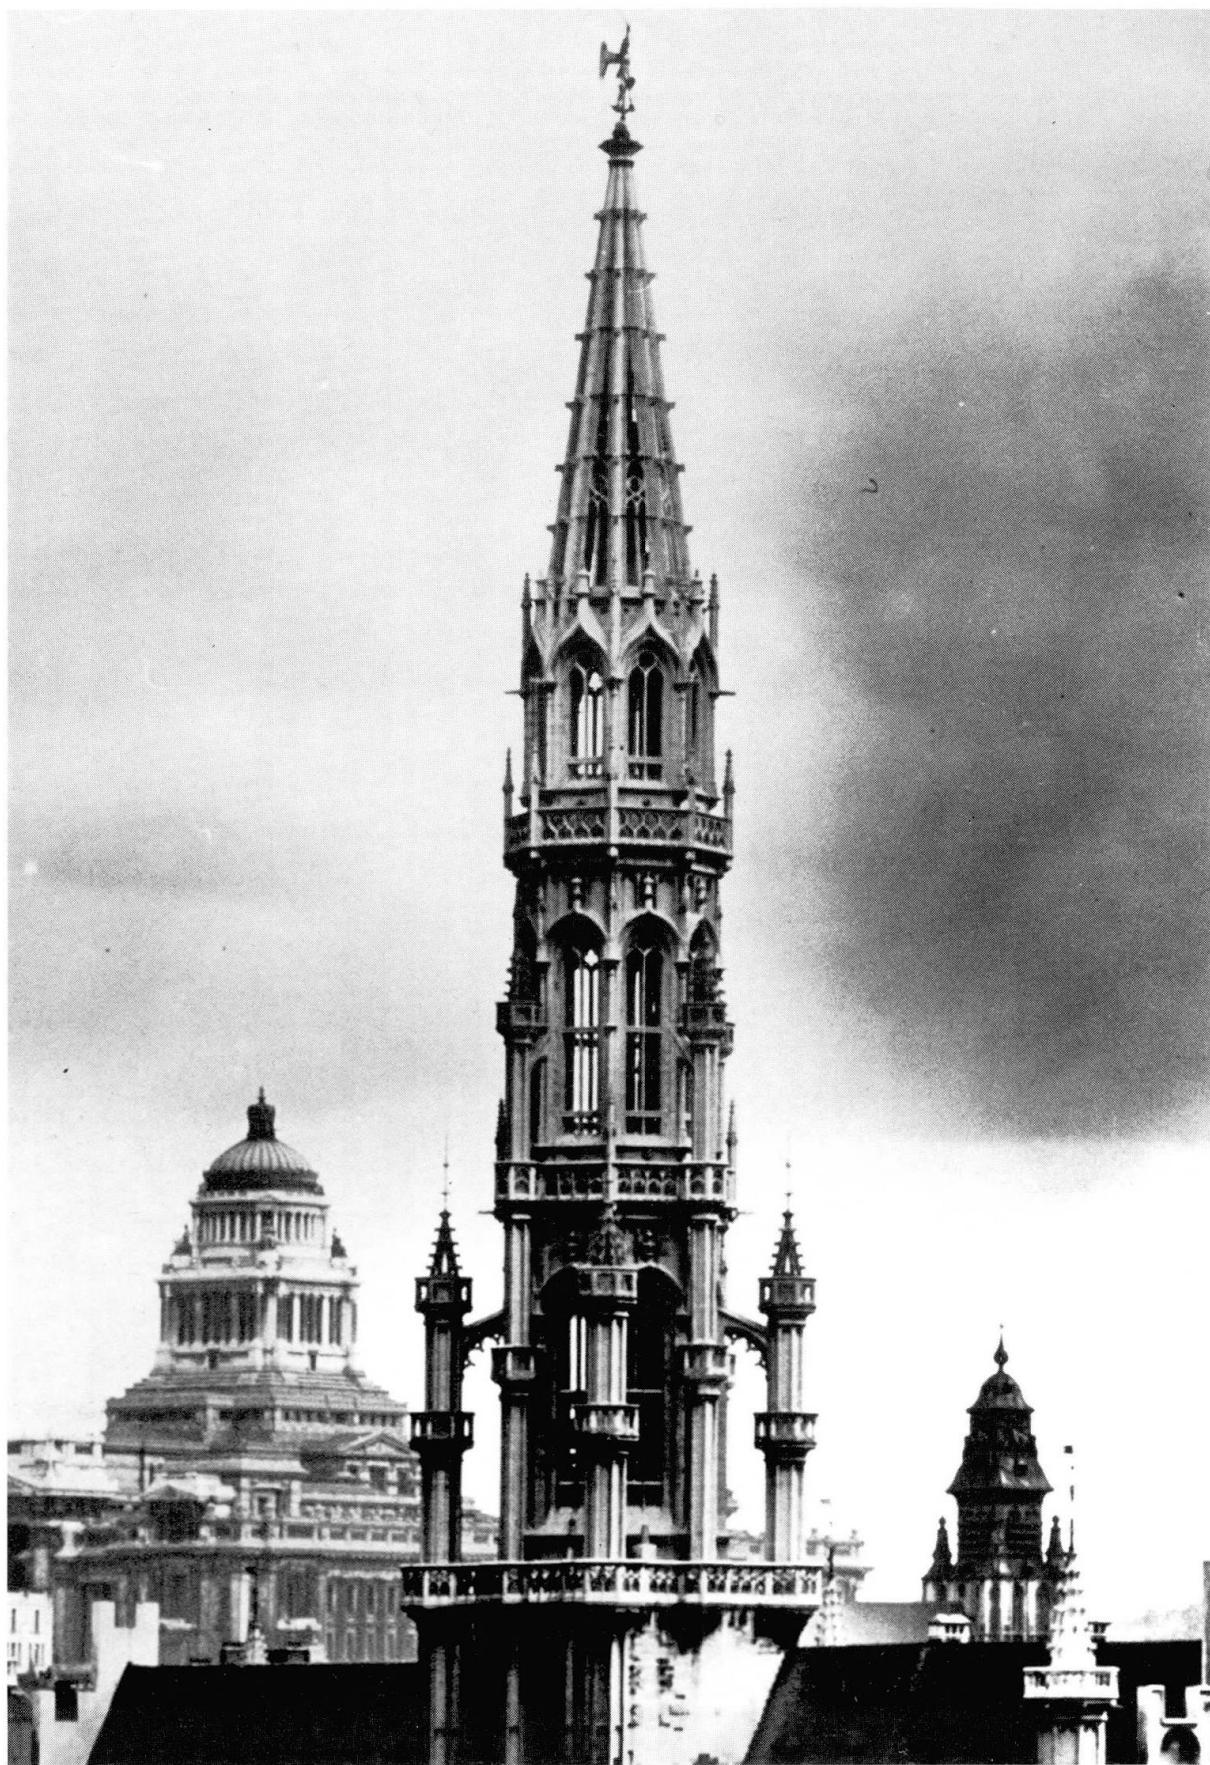
Fig. 1 The tower of the Brussels town hall (96m)

The main tower of the Brussels town hall (Fig.1) is a masterpiece of Gothic architecture dating back to the middle of the 15th Century (1449-1454). The tower suffers now from severe disorders which may be attributed to sequels of the bombing by the armies of Louis XIV and to unwise previous restorations with unsuitable materials and reinforcements like iron rods that rust and induce fracturing of the stones. A major restoration is therefore needed and is presently taking place.

The most damaged part of the tower is its spire. The spire looks like a pyramid with octagonal cross section. The height of the spire is 20m. Its lower, or skeletal part (11m), consists of 8 slender inclined columns at the 8 edges of the pyramidal volume; the architects called these inclined columns ribs ("côtes"). The upper part (9m) is a solid (or assumed so) pyramidal shaped volume supporting a 3.1m height statue of archangel St Michael culminating at 96m above ground level.
