**Zeitschrift:** IABSE reports = Rapports AIPC = IVBH Berichte  
**Band:** 70 (1993)

**Artikel:** Ultrasonic methods for damage evaluation in limestone columns  
**Autor:** Benedetti, Andrea / Barboni, Marco  
**DOI:** <https://doi.org/10.5169/seals-53331>

## **Ultrasonic Methods for Damage Evaluation in Limestone Columns**

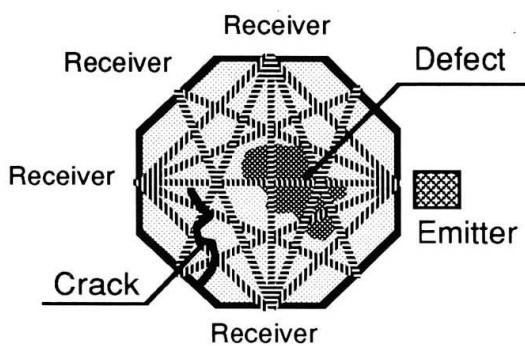
Fig. 1 : Multi path scanning for defect positioning

More precisely, in presence of rough localised cracks, ultrasonic scanning can be used in a way similar to tomography, by means of several intersecting travelling paths, which enable to draw information on the geometry of cracks [9] (fig.1).

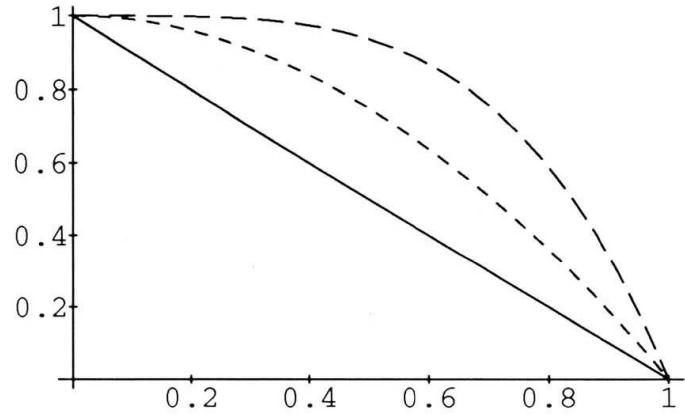
Fig. 2 : Damage index as a function of the proposed velocity relations

In fig. 2 the results of the presented damage laws are compared; As is clearly apparent, the different order of the exponent gives rise to a divergence of the indices; on the other hand, each definition is tailored on a different parameter and this should be taken into account when a damage measure has to be kept.

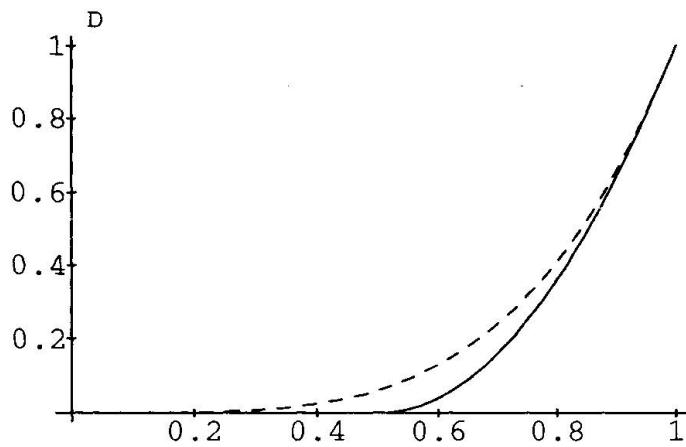
**Fig. 3.a** : Damage evolution as a function of stress level  $\sigma/\sigma_k$ , as predicted by dilatancy

A drawback of rel. (5) is the need of the value of  $\sigma_{vc}$  which is of difficult definition indeed. However, contrary to the linear damage law, this type of representation involves a filtering (due to the exponent  $m$ ), which runs finally to a step damage function; in fig.3 the results for  $m=2$  and  $m=4$  (solid lines) are compared with the case  $\sigma_{vc}=0$ , showing a relative insensitivity to the choice of the various constants.

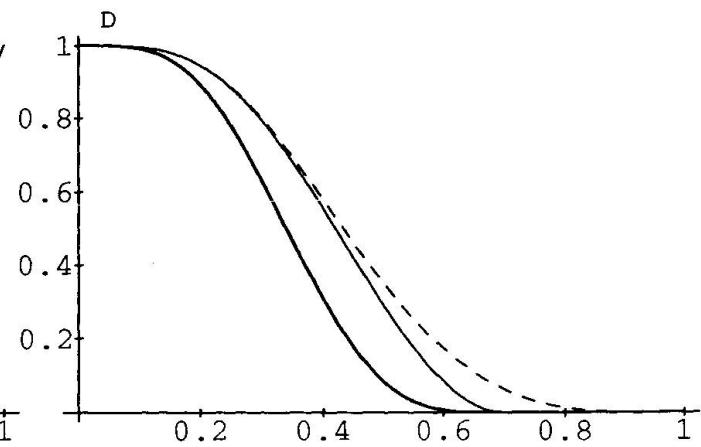
**Fig. 3.b** : Damage evolution as a function of the ultrasonic velocity ratio  $v_{us}/v_o$

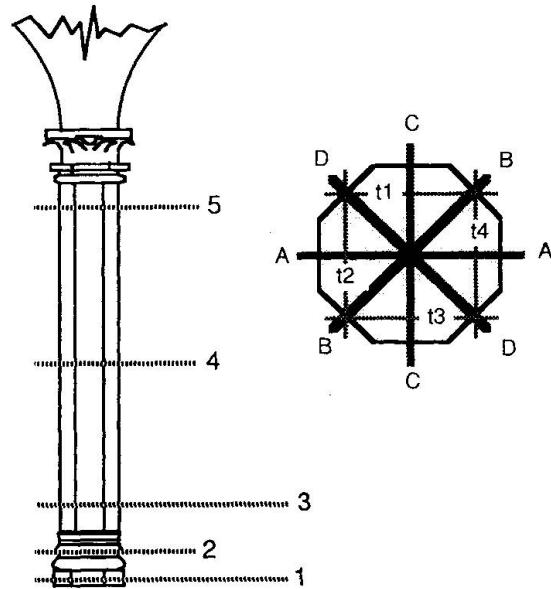
**Fig. 4** : Representation of the measure paths

Section	Path	Initial	Repaired
1	a	-	2767
	b	-	3131
	c	1758	2344
	d	-	2103
2	a	-	1994
	b	1875	1857
	c	1825	1867
	d	-	1923
3	a	1740	2255
	b	1955	2056
	c	2157	1891
	d	1864	2062
4	a	1907	2272
	b	2161	1975
	c	2262	1852
	d	2036	2076
5	a	2037	2850
	b	2211	2461
	c	2408	2222
	d	2183	2091
	m/s	m/s

microcracks are present resulting in the ultrasonic velocities reported in fig.4.

In the table of fig. 4 the values of the ultrasonic velocities measured after the filling operation are shown; as is apparent, the major change involves the sections what initially were not transparent.

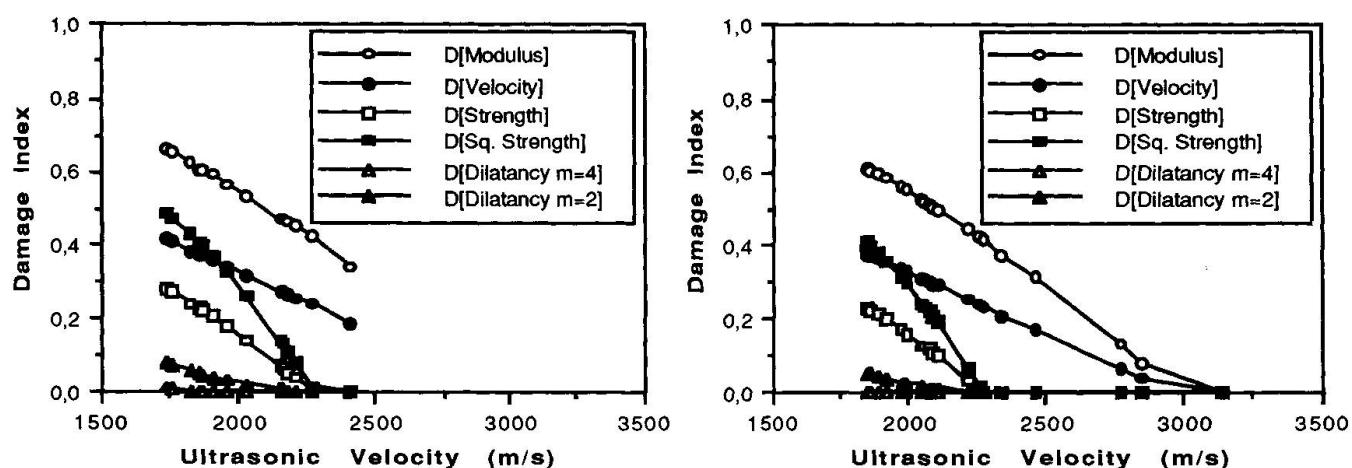
Fig. 5 & 6 : Damage indices resulting from the various formulations for the damaged and restored column

In fig.s 5 and 6 the computed damage indices are compared for both conditions, before and after repair. As we said before, the various statements differ dramatically and is difficult to extract the correct one.

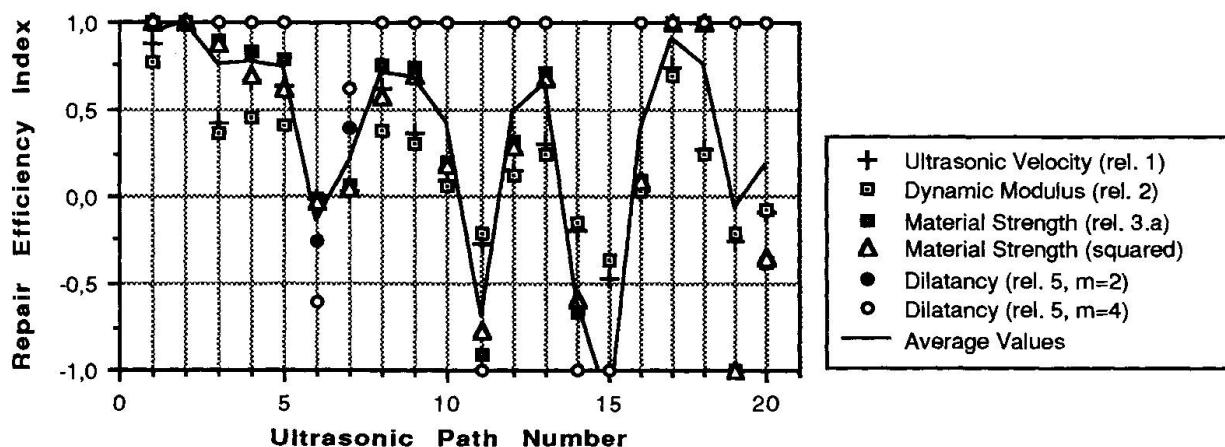
Fig. 7 : Repair Efficiency as computed from the ratio of damage indices, before and after the strengthening

On the contrary, expressing the efficiency of the strengthening by means of the ratio of the relevant damage indices we can observe a significant agreement of the introduced indices. In fig. 7 the efficiency ratios for the various measurement paths are compared.
