Zeitschrift: IABSE reports = Rapports AIPC = IVBH Berichte

Artikel: Ultrasonic methods for damage evaluation in limestone columns

Autor: Benedetti, Andrea / Barboni, Marco

Ultrasonic Methods for Damage Evaluation in Limestone Columns

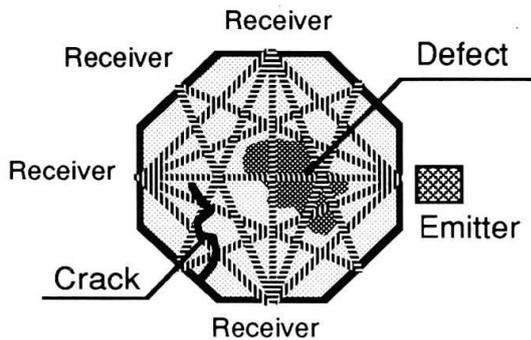
More precisely, in presence of rough localised cracks, ultrasonic scanning can be used in a way similar to tomography, by means of several intersecting travelling paths, which enable to draw information on the geometry of cracks [9] (fig.1).

Fig. 1 : Multi path scanning for defect positioning

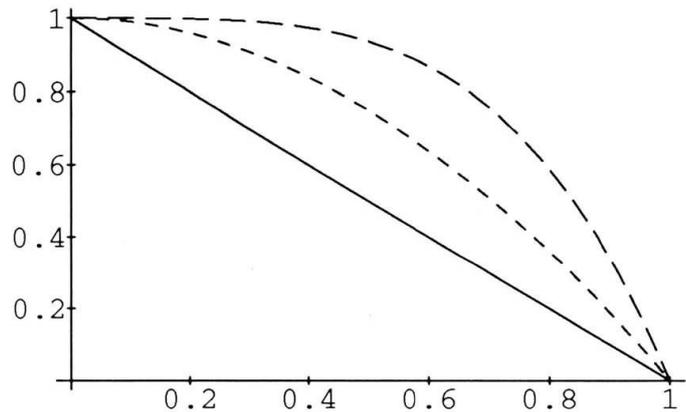
Fig. 2 : Damage index as a function of the proposed velocity relations

In fig. 2 the results of the presented damage laws are compared; As is clearly apparent, the different order of the exponent gives rise to a divergence of the indices; on the other hand, each definition is tailored on a different parameter and this should be taken into account when a damage measure has to be kept.

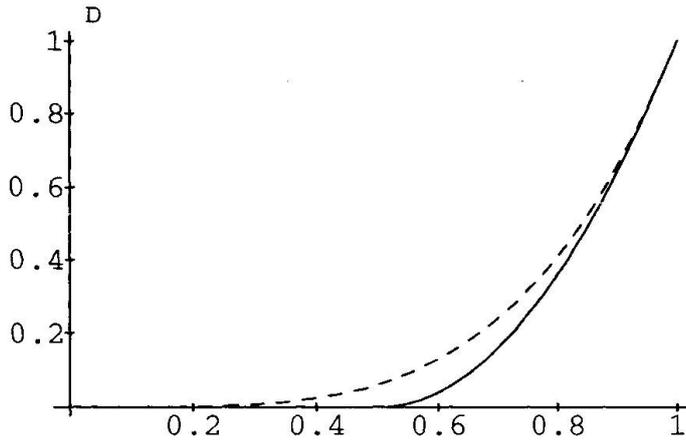
A drawback of rel. (5) is the need of the value of σ_{vc} which is of difficult definition indeed. However, contrary to the linear damage law, this type of representation involves a filtering (due to the exponent m), which runs finally to a step damage function; in fig.3 the results for $m=2$ and $m=4$ (solid lines) are compared with the case $\sigma_{vc}=0$, showing a relative insensitivity to the choice of the various constants.

Fig. 3.a : Damage evolution as a function of stress level σ/f_k , as predicted by dilatancy

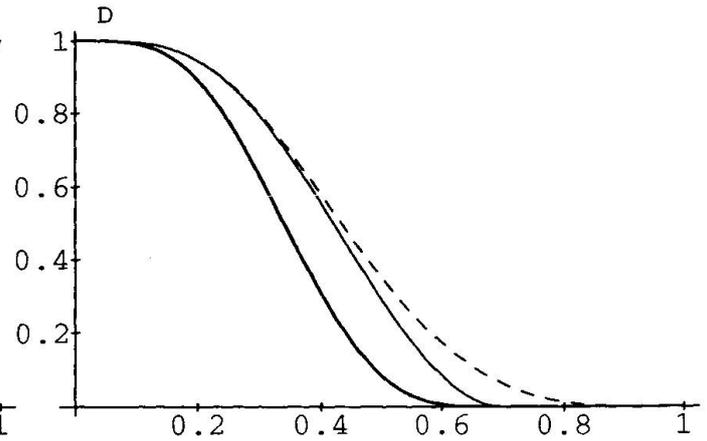
Fig. 3.b : Damage evolution as a function of the ultrasonic velocity ratio v_{US}/v_0

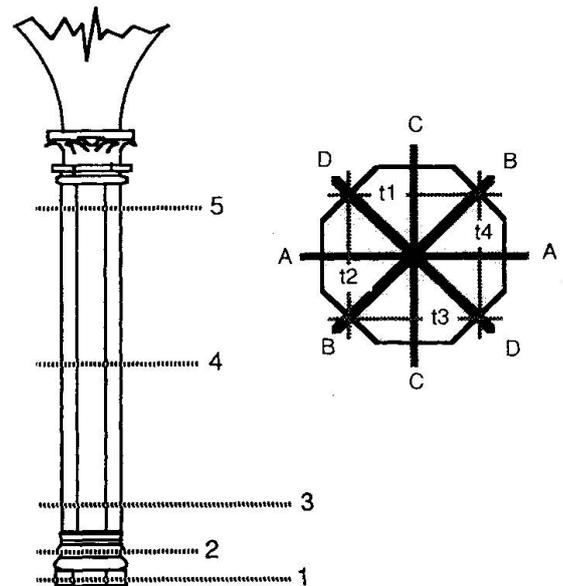
Fig. 4 : Representation of the measure paths

microcracks are present resulting in the ultrasonic velocities reported in fig.4.

In the table of fig. 4 the values of the ultrasonic velocities measured after the filling operation are shown; as is apparent, the major change involves the sections what initially were not transparent.

Section	Path	Initial	Repaired
1	a	-	2767
	b	-	3131
	c	1758	2344
	d	-	2103
2	a	-	1994
	b	1875	1857
	c	1825	1867
	d	-	1923
3	a	1740	2255
	b	1955	2056
	c	2157	1891
	d	1864	2062
4	a	1907	2272
	b	2161	1975
	c	2262	1852
	d	2036	2076
5	a	2037	2850
	b	2211	2461
	c	2408	2222
	d	2183	2091
		m/s	m/s

Table I

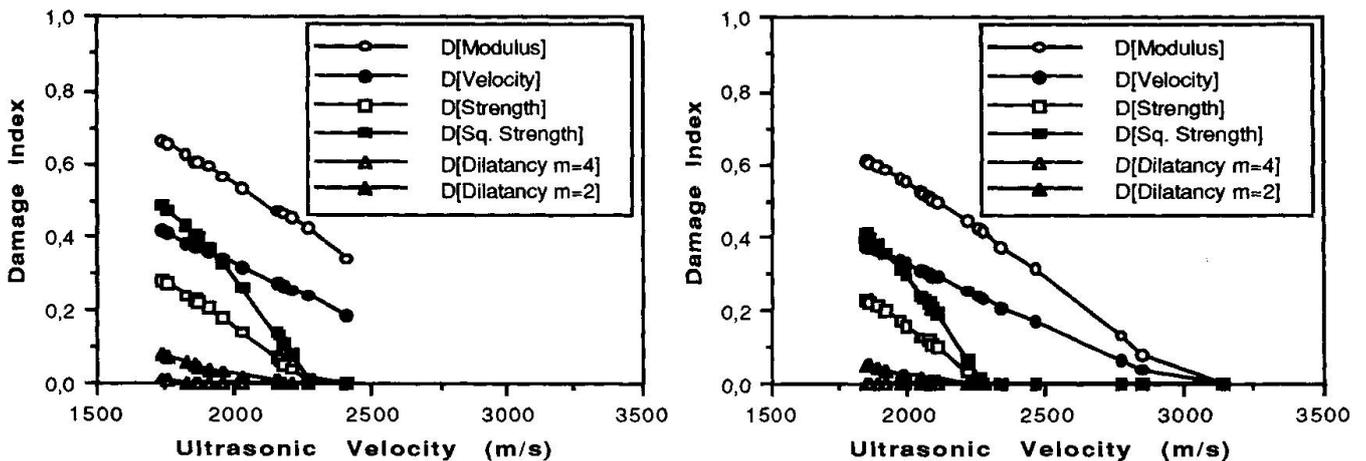
In fig.s 5 and 6 the computed damage indices are compared for both conditions, before and after repair. As we said before, the various statements differ dramatically and is difficult to extract the correct one.

Fig. 5 & 6 : Damage indices resulting from the various formulations for the damaged and restored column

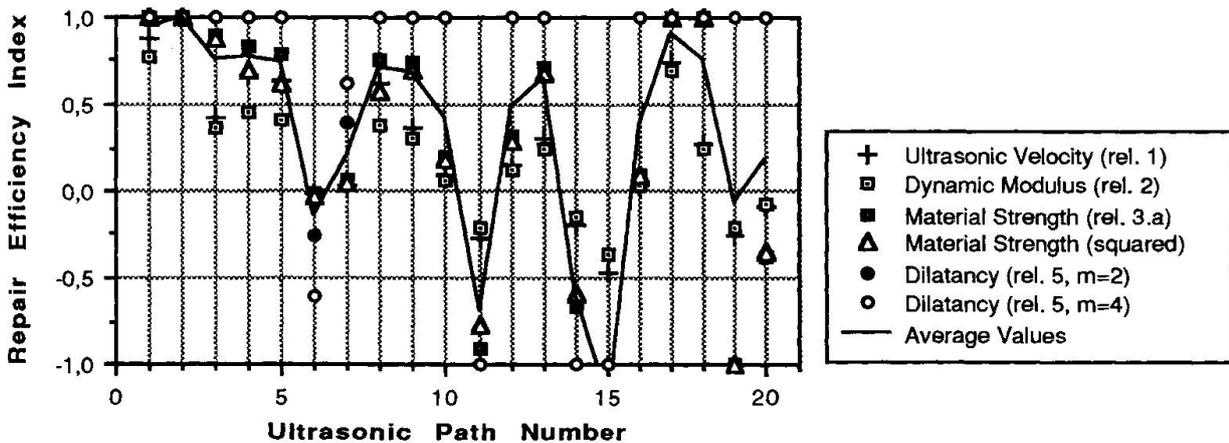
Fig. 7 : Repair Efficiency as computed from the ratio of damage indices, before and after the strengthening

On the contrary, expressing the efficiency of the strengthening by means of the ratio of the relevant damage indices we can observe a significant agreement of the introduced indices. In fig. 7 the efficiency ratios for the various measurement paths are compared.
