**Zeitschrift:** IABSE reports = Rapports AIPC = IVBH Berichte  
**Band:** 70 (1993)

**Artikel:** Repair and strengthening of arch bridges  
**Autor:** Page, John  
**DOI:** <https://doi.org/10.5169/seals-53347>

## Repair and Strengthening of Arch Bridges

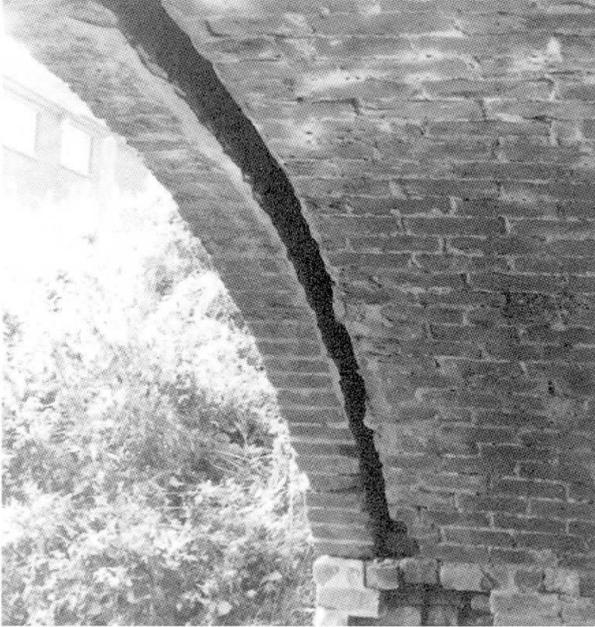
Fig 2 Crack in arch ring

Spandrel walls stiffen the arch ring at its edges. Flexing of the arch ring due to traffic loads will produce shear stresses in the ring where the relatively flexible part with only fill above it is stiffened by the spandrel wall, and these stresses may result in a crack. A severe example of such a crack is shown in figure 2. This type of failure may be assisted by rainwater getting into the structure at the parapet/surface joint and causing particular damage to the arch ring mortar where the spandrel wall meets the ring.

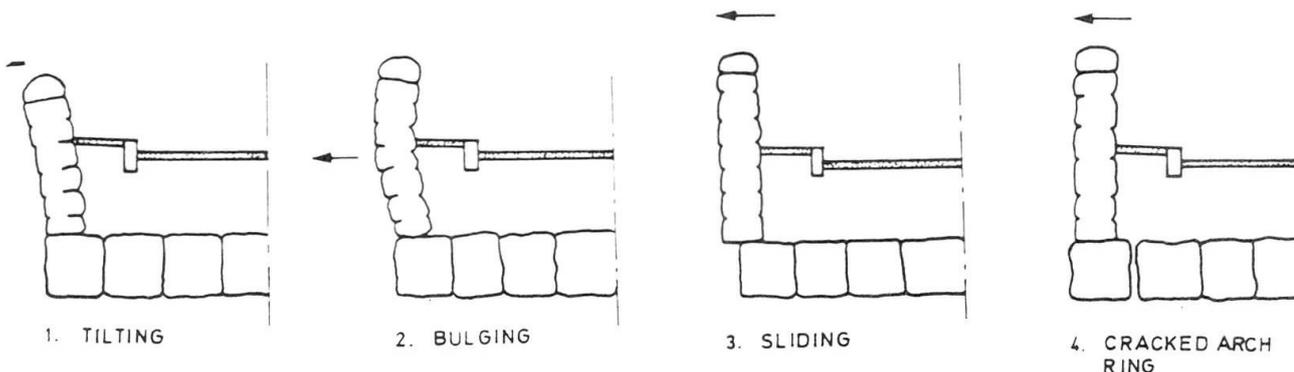
Fig 3 Spandrel wall failures

Spandrel walls probably represent the biggest single problem with masonry arch bridges. They suffer from the normal problems associated with exposed masonry such as weathering and loss of pointing. They are also frequently affected by dead and live load lateral forces generated through the fill or as a result of vehicle impact on the parapet or by freezing of the fill. The effect may be (see figure 3) outward rotation, sliding on the arch ring, cracking of the arch ring, or bulging.
