Artikel: Repair and strengthening of arch bridges
Autor: Page, John
DOI: <https://doi.org/10.5169/seals-53347>

Repair and Strengthening of Arch Bridges

John PAGE

Principal Scientific Officer
Transp. Res. Lab.
Crowthorne, UK

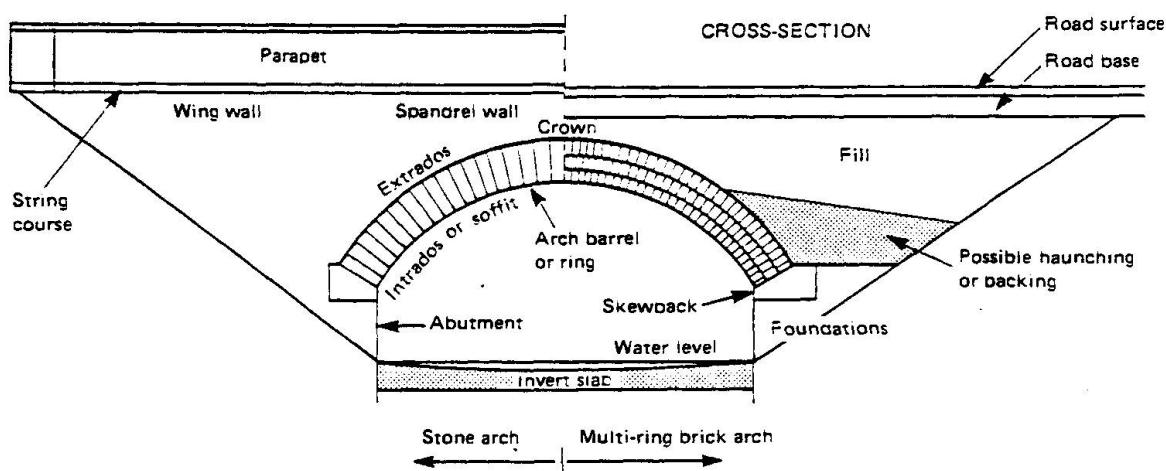
Many of them have deteriorated due to the effects of weathering and traffic: some of the traffic they are now required to carry is much heavier than was envisaged when they were built. There are a variety of commonly used repair and strengthening methods used to maintain their function or to increase their load carrying capacity. This paper discusses the common types of deterioration and the effectiveness and cost of some repair and strengthening methods. Typical construction of masonry arch bridges is shown in figure 1.

Fig 1 Typical masonry arch bridge construction

An invert slab (see figure 1) is a slab of concrete or masonry placed between the abutment walls or piers with its top surface at or below river bed level. It helps to prevent scour. If incorrectly installed however, there is a risk of scour beneath the slab, particularly at its downstream end, and this was found in one of the cases studied.

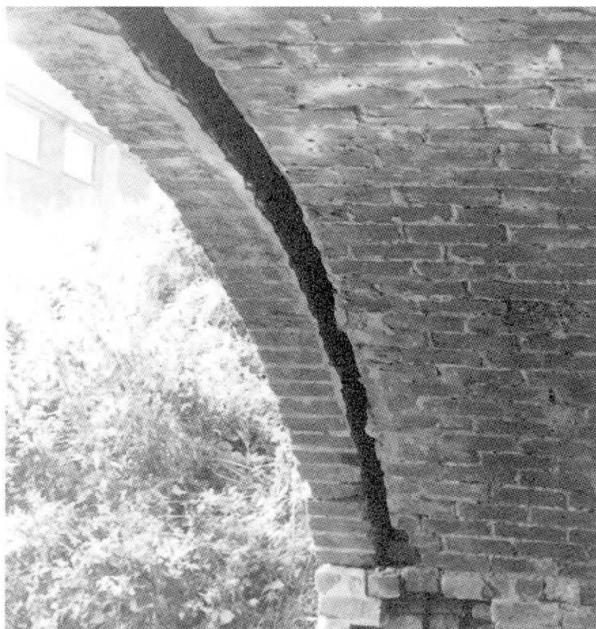
Fig 2 Crack in arch ring

Spandrel walls stiffen the arch ring at its edges. Flexing of the arch ring due to traffic loads will produce shear stresses in the ring where the relatively flexible part with only fill above it is stiffened by the spandrel wall, and these stresses may result in a crack. A severe example of such a crack is shown in figure 2. This type of failure may be assisted by rainwater getting into the structure at the parapet/surface joint and causing particular damage to the arch ring mortar where the spandrel wall meets the ring.

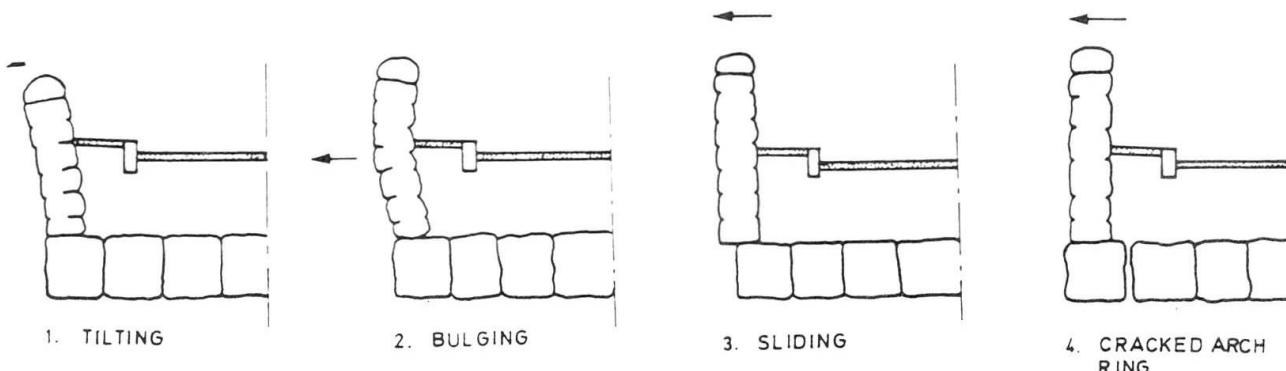
Spandrel walls probably represent the biggest single problem with masonry arch bridges. They suffer from the normal problems associated with exposed masonry such as weathering and loss of pointing. They are also frequently affected by dead and live load lateral forces generated through the fill or as a result of vehicle impact on the parapet or by freezing of the fill. The effect may be (see figure 3) outward rotation, sliding on the arch ring, cracking of the arch ring, or bulging.

Fig 3 Spandrel wall failures
