Artikel: Repair and strengthening of arch bridges

Repair and Strengthening of Arch Bridges

John PAGE
Principal Scientif Officer
Transp. Res. Lab.
Crowthorne, UK

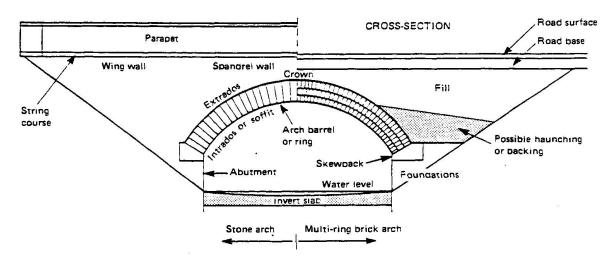
Fig 1 Typical masonry arch bridge construction

Many of them have deteriorated due to the effects of weathering and traffic: some of the traffic they are now required to carry is much heavier than was envisaged when they were built. There are a variety of commonly used repair and strengthening methods used to maintain their function or to increase their load carrying capacity. This paper discusses the common types of deterioration and the effectiveness and cost of some repair and strengthening methods. Typical construction of masonry arch bridges is shown in figure 1.

An invert slab (see figure 1) is a slab of concrete or masonry placed between the abutment walls or piers with its top surface at or below river bed level. It helps to prevent scour. If incorrectly installed however, there is a risk of scour beneath the slab, particularly at its downstream end, and this was found in one of the cases studied.

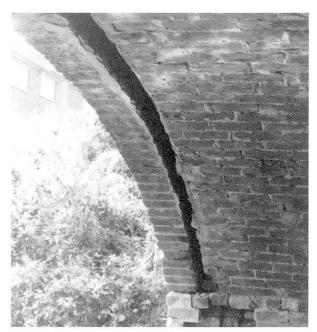
Fig 2 Crack in arch ring

Spandrel walls stiffen the arch ring at its edges. Flexing of the arch ring due to traffic loads will produce shear stresses in the ring where relatively flexible part with only fill above it is stiffened by the spandrel wall, and these stresses may result in a crack. A severe example of such a crack is shown in figure 2. This type of failure may be assisted by rainwater getting into the structure at the parapet/surface joint and causing particular damage to the arch ring mortar where the spandrel wall meets the ring.

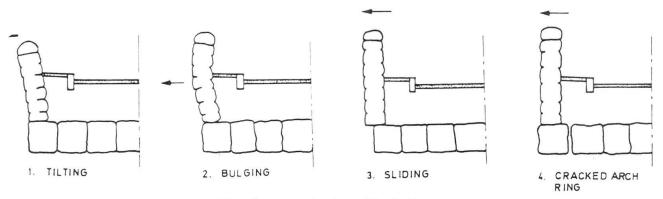
Spandrel walls probably represent the biggest single problem with masonry arch bridges. They suffer from the normal problems associated with exposed masonry such as weathering and loss of pointing. They are also frequently affected by dead and live load lateral forces generated through the fill or as a result of vehicle impact on the parapet or by freezing of the fill. The effect may be (see figure 3) outward rotation, sliding on the arch ring, cracking of the arch ring, or bulging.

Fig 3 Spandrel wall failures
