**Artikel:** New concept for foundations of Saint Michael compound in Rome  
**Autor:** De Tomasso, Francesco / Marchetti, Patrizia  
**DOI:** <https://doi.org/10.5169/seals-53351>

## **New Concept for Foundations of Saint Michael Compound in Rome**

### **SUMMARY**

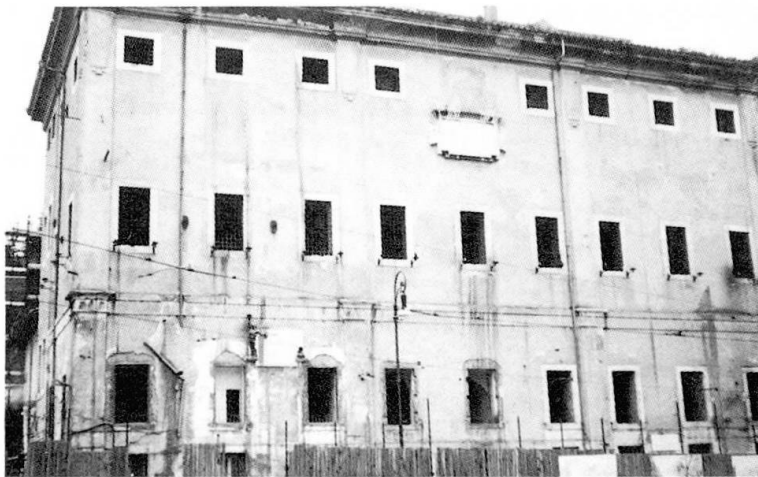
photo 1

The St. Michael Hospice (photo 1) was founded under a papal initiative to solve the problem of beggary and homelessness in Rome at the end of the seventeenth century, works continued for the following 150 years. Thus the St. Michael complex is architectonically fragmented in contrast to the formal and unified elevation along the Tiber river.

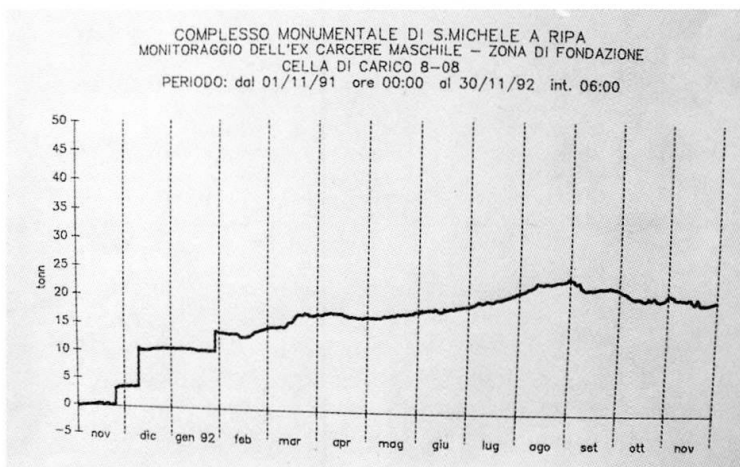
photo 9

This result is confirmed by the diagram of the load sensor which indicates the value of the loads on the foundations in correspondance to the jacks (photo 9). In this diagram the different phases of the load transfer, through the jacks, are evident from the variations of the forces. During the monitoring period it is possible to detect a gradual increase of the pressure in the jacks, corresponding to the trend observed in the adjustment of the settlements of the structures which, together with the sudden variations verified during the loading phases, appear to have a positive drift: the load on the foundation structure increases over time.
