Zeitschrift: IABSE reports = Rapports AIPC = IVBH Berichte
Band: 70 (1993)

Artikel: Strengthening of a 400 year old Ottoman Minaret
Autor: Penelis, George / Papayianni, Ioanna / Stylianidis, Kosmas
DOI: <https://doi.org/10.5169/seals-53355>

Strengthening of a 400 Year Old Ottoman Minaret

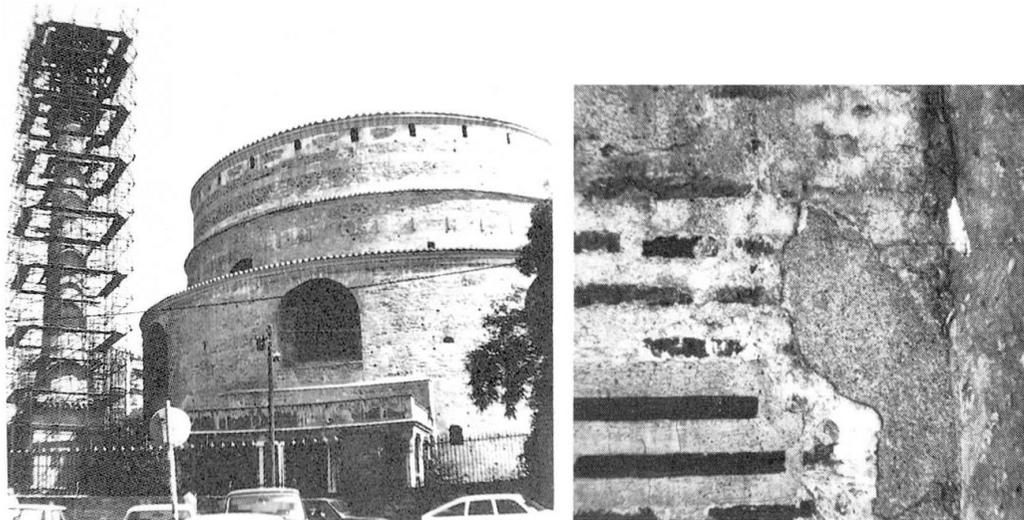
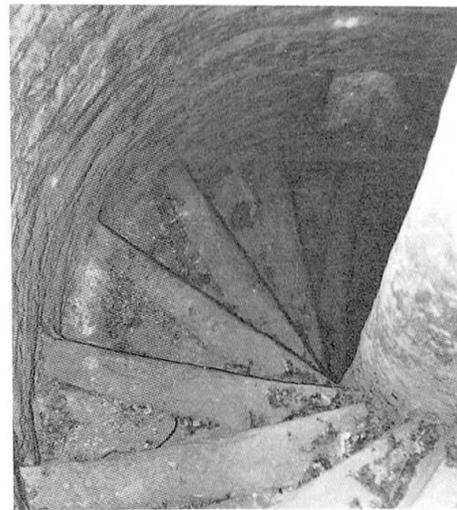
Fig.1

(a) Rotunda-Minaret: Southern view. (b) Masonry close-up: Merely visible horizontal crack. (c) Internal staircase. (d) Balcony and upper cylindrical part

The Minaret is located at a distance of 3.50m western of Rotunda (see Fig.1a). It consists of a 4.50x4.50m square cross-sectioned base, 7.50m in height and is founded on a thick stiff red clay layer approximately 6.00m below the ground level. The base is supporting the trunk of the Minaret consisting of two successive twenty-sided truncated conical parts of 22.00m total height crowned by the muezzin's balcony and the highest fifteen-sided cylindrical part 6.00m in height (see Fig.2). The external diameter of the trunk decreases gradually from 3.25m to 2.10m and finally to 1.75m at the highest cylindrical part. The narrow entrance (0.85x1.95m) is located at the northern face of the base. The internal helical staircase with gradually decreasing diameter ($D=1.80-1.45m$) leads up to the balcony at a height of 29.50m. The small muezzin's doorway (0.50x1.50m) is located at the southern face of the cylindrical trunk penetrated till the top by the narrow staircase ($D=1.35m$). Five narrow loopholes are located along the height of the southern side of the trunk.

The base of the Minaret is consisted of successive stone and brick masonry layers while the masonry of the trunk is pure brickwork built by flattened bricks (30x40x4cm) with thick mortar joints (4cm), (see Fig.1b). The balcony consists also of brickwork supported by successive horizontal wooden beams tangentially projecting from the cylindrical trunk. The staircase is masoned together with the surrounding trunk. At the edge of every step a wooden beam is located diametrically and is embedded in the masonry of the trunk, while along the axis of the staircase a masonry column ($D=0.25m$) is constructed (see Fig.1c).

Emergency works were undertaken just after the 1978 earthquake including general external scaffolding (see Fig.1a) and temporary external confinement by steel rings and wooden beams as well as internal helical concrete jacket at the upper 10m of the Minaret (see Fig.1d,2).

Non destructive tests in combination with a limited number of laboratory destructive tests were applied to make an estimation of mechanical characteristics of bricks, mortar and masonry. To this direction a new series of hammer and ultrasonic tests on bricks and mortar, beyond those performed by the 9th Ephorate, was carried out. Three masonry "triplets" were extracted from the base and the trunk of the Minaret (see Fig. 1b) and were used for the laboratory tests. The results are shown in Table 1.

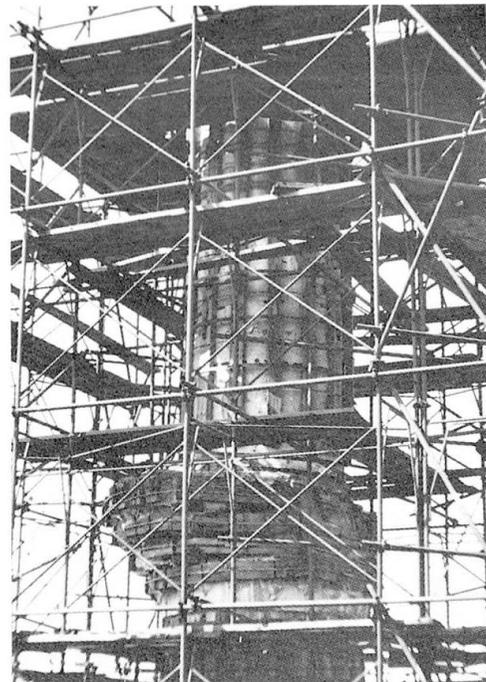
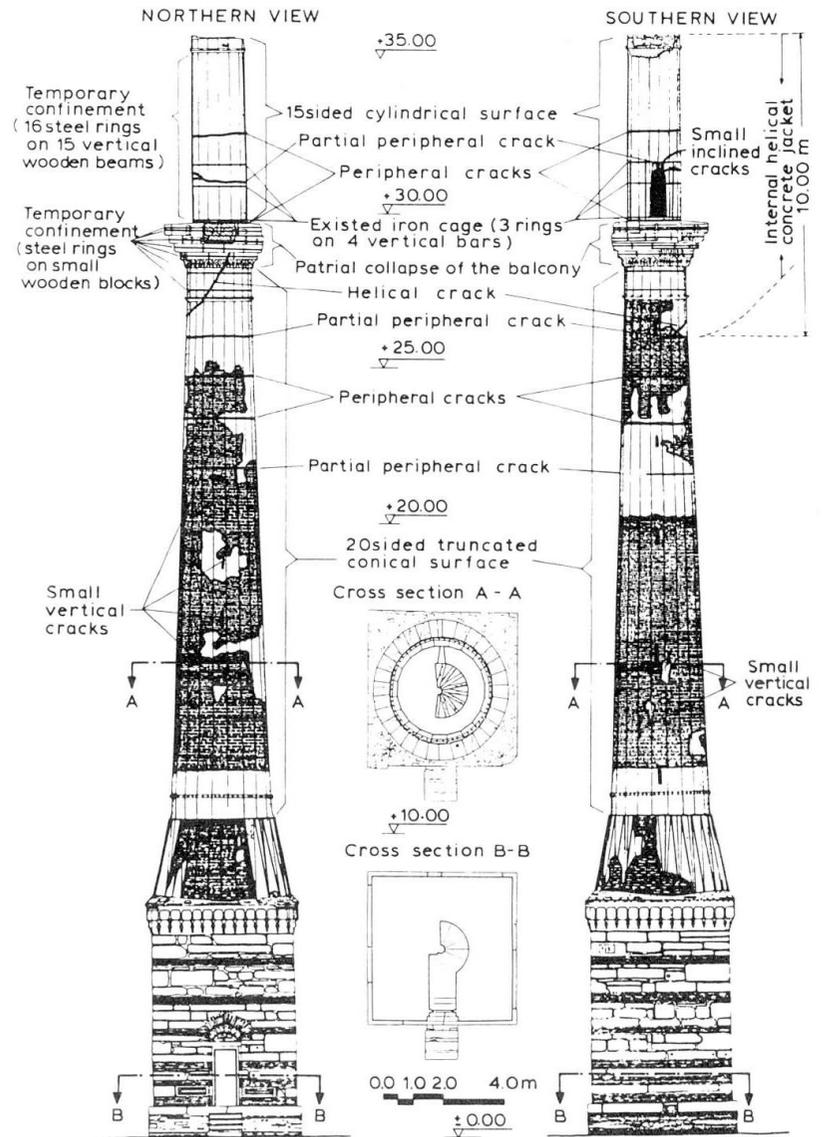
Fig.2 Northern and Southern elevations of the Minaret. Cracking pattern, external emergency interventions

As it can be easily seen in Fig.2, the base of the Minaret is unplastered. The plaster covering has been collapsed at the major part of the trunk, while at the rest of the surface, as well as at the upper cylindrical trunk, it is heavily cracked. Limited superficial deterioration of masonry, especially at the northern face of the trunk has been detected and confirmed by the hammer tests. The wooden beams at the highest steps of the staircase have been heavily corroded due to rain water passing through the open top, as the wooden acute conical roof of the Minaret fall down, probably during an earthquake, at the beginning of the

present century. Successive horizontal peripheral cracks have been ascertained at the upper two fifths of the Minaret and have been drawn in Fig.2. There is one helical crack starting from the highest loophole, following the ascending steps and cutting the balcony. All the cracks, being under vertical compression, are just visible (see Fig.1b). During the earthquake of June 20,1978 (epicenter 30km from Thessaloniki, magnitude 6.5 grades in Richter scale) a part of the balcony collapsed and the upper half of the cylindrical trunk was slightly translocated (see Fig.1d,2). It must be pointed out that, despite of the damages, no permanent horizontal drift of the structure has been ascertained and no foundation problem has been detected.

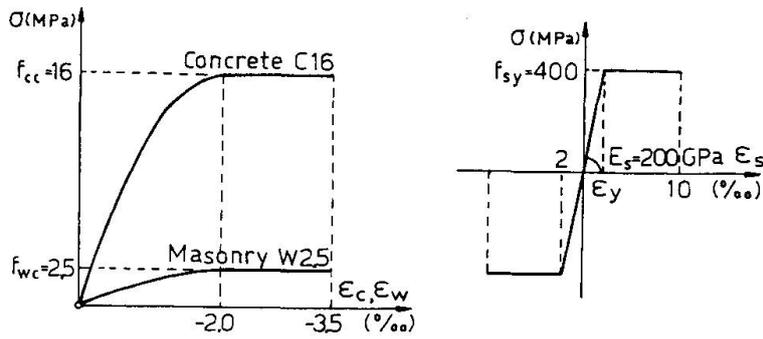
Fig.3 Idealized stress-strain curves for masonry and intervention materials (Concrete, Steel)

Significant difference in the composition of mortars between the highest cylindrical part and the rest of the Minaret below the balcony has been found out, although the compressive strengths of the mortars were almost equal. Consequently, either the Minaret had been erected in two phases, or the part over the balcony had probably been collapsed and rebuilt. In Fig.3 the idealized masonry stress-strain curve adopted for the analyses and the stress-strain curves of concrete and steel for the strengthening interventions are shown.

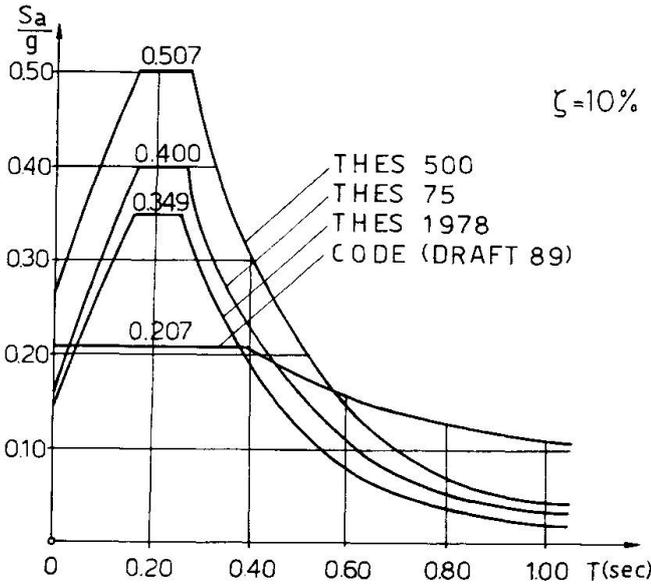
Fig.4 Design seismic acceleration spectrums

To determine the soil shear modulus (G) throughout the foundation depth, two bore holes were drilled very close to the Minaret and the Cross Hole technic was carried out. Resonant Column Tests on foundation red clay samples were also performed. Based on the obtained values of G , the deformational characteristics of appropriate soil springs, necessary for a reliable analytical model, were estimated. The analytical procedure was performed using four elastic acceleration response spectrums. Three of them were based on the seismic excitation of 1978 at the region of Thessaloniki. The motion at bedrock of this earthquake was multiplied by the factors 1.000, 1.267, 1.756 and then, using the SHAKE program [2], the ground motions at the site of Minaret were determined. The first motion (THES 1978, $a_{max}=0.172g$) corresponds to the earthquake of 1978 since the other two correspond to similar earthquakes for return periods of 75 (THES 75, $a_{max}=0.218g$) and 500 years (THES 500, $a_{max}=0.302$). For the estimation of the latter maximum ground accelerations a statistical evaluation of the strong ground motions at the territory from 1500 till 1990 was performed. The adoption of such a long return period (500 years) was necessary because of the monumental character of the structure and the need of a long-life intervention. The fourth response spectrum corresponds to the new Greek Seismic Code (draft 1989). These response spectrums, after being appropriately smoothed and normalised, were multiplied by the foundation factor $\theta=0.8$ and were divided by the behaviour factor $q=1.5$ to take design spectrums (see Fig.4).

The structure at its virginal state was analyzed under the four design spectrums of Fig.4. The corresponding results are presented in Fig.5a by means of eccentricities of the dead load axial forces due to seismic bending moments ($e=M/N$). It must be pointed out that these diagrams are more informative than the conventional bending moments and axial forces diagrams since they include their combined action on the structure. From Fig.5a it is obvious that over the height of about 17m, where the eccentricity curves surround the semi-elevation of the structure, the masonry, having an almost zero tensile strength, is inadequate to carry the pair of (N,M) since the axial forces act outside of the cross section.

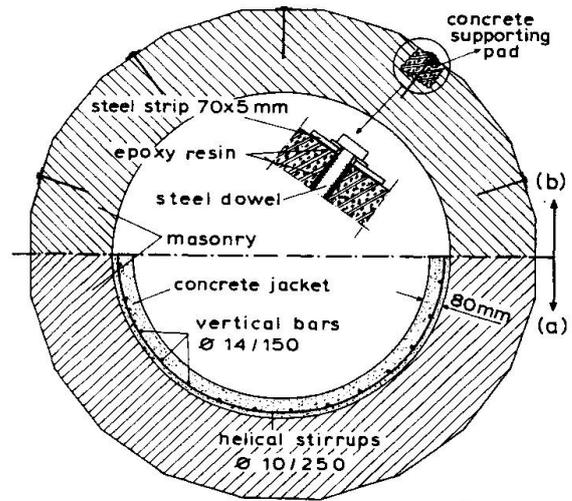
Fig.6 Semisections of Minaret trunk: (a) Internal concrete jacket, (b) External steel strips

The helical concrete jacket, constructed after the 1978 earthquake at the upper 10m of the structure, had a thickness of 80mm and a longitudinal reinforcement $\phi 14/150$, S400. It was decided that the already constructed jacket must be extended, having the same geometrical, mechanical and constructional characteristics (see Fig.6a), by welding the existing longitudinal reinforcements to the new ones. Using the modified analytical model mentioned in chapter 3.1, it was proved that the jacketing had a limited influence on the dynamic characteristics

After some pilot calculations, the use of ten, grade S400, austenitic stainless steel strips having an effective cross section of 50x5mm was adopted (see Fig.6b). Because of the relatively small increase in stiffness and the practically zero increase in mass due to steel strips, the response of the structure, under seismic loads was assumed to be equal to the one of the virginal state. Using the same computer program, the strength curve shown in Fig.5c was calculated and it can be seen that it is almost identical with that of Fig.5b, which means that the selected strengthening proposals are equivalent in strength.

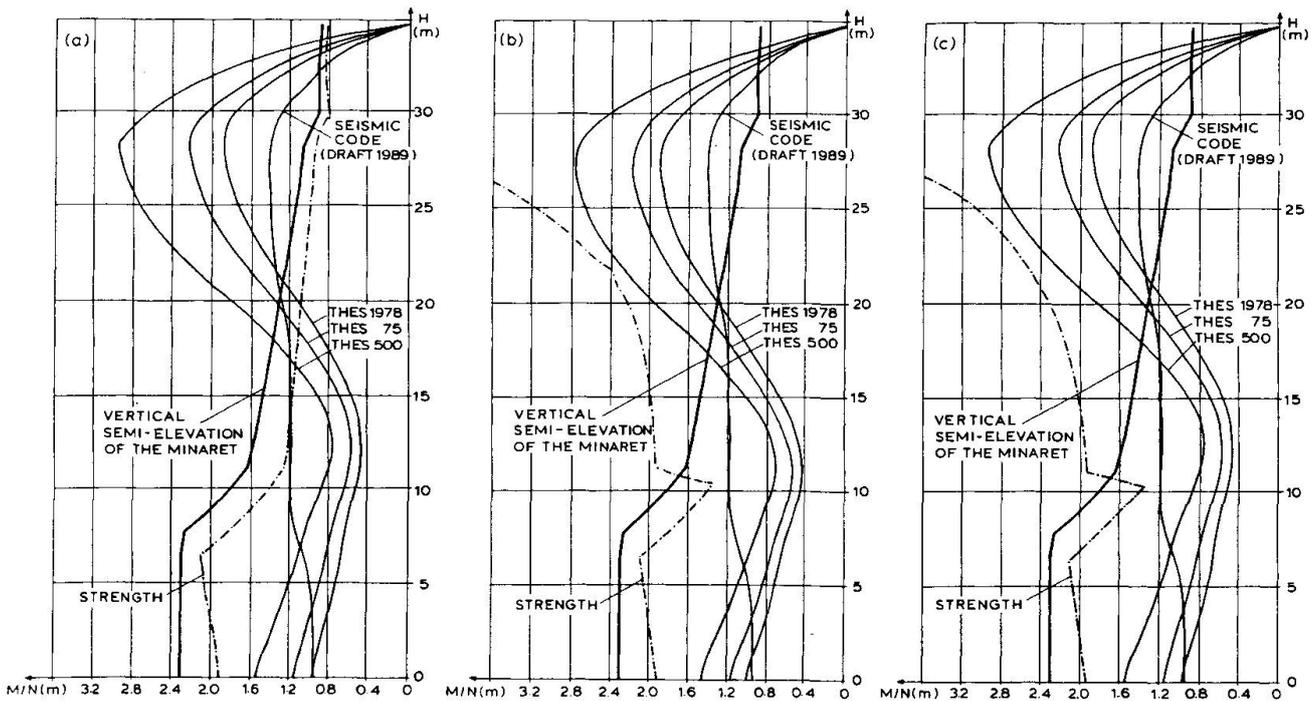
Fig.5 Eccentricity curves under seismic spectrums and strength eccentricity curve: (a) Virginal state, (b) Concrete jacket, (c) External steel strips

In order to determine more precisely the region of the structure which needs to be strengthened, the strength curve shown in Fig.5a was determined with the aid of a specific computer program which can calculate the ultimate bending moment, under a given axial force, of a polygonal section composed of various materials (masonry, concrete, steel) and given stress-strain relations of the materials (see Fig.3). It can be seen that under the height of 14m, the structure is adequate to carry out the combination of dead and seismic loads. In order to secure a reasonable safety factor, slightly greater than one, it was decided that the region to be strengthened extends from 12m height to the top of the structure.

of the structure. In Fig.5b, the eccentricities of the axial forces due to seismic bending moments under the design spectrums of Fig.4 are shown. It is obvious that, in comparison to the relative curves of Fig.5a, the differences are small. The calculation of the ultimate bending moment of the cross sections under the acting axial force was based on the specific computer program mentioned in chapter 3.2. From the strength curve, shown in Fig.5b, it can be concluded that the strengthening proposal is adequate.
