Artikel: Strengthening of a 400 year old Ottoman Minaret

Autor: Penelis, George / Papayianni, Ioanna / Stylianidis, Kosmas

Renforcement d'un minaret ottoman de 400 ans Verstärkung eines 400 Jahre alten ottomanischen Minaretts

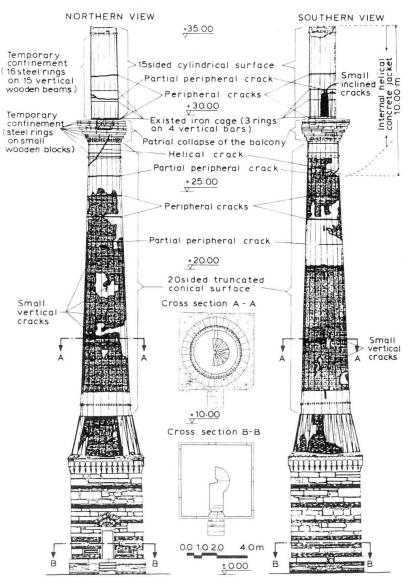
Fig.2 Northern and Southern elevations of the Minaret. Cracking pattern, external emergency interventions

present century. Successive horizontal peripheral cracks have been ascertained at the upper two fifths of the Minaret and have been drawn in Fig.2. There is one helical crack starting from the highest loophole, following the ascenting steps and cutting the balcony. All the cracks, being under vertical compression, are just visible (see Fig.1b). During the earthquake of June 20,1978 (epicenter 30km from Thessaloniki, magnitude 6.5 grades in Richter scale) a part of the balcony collapsed and the upper half of the cylindrical trunk was slightly translocated (see Fig.1d,2). It must be pointed out that, despite of the damages, no permanent horizontal drift of the structure has been ascertained and no foundation problem has been detected.

As it can be easily seen in Fig.2, the base of the Minaret is unplastered. The plaster covering has been collapsed at the major part of the trunk, while at the rest of the surface, as well as at the upper cylindrical trunk, it is heavily cracked. Limited superficial deterioration of masonry, especially at the northern face of the trunk has been detected and confirmed by the hammer tests. The wooden beams at the highest steps of the staircase have been heavily corroded due to rain water passing through the open top, as the wooden acute conical roof of the Minaret fall down, probably during an earthquake, at the begining of the

Emergency works were undertaken just after the 1978 earthquake including general external scaffolding (see Fig.1a) and temporary external confinement by steel rings and wooden beams as well as internal helical concrete jacket at the upper 10m of the Minaret (see Fig.1d,2).

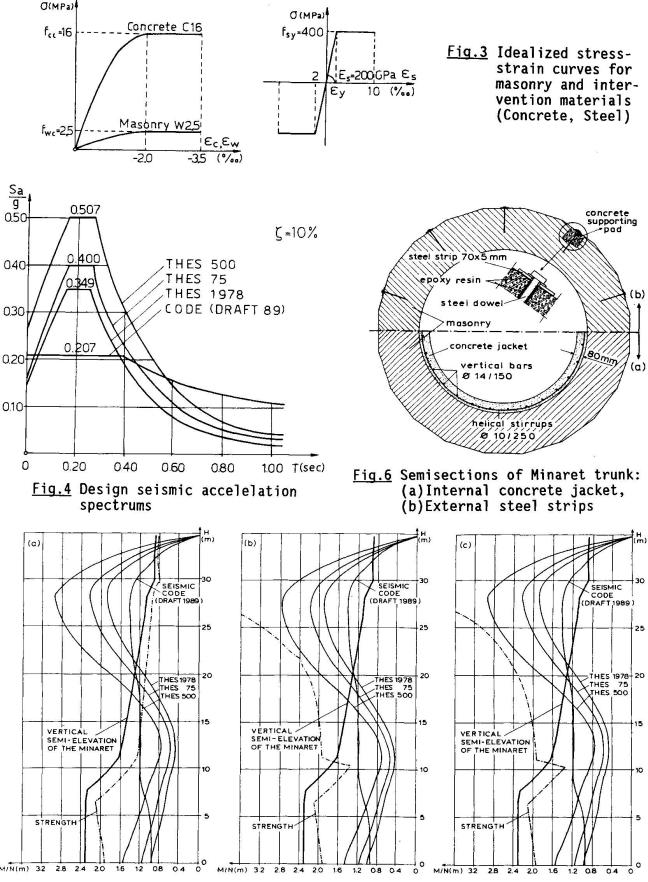
Fig.5 Eccentricity curves under seismic spectrums and strength eccentricity curve: (a) Virginal state, (b) Concrete jacket, (c) External steel strips

The structure at its virginal state was analyzed under the four design spectrums of Fig.4. The corresponding results are presented in Fig.5a by means of eccentricities of the dead load axial forces due to seismic bending moments (e=M/N). It must be pointed out that these diagrams are more informative than the conventional bending moments and axial forces diagrams since they include their combined action on the structure. From Fig.5a it is obvious that over the height of about 17m, where the eccentricity curves surround the semi-elevation of the structure, the masonry, having an almost zero tensile strength, is unadequate to carry the pair of (N,M) since the axial forces act outside of the cross section.

In order to determine more precisely the region of the structure which needs to be strengthened, the strength curve shown in Fig.5a was determined with the aid of a specific computer program which can calculate the ultimate bending moment, under a given axial force, of a polygonal section composed of various materials (masonry, concrete, steel) and given stress-strain relations of the materials (see Fig.3). It can be seen that under the height of 14m, the structure is adequate to carry out the combination of dead and seismic loads. In order to secure a reasonable safety factor, slightly greater than one, it was decided that the region to be strengthened extends from 12m height to the top of the structure.

of the structure. In Fig.5b, the eccentricities of the axial forces due to seismic bending moments under the design spectrums of Fig.4 are shown. It is obvious that, in comparison to the relative curves of Fig.5a, the differences are small. The calculation of the ultimate bending moment of the cross sections under the acting axial force was based on the specific computer program mentioned in chapter 3.2. From the strength curve, shown in Fig.5b, it can be concluded that the strengthening proposal is adequate.

After some pilot calculations, the use of ten, grade S400, austenitic stainless steel strips having an effective cross section of 50x5mm was adopted (see Fig.6b). Because of the relatively small increase in stiffness and the practically zero increase in mass due to steel strips, the response of the structure, under seismic loads was assumed to be equal to the one of the virginal state. Using the same computer program, the strength curve shown in Fig.5c was calculated and it can be seen that it is almost identical with that of Fig.5b, which means that the selected strengthening proposals are equivalent in strength.
