## Restoration Process of the Fronteira Palace

### Frederico H. GEORGE

### Jorge N. BASTOS

### SUMMARY

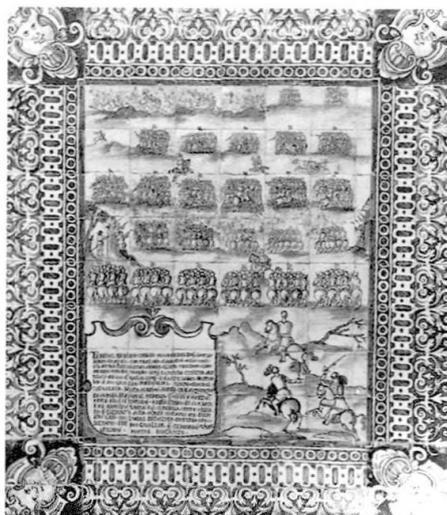
Fig. 3 - Battle Room "Azulejos" Panel.

The rich decoration with its glazed ceramic tiles, the "azulejos", makes it one of the most interesting palaces in Portugal. Particularly interesting are the Battle Room "azulejos" which contain a remarkable series of battle scenes portraying the military history of the Restoration War (1640-1667), e.g., the battles of São Miguel (1658), Elvas (1659), Ameixial (1663) and Montes Claros (1665), Fig. 3. In these battles which guaranteed the Independence of Portugal from Spain, until the peace treaty signed in 1668, the First Marquis de Fronteira, D. João de Mascarenhas, is depicted in battle scenes where he distinguished himself with particular bravery.

a. "Azulejos" Panel

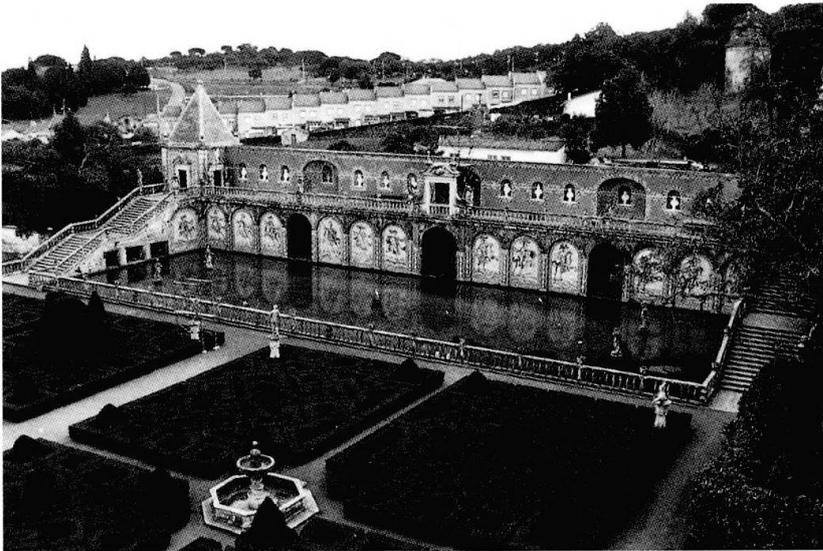
Fig. 5 - The Kings Gallery and the Great Lake

Adjacent to the Classical Garden is the Kings Gallery (7) with the remarkable marble statues (first floor) and the "azulejos" panels depicting twelve knights and two Marquis of Fronteira. The spatial effect created by the reflection in the Great Lake pond strongly enhances the garden, the Kings Gallery and the Palace building ensemble, Fig 5.
