**Zeitschrift:** IABSE reports = Rapports AIPC = IVBH Berichte  
**Band:** 70 (1993)

**Artikel:** Case studies of structural preservation in Taiwan  
**Autor:** Lee, Horng-Ji / Jiang, Du-Hsin / Lai, Cheng-Hsiung  
**DOI:** <https://doi.org/10.5169/seals-53360>

## Case Studies of Structural Preservation in Taiwan

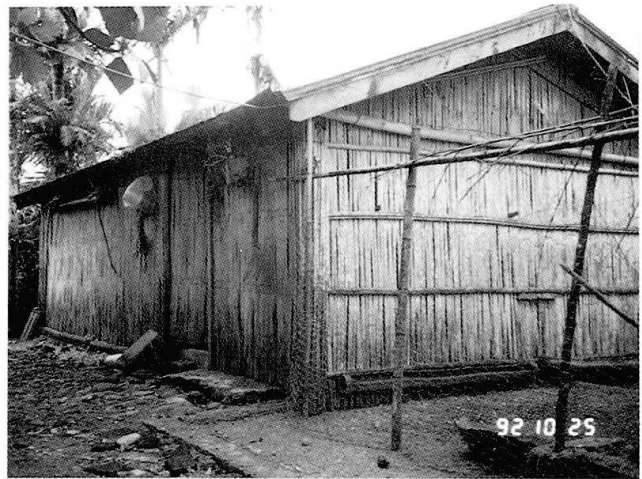
Fig. 2 Bamboo house of an  
aboriginal

In this paper we take some examples of the removing and reconstruction of the homestead, most of them are wooden structures used for Chinese immigrant clan to Taiwan or the aboriginal cottages, for case study (Fig.1,2). The way of study are thus:

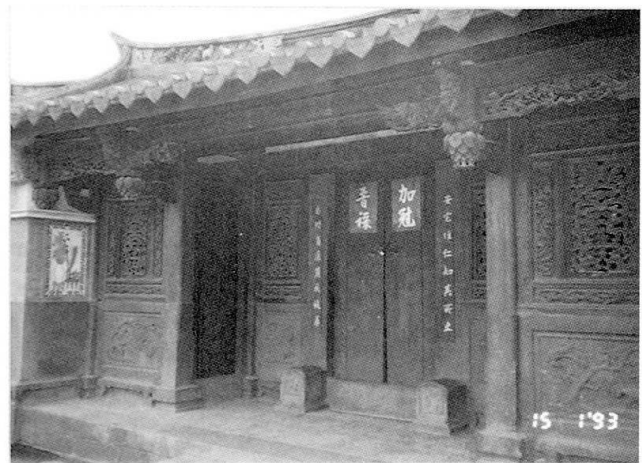
Fig. 4 The stone carving part

- B. The stone carving part: The stone materials are all connected by using hidden dovetail keys, and the stone materials and the wood materials are also connected by the use of tenons and mortises. The same is true of the doorposts, wainscots, stone thresholds, and pillar bases. With ordinary houses, the stone hinges and the doorpost pedestals are two separate parts, but in the Homestead they are carved as an integrate piece. The same skill is applied to the stone hinges at the bottom. The stone steps, stone wall bases and the friezes are all well proportioned in their dimensions. The igneous stone used in paving the inner court, the open drain, and the front court, though not carved very exquisitely, are well selected, and their sizes are all very accurated. Owing to their old age, the stone slates are no longer very even; but the crevices were adjusted by using copper coins as tools, and ground leveling was secured by melting lead underneath. These all show the great care taken in its construction (Fig.4).

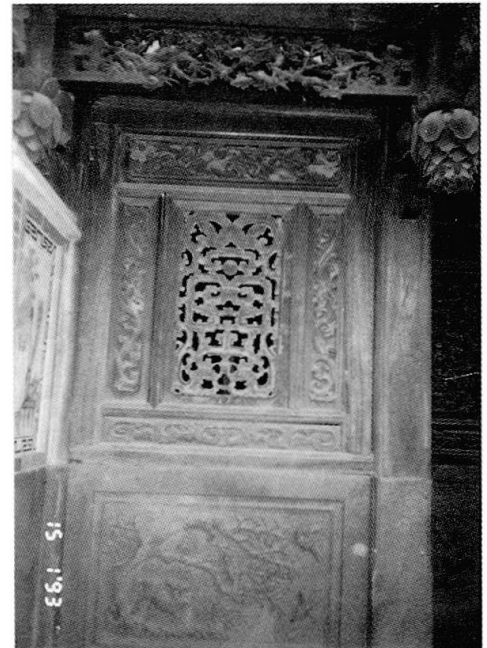
Fig. 6 The fine wood carving on window and door

- D. The fine wood carving and the windows and doors: The main gate and the slide windows of the main hall are carved hollow. The ornamented waist panels design and engraving techniques are different from one another. The wainscots and waist panels of the doors and bar windows are all carved in one whole piece. The bar windows are of various designs, and since most of them are composed of many single pieces, they are fragile and not easy to preserve. Most of them have decayed and became loose which makes them rather difficult to repair after they are dismantled (Fig.6).
